# Investigation report

## Rejected take-off and runway overrun, Tarlton Springs - ATSB-style final report

Drafted 05/10/2026

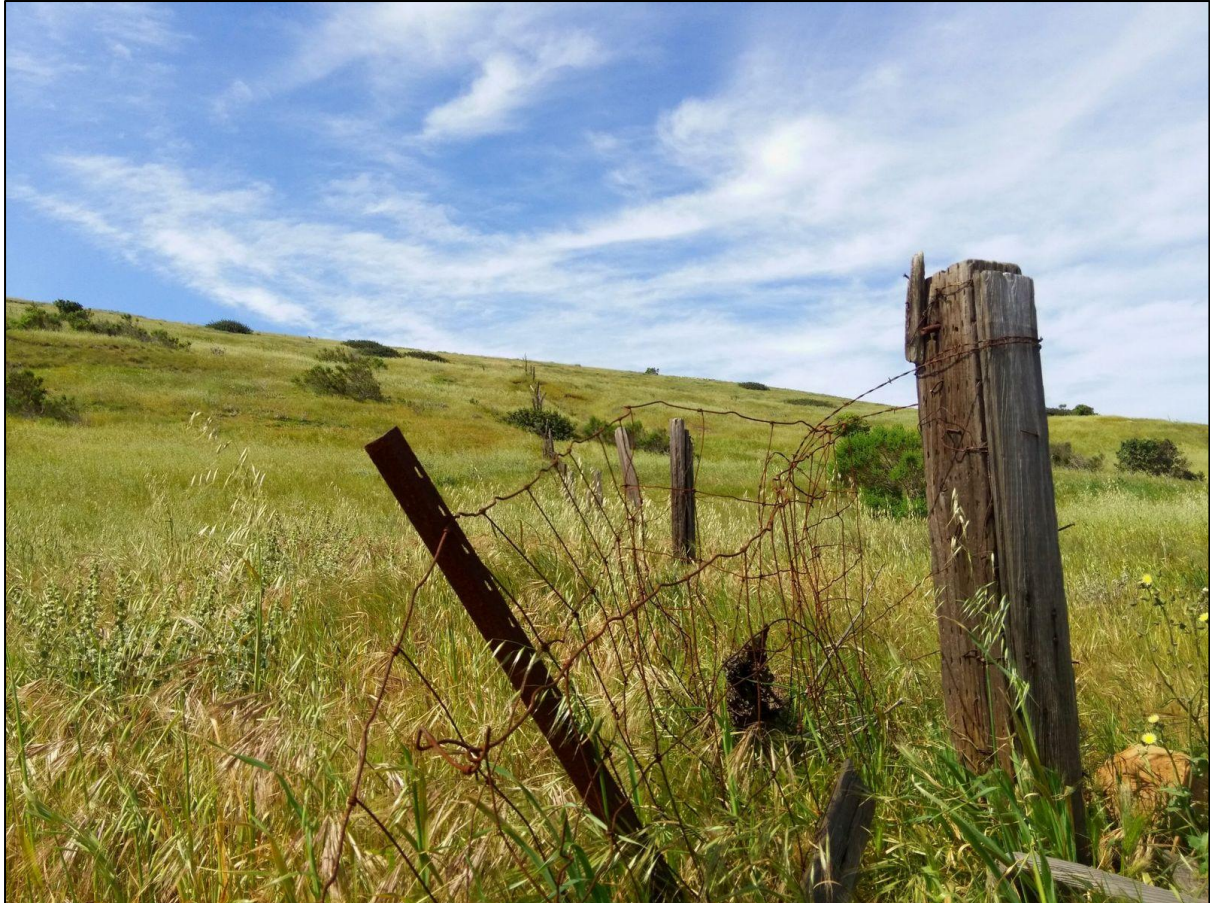
On 23/06/2026 a continuous 140 m section of the northern fence had its bottom two wires separated from the posts. A clear animal pad ran through the fence at the 1,050 m mark (Figure 1), on the same side as the carcasses and 138 m before the first carcass at 1,188 m.

*Figure 1: The northern perimeter fence at the 1,050 m mark, photographed on the site visit: the fallen section and the animal pad through it. Site inspection photograph SV-2026-0417-07, northern boundary at the 1,050 m runway marker, taken 23/06/2026*

The aerodrome operator's works register shows that the northern perimeter fence was known to have failed more than three years before the occurrence. Item WR-221, raised in 04/2023, recorded four displaced panels and strained wire on the northern boundary between the 700 m and 1,300 m runway markers, and noted that animals had been seen passing through. Replacement was recommended at an estimated cost of \$41,000. The item was deferred as unfunded at the 2023, 2024 and 2025 budget rounds, and each deferral carried it forward for review at the next cycle. In 02/2026, item WR-263 recorded that the same section was deteriorating further.

The site inspection on 23/06/2026 found the fence in that condition. A continuous 140 m section had the bottom two wires separated from the posts, and a clear animal pad ran through the fence at the 1,050 m mark (Figure 1). The runway survey recovered the two carcasses at 1,188 m and 1,221 m from the runway 09 threshold, on the same side of the runway as the breach. The first officer saw the animals moving onto the runway from the northern side, past the 1,100 m point, and crossing towards the south.

It was virtually certain that the fence had been left unrepaired across three budget cycles. The aerodrome operator's own register documents the deferrals, and the site inspection confirmed the condition of the fence. A fence in that condition does not exclude kangaroos. The animal pad through the breach lay directly upstream of the strike position, so the breach was the physical route by which the animals reached the movement area. On that basis it was very likely that the deferred repair contributed to the two kangaroos entering the runway strip and moving onto the sealed surface.

- It is virtually certain that the repair of the failed northern perimeter fence was deferred for three budget cycles, and very likely that this contributed by leaving an animal route through the fence 138 m before the first carcass position, on the same side of the runway. (Safety Issue)

inspection before every departure there after last light. On 25/06/2026 the aerodrome operator installed a temporary electric wire. It funded the fence repair from its 2026 contingency and programmed replacement of the 140 m section for 09/2026. The investigation recommended that the operator list aerodromes on wildlife exposure rather than a reported strike. It also recommended a route risk assessment trigger for any aerodrome first operated into after last light. No safety action has been recorded for the other safety issues.
