# **E/I/I test tables**

Rejected take-off and runway overrun, Tarlton Springs

Exported 3 October 2026

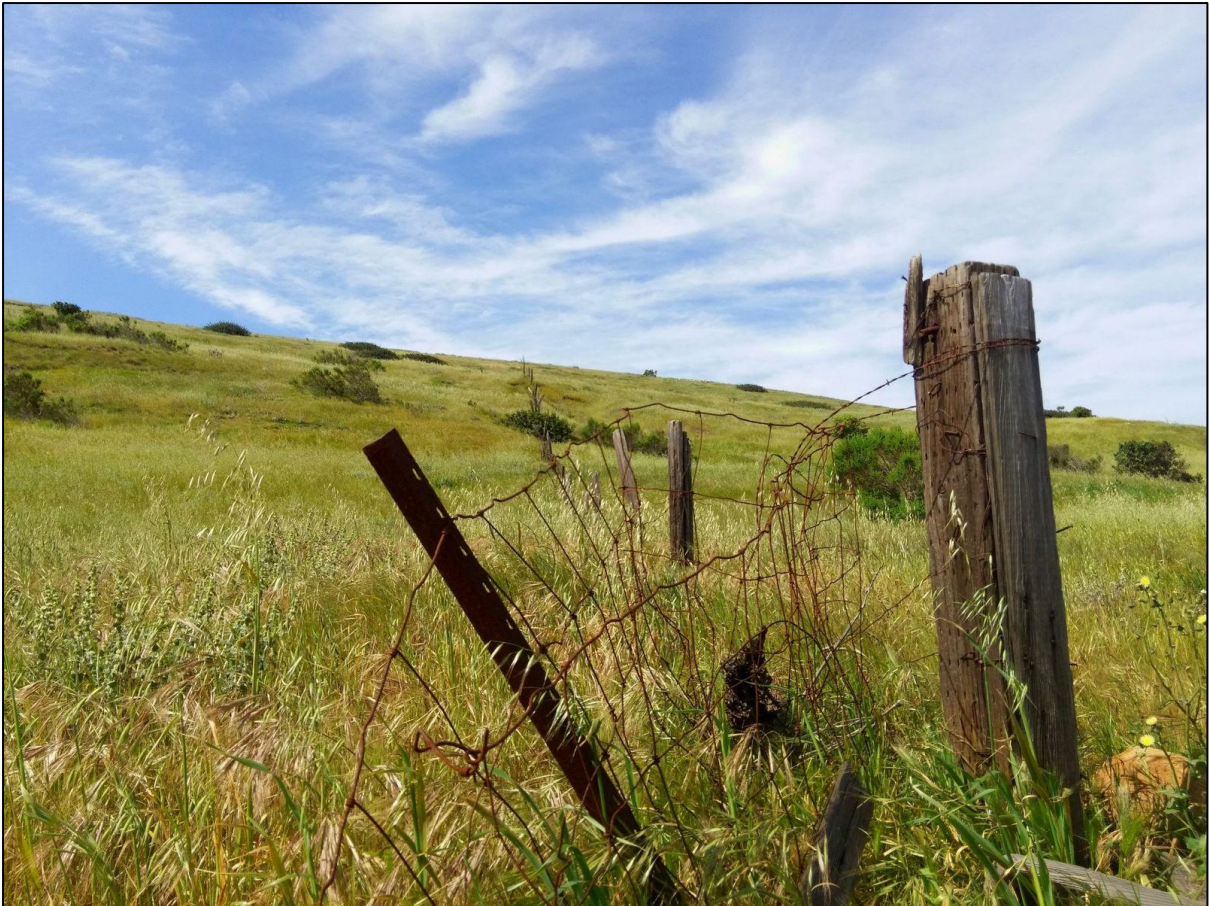
| Test | Result | Supporting text |
|---|---|---|
| Existence | Pass - virtually certain (100%) | Works register item WR-221, raised 04/2023: four displaced panels and strained wire on the northern boundary between the 700 m and 1,300 m runway markers, with animals observed passing through, replacement estimated at \$41,000. Deferred at the 2023, 2024 and 2025 budget rounds, each entry reading 'defer, unfunded, review next cycle'. WR-263 (02/2026) records the same section deteriorating further. The investigator's site inspection on 23/06/2026 found a continuous 140 m section with the bottom two wires separated from the posts and a clear animal pad through the fence at the 1,050 m mark, 110 m before the point at which the first carcass was recovered. |
| Influence | Pass - very likely (90%) | This is the physical route by which the animals reached the movement area. The pad through the fence at 1,050 m and the carcasses at 1,188 m and 1,221 m are 140 m apart on the same side of the runway. |

Item WR-221, raised 04/2023: "Perimeter fence, northern boundary between the 700 m and 1,300 m runway markers, four panels displaced and wire strained, animals observed passing through. Recommend replacement, estimated \$41,000." Deferred at the 2023, 2024 and 2025 budget rounds, each time with the entry "defer, unfunded, review next cycle". Item WR-263, raised 02/2026, records the same section as "deteriorating further". A site inspection on 23/06/2026 found a continuous 140 m section of the northern fence with the bottom two wires separated from the posts and a clear animal pad through it at the 1,050 m mark.

*The northern perimeter fence at the 1,050 m mark, photographed on the site visit: the fallen section and the animal pad through it. Site inspection photograph SV-2026-0417-07, northern boundary at the 1,050 m runway marker, taken 23/06/2026*
