# Investigation report

## Rejected take-off and runway overrun, Tarlton Springs - Executive brief

Drafted 02/10/2026

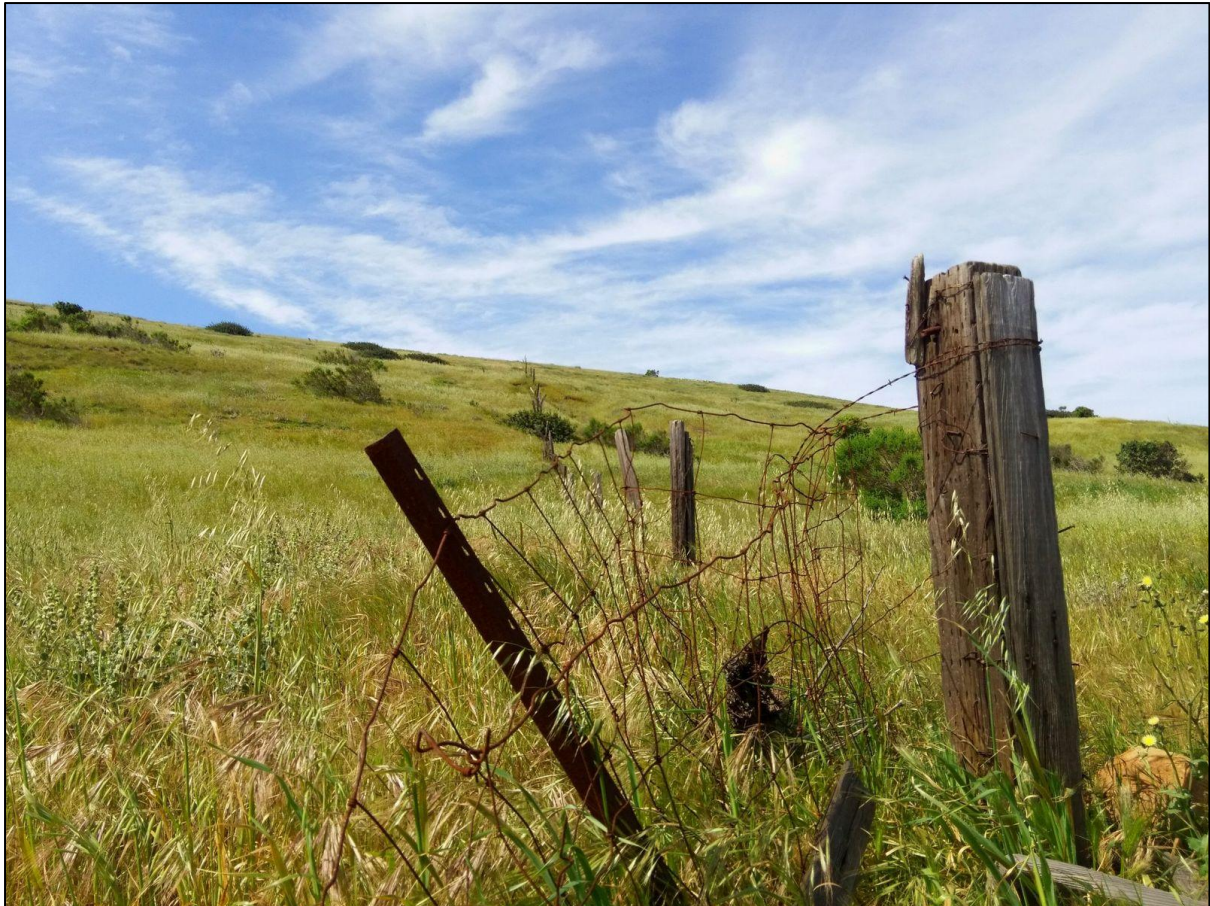
The kangaroos were on the runway for several connected reasons. The aircraft departed in the hour after last light, which is the peak period of kangaroo movement, and it was likely that this timing contributed. The repair of the aerodrome perimeter fence had been deferred for three budget cycles. It was very likely that this deferral contributed to the animals reaching the runway, and it was a safety issue. A documented wildlife plan was required only at aerodromes above a size threshold, and Tarlton Springs did not meet that threshold. It was likely that this requirement influenced both the fence deferral and the runway inspection arrangements described below. This was also a safety issue.

- The perimeter fence repair had been deferred for three budget cycles, which was virtually certain, and this deferral very likely contributed to the occurrence. (Safety issue)

*Figure 1: The northern perimeter fence at the 1,050 m mark, photographed on the site visit: the fallen section and the animal pad through it. Site inspection photograph SV-2026-0417-07, northern boundary at the 1,050 m runway marker, taken 23/06/2026*

**Perimeter fence repair deferred for three budget cycles.** The northern fence remained unrepaired when the investigation inspected it on 23 June 2026. No action has been recorded against this issue. [NOT ESTABLISHED: any decision by the aerodrome operator to fund or carry out the repair, and its status]
