# Preliminary investigation update

Rejected take-off and runway overrun, Tarlton Springs - Preliminary investigation update

Drafted 02/10/2026

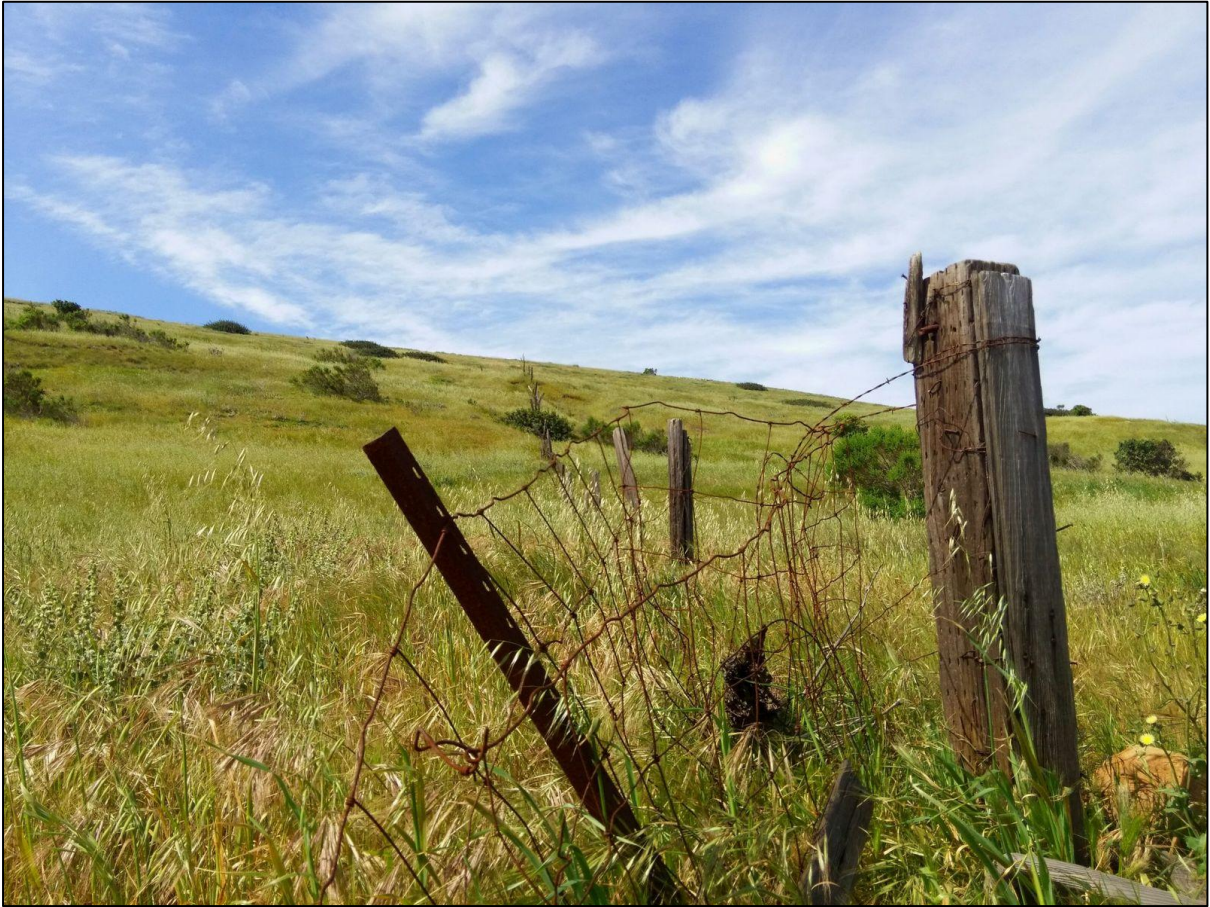
- 1. How the animals reached the runway.** The investigation is examining the northern perimeter fence, its repair history and the aerodrome's wildlife arrangements. The fence was recorded as damaged in 04/2023, with animals seen passing through. Its repair was deferred at three budget rounds. An animal track through it was found at the 1,050 m mark, on the same side of the runway as both carcasses. The aerodrome falls below the size threshold in AS-139 10.4.2 that would require a documented wildlife plan.

*Figure 1: The northern perimeter fence at the 1,050 m mark, photographed on the site visit: the fallen section and the animal pad through it. Site inspection photograph SV-2026-0417-07, northern boundary at the 1,050 m runway marker, taken 23/06/2026*

- **Perimeter fence.** The aerodrome operator installed a temporary electric wire on 25/06/2026. It has funded the northern boundary fence repair from its 2026 contingency and programmed replacement of the 140 m section for 09/2026. This work is still being implemented. [NOT ESTABLISHED: whether the fence replacement programmed for 09/2026 has been completed]
