# Investigation report

Rejected take-off and runway overrun, Tarlton Springs - Standard investigation

Drafted 02/10/2026

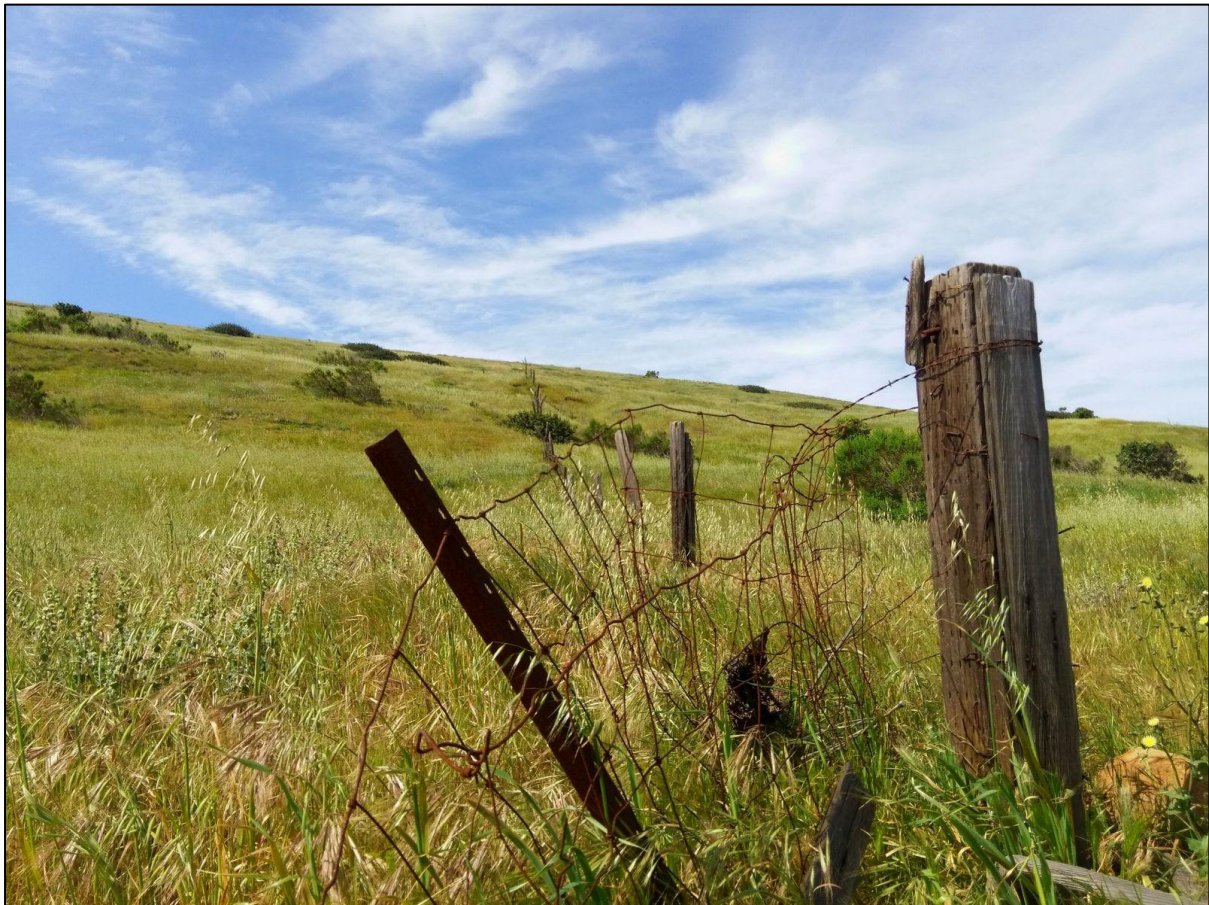
The failure of the northern fence was known to the aerodrome operator for more than three years before the occurrence. Works register item WR-221, raised in 04/2023, recorded four displaced panels and strained wire on the northern boundary between the 700 m and 1,300 m runway markers. It also recorded that animals had been observed passing through. Replacement was estimated at \$41,000.

The repair was deferred at the 2023, 2024 and 2025 budget rounds. Each time it was recorded as unfunded and to be reviewed at the next cycle. Item WR-263, raised in 02/2026, recorded that the same section was deteriorating further.

The investigator's site inspection on 23/06/2026 found a continuous 140 m section of the northern fence with the bottom two wires separated from the posts. There was a clear animal pad through the fence at the 1,050 m mark (Figure 1).

*Figure 1: The northern perimeter fence at the 1,050 m mark, photographed on the site visit: the fallen section and the animal pad through it. Site inspection photograph SV-2026-0417-07, northern boundary at the 1,050 m runway marker, taken 23/06/2026*

The breach is the most likely physical route by which the animals reached the movement area. The pad at 1,050 m lies on the northern side, the same side from which the animals crossed and on which the carcasses were recovered at 1,188 m and 1,221 m. A fence in the condition found does not exclude kangaroos. The animal pad was directly upstream of the strike position. Nothing in this

It was virtually certain that the perimeter fence repair was deferred for three budget cycles, and very likely that this contributed to the two kangaroos entering the runway strip and moving onto the sealed surface (Safety Issue).

- The operator listed Tarlton Springs in Appendix 8A by temporary revision on 26/06/2026.
- The aerodrome operator funded the fence replacement for 09/2026 and installed a temporary electric wire on 25/06/2026.
- The investigation recommended that the operator base Appendix 8A listing on wildlife exposure rather than a reported strike, and add a route risk assessment trigger for any aerodrome first operated into after last light.
