# Evidence and Argument Tables

Rejected take-off and runway overrun, Tarlton Springs

INVESTIGATION WORKFLOW SUITE

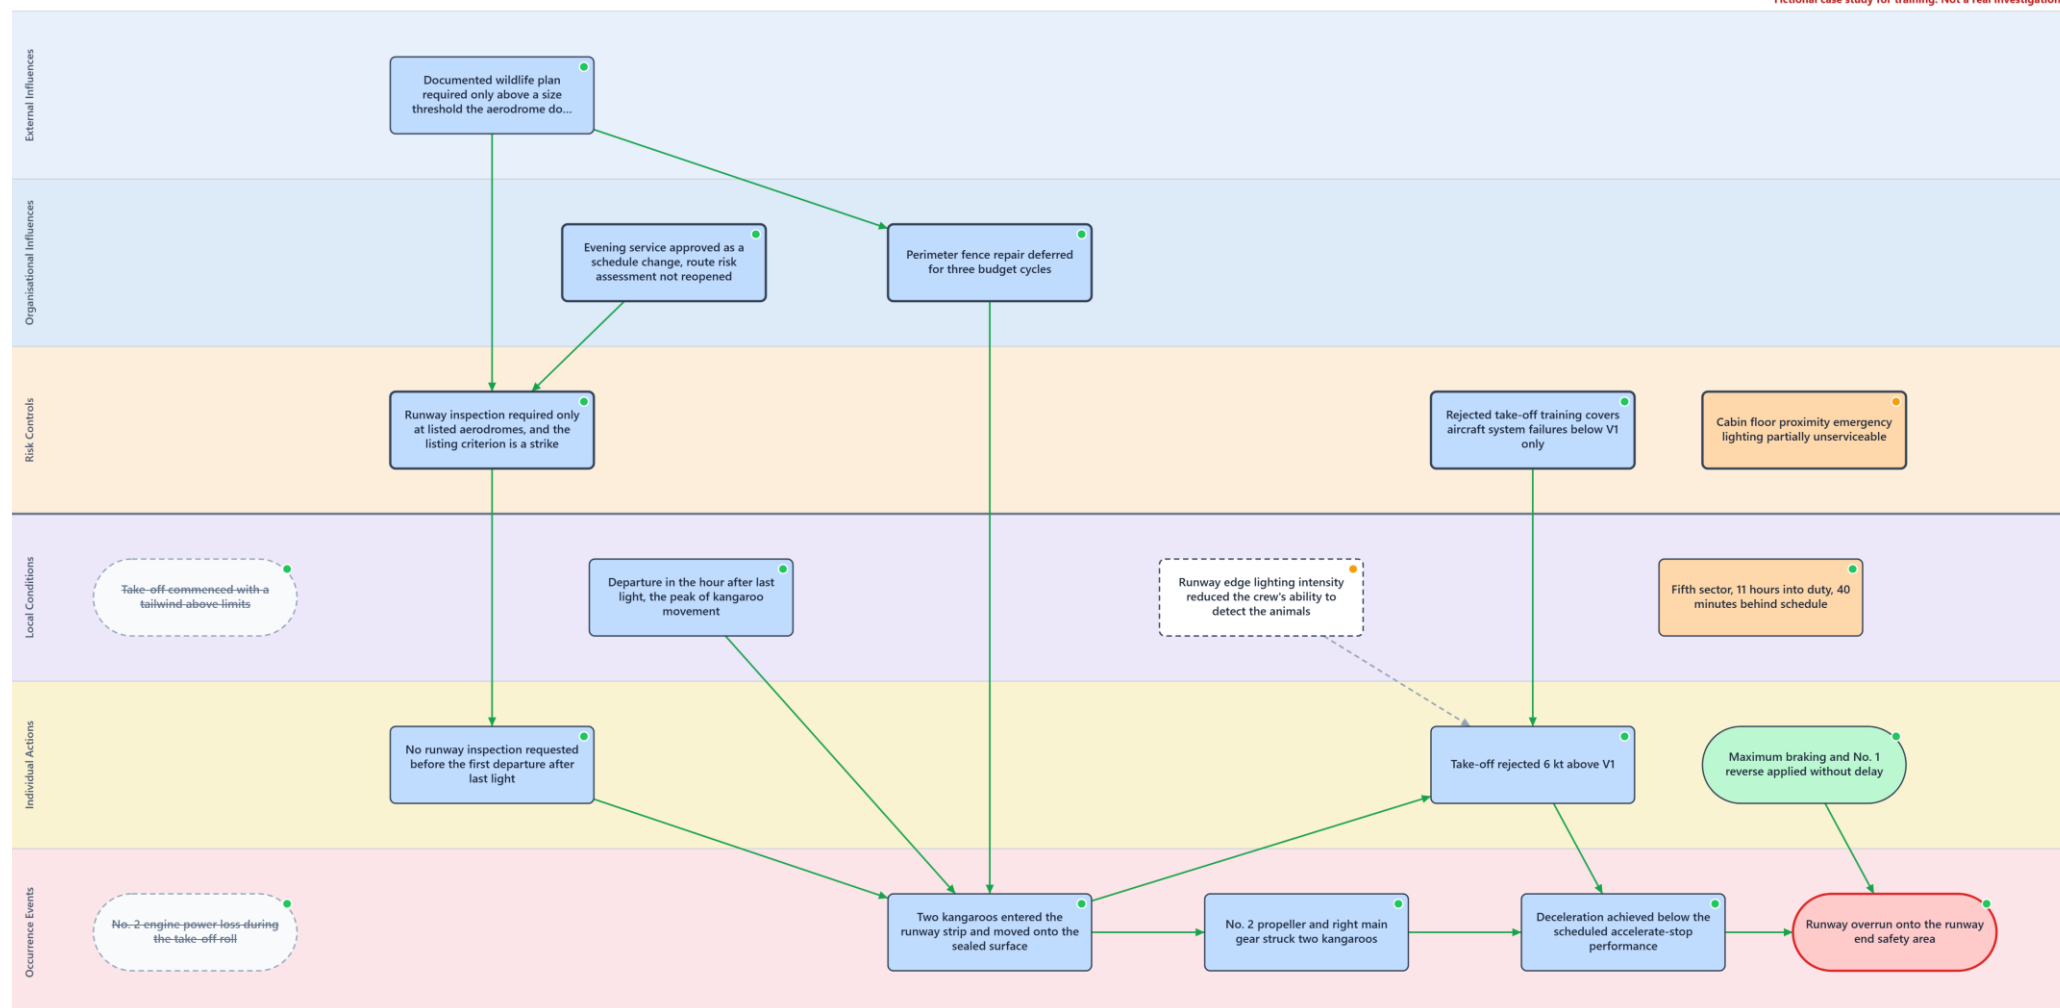
## AcciMap

Existence: did it exist or occur? Influence: did it influence this occurrence? Importance: is it worth addressing regardless?
