# Investigation report

## Rejected take-off and runway overrun, Tarlton Springs - Standard investigation

Drafted 05/10/2026

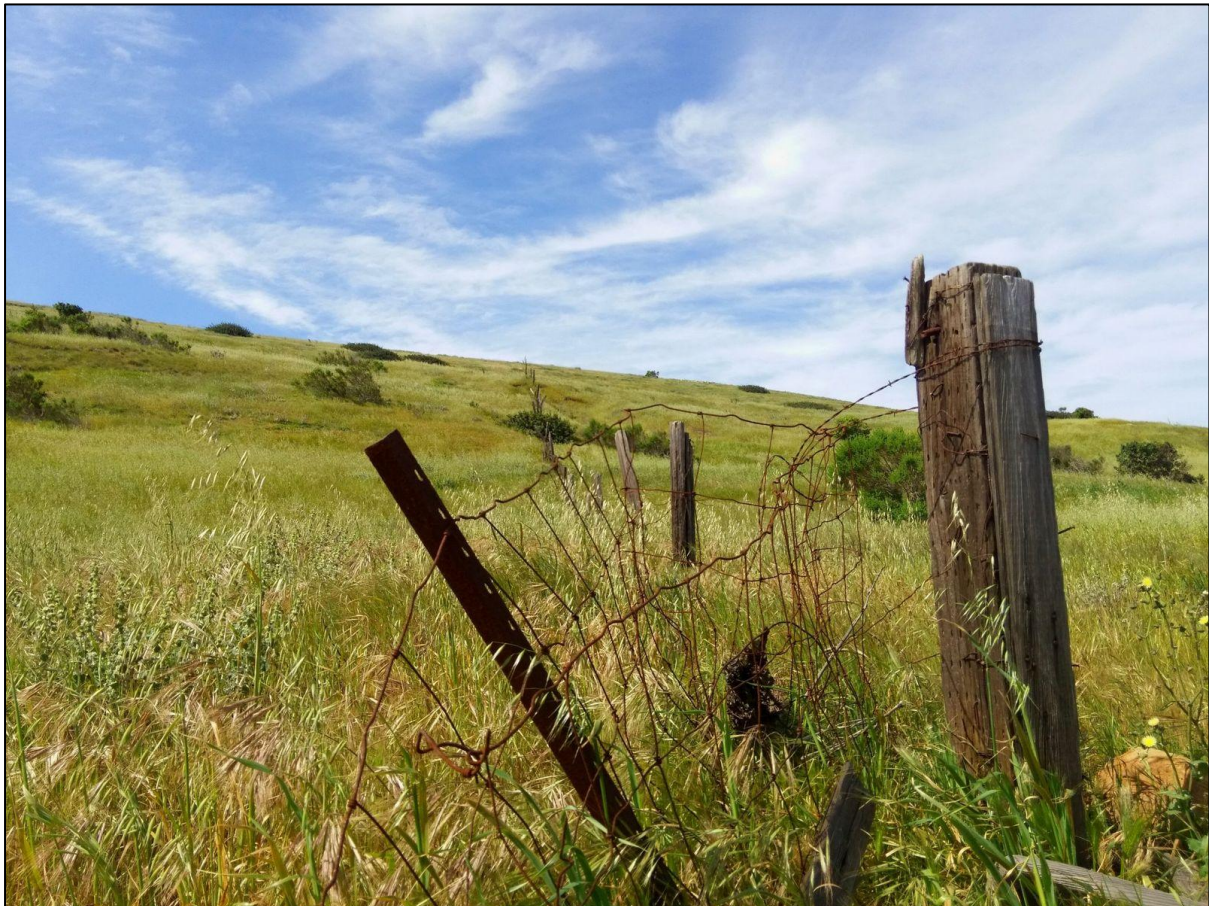
The failure of the northern perimeter fence was known to the aerodrome operator for more than three years before the occurrence. Works register item WR-221, raised in 04/2023, recorded four displaced panels and strained wire on the northern boundary between the 700 m and 1,300 m runway markers. It recorded that animals had been observed passing through and recommended replacement at an estimated \$41,000.

The item was deferred at the 2023, 2024 and 2025 budget rounds. Each deferral was recorded as unfunded, for review at the next cycle. Item WR-263, raised in 02/2026, recorded the same section as deteriorating further.

The investigator's site inspection on 23/06/2026 found a continuous 140 m section of the northern fence with the bottom two wires separated from the posts. A clear animal pad ran through it at the 1,050 m mark (Figure 1). The pad is 138 m before the first carcass at 1,188 m, on the same side of the runway. It is also consistent with the first officer's observation of the animals crossing from the northern side.

*Figure 1: The northern perimeter fence at the 1,050 m mark, photographed on the site visit: the fallen section and the animal pad through it. Site inspection photograph SV-2026-0417-07, northern boundary at the 1,050 m runway marker, taken 23/06/2026*

It is virtually certain that repair of the northern perimeter fence was deferred for three budget cycles, and very likely that this contributed to the kangaroos entering the runway strip and moving onto the sealed surface (Safety Issue).

On 26/06/2026 the operator listed Tarlton Springs in Appendix 8A by temporary revision. The aerodrome operator installed a temporary electric wire on 25/06/2026 and funded fence replacement for 09/2026. The investigation makes two recommendations to the operator. It should list aerodromes on wildlife exposure rather than a reported strike. It should also trigger a route risk assessment for any aerodrome it first operates into after last light.
