## Preliminary investigation report

# Rejected take-off and runway overrun, Tarlton Springs

07/10/2026

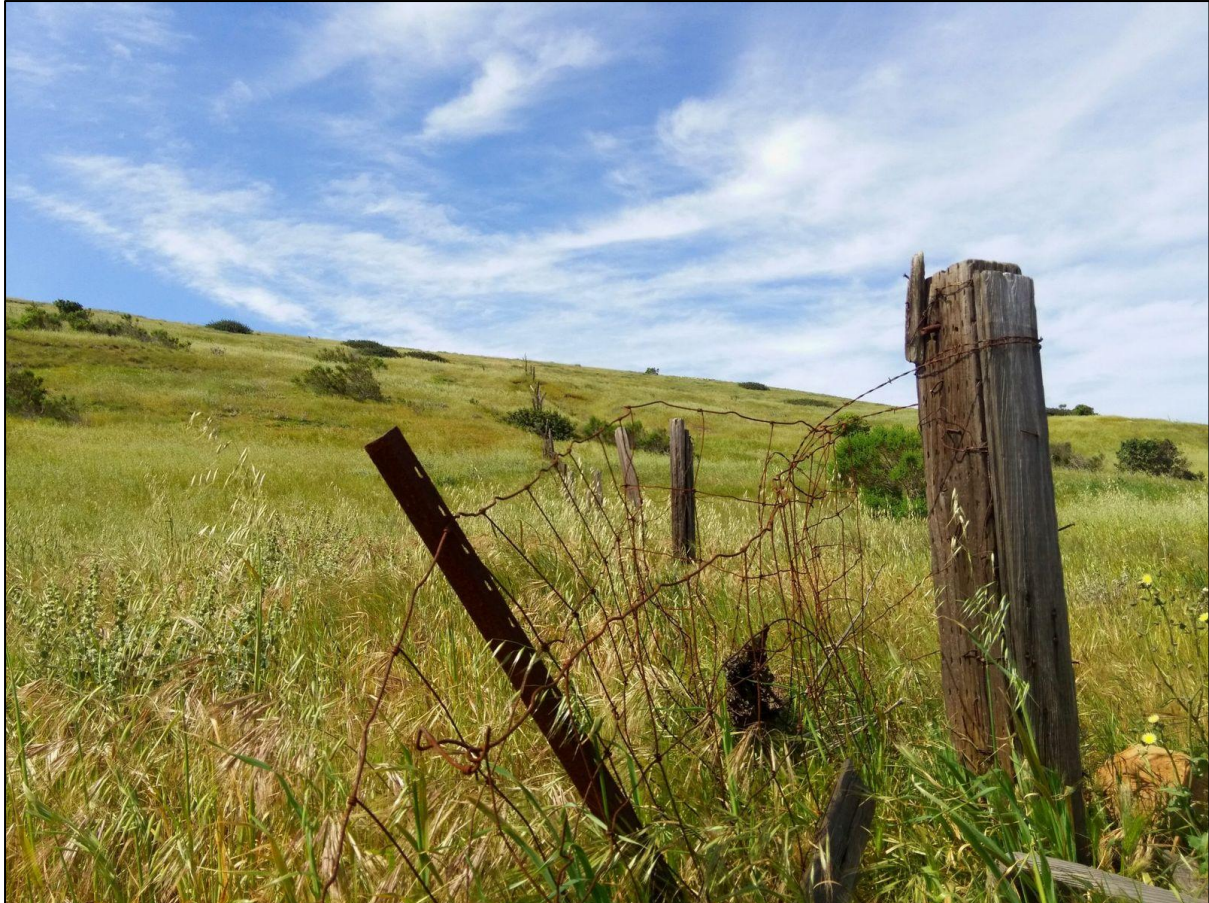
1. **How the animals reached the runway.** The investigation is examining the northern perimeter fence and the aerodrome's use of its wildlife sighting log. Works register item WR-221 recorded the fence as failed in 04/2023, and the repair was deferred at three budget rounds. An animal pad through the fence at the 1,050 m mark (Figure 1) lies 138 m before the first carcass, on the same side of the runway.

*Figure 1: The northern perimeter fence at the 1,050 m mark, photographed on the site visit: the fallen section and the animal pad through it. Site inspection photograph SV-2026-0417-07, northern boundary at the 1,050 m runway marker, taken 23/06/2026*

- The Head of Flying Operations suspended the evening Tarlton Springs service on 19/06/2026. [NOT ESTABLISHED: whether the suspension remains in place]
- On 26/06/2026 the Head of Flying Operations amended Appendix 8A by temporary revision TR-2026-04 to list Tarlton Springs. The Part A 8.14.2 runway inspection now applies to every departure there after last light, pending a permanent change. This action is in place.
- The aerodrome operator has funded works register item WR-221 from its 2026 contingency. A temporary electric wire was installed on 25/06/2026. Replacement of the 140 m northern boundary fence section is programmed for 09/2026, and this action is still being implemented.
