Final investigation report

# Rejected take-off and runway overrun, Tarlton Springs

07/10/2026

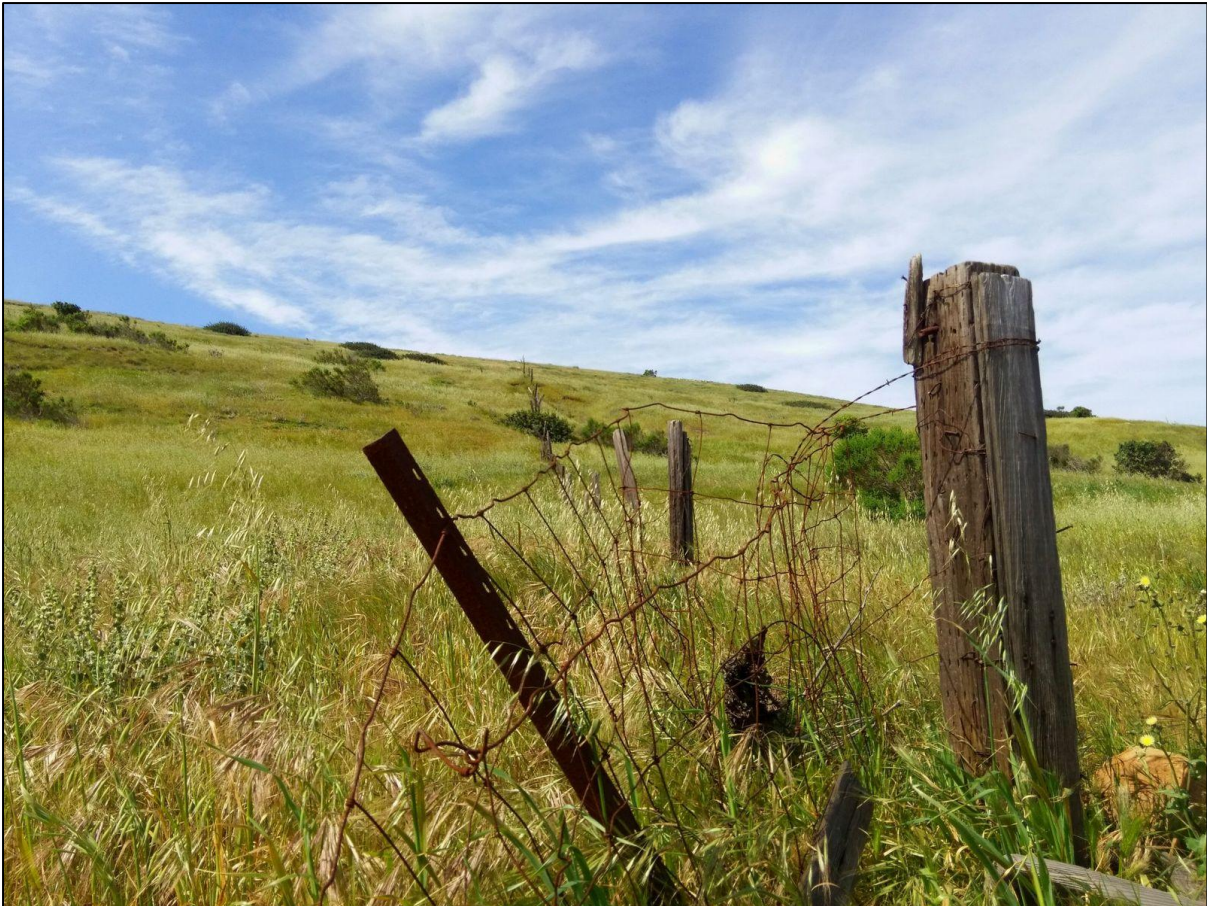
Their route onto the runway is a separate question, and it is examined under Organisation. The geometry is nonetheless relevant here. The animal pad through the failed northern fence is at the 1,050 m mark, 138 m before the first carcass and on the same side of the runway (Figure 1). The aerodrome's sighting log holds eleven entries for kangaroos on the sealed surface of runway 09/27, all around last light. No inspection had been carried out since 07:35 local.

*Figure 1: The northern perimeter fence at the 1,050 m mark, photographed on the site visit: the fallen section and the animal pad through it. Site inspection photograph SV-2026-0417-07, northern boundary at the 1,050 m runway marker, taken 23/06/2026*

raised in 02/2026, described the same section as deteriorating further. The investigator's site inspection on 23/06/2026 found a continuous 140 m section with the bottom two wires separated from the posts and a clear animal pad through the fence at the 1,050 m mark (Figure 1). The failure, its known effect and its deferral all appear in the aerodrome operator's own register, and the site visit found the fence in that condition.

The failed section is the physical route by which these animals reached the movement area. The pad at 1,050 m and the carcasses at 1,188 m and 1,221 m are on the same northern side of the runway, and the register has recorded animals passing through this section since the item was first raised. Had it been repaired in 2023, the section from 700 m to 1,300 m would have been intact in 06/2026, and this route would have been closed.

It is virtually certain that the failed northern fence was left unrepaired through three budget rounds, and likely that this contributed to the two kangaroos reaching the sealed runway.

On 26/06/2026 the operator listed Tarlton Springs in Appendix 8A by temporary revision TR-2026-04, requiring an inspection before every departure there after last light. The investigation has recommended that the operator list aerodromes on wildlife exposure rather than a reported strike, and adopt a route risk assessment trigger for any aerodrome first operated into after last light. A response is due by 30/09/2026. The aerodrome operator installed a temporary electric wire on 25/06/2026 and has funded fence replacement for 09/2026.
