# Investigation report

## Rejected take-off and runway overrun, Tarlton Springs - Executive brief

Drafted 05/10/2026

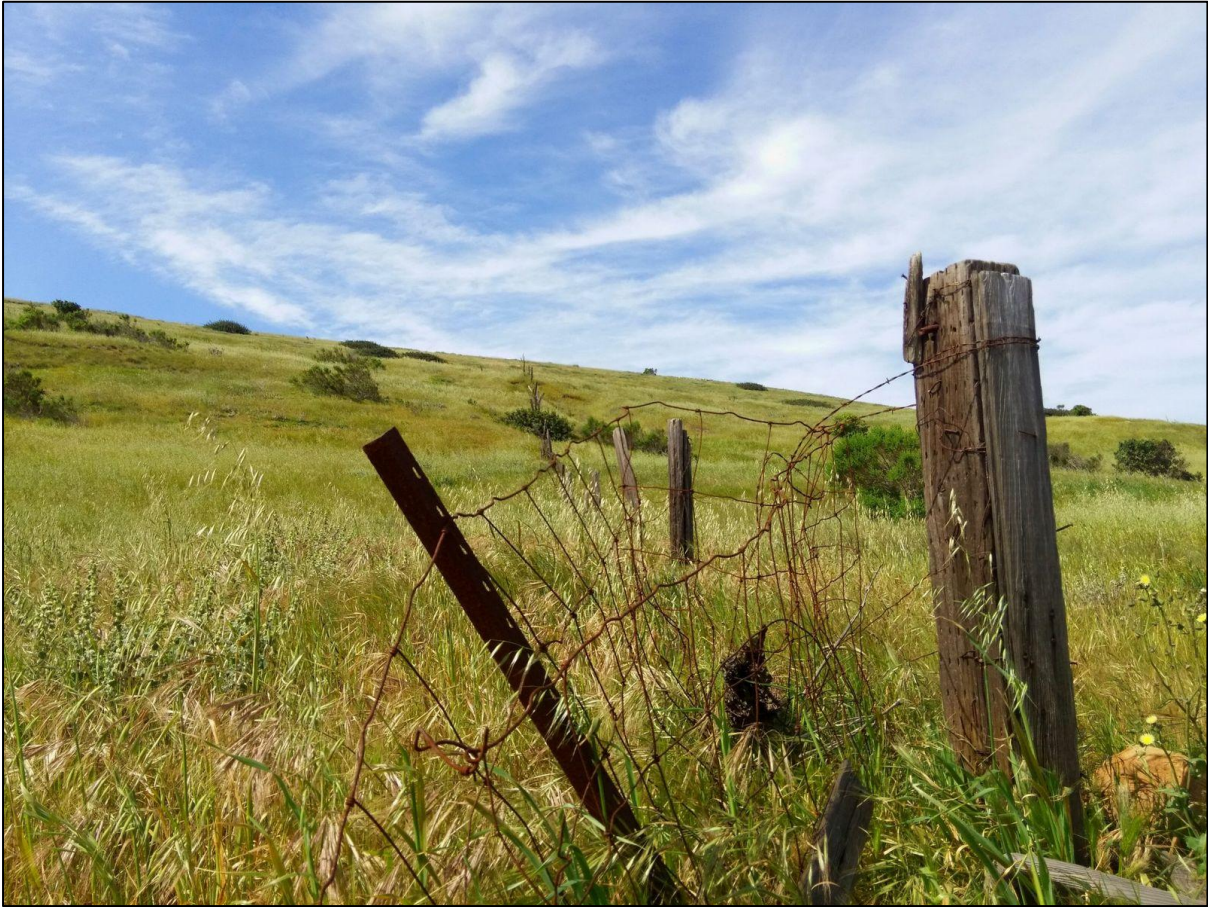
- The perimeter fence repair had been deferred for three budget cycles, which was virtually certain, and this very likely contributed to the occurrence. (Safety issue)

The aerodrome's own works register recorded the northern perimeter fence as failed in 2023. Its repair was then deferred at three budget rounds. The investigation walked and photographed the failed section on 23 June 2026. Even so, no repair, funding decision or other response by the aerodrome operator has been recorded. [NOT ESTABLISHED: the aerodrome operator's response to the fence deferral]

*Figure 1: The northern perimeter fence at the 1,050 m mark, photographed on the site visit: the fallen section and the animal pad through it. Site inspection photograph SV-2026-0417-07, northern boundary at the 1,050 m runway marker, taken 23/06/2026*
