# **E/I/I test tables**

Rejected take-off and runway overrun, Tarlton Springs

INVESTIGATION WORKFLOW SUITE

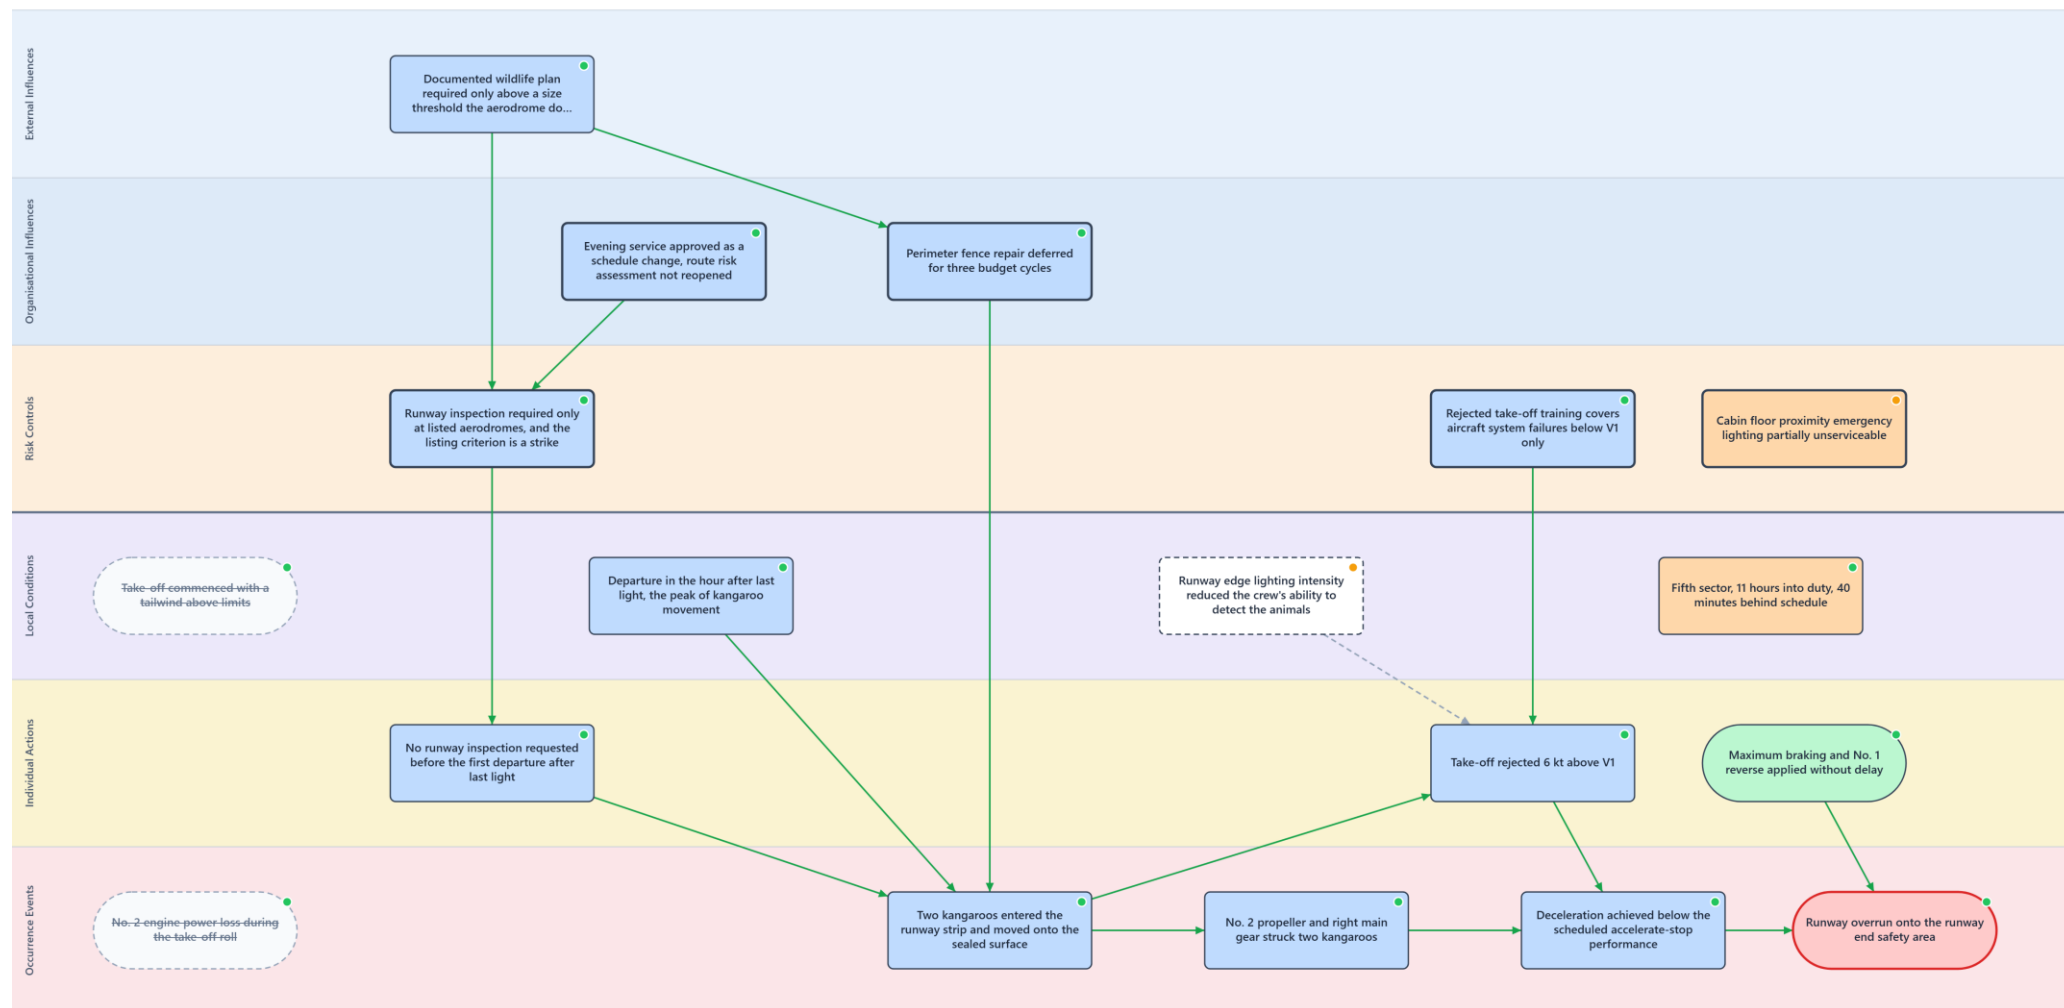
# AcciMap

Existence: did it exist or occur? Influence: did it influence this occurrence? Importance: is it worth addressing regardless?
