# Preliminary investigation update

Rejected take-off and runway overrun, Tarlton Springs - Preliminary investigation update

Drafted 05/10/2026

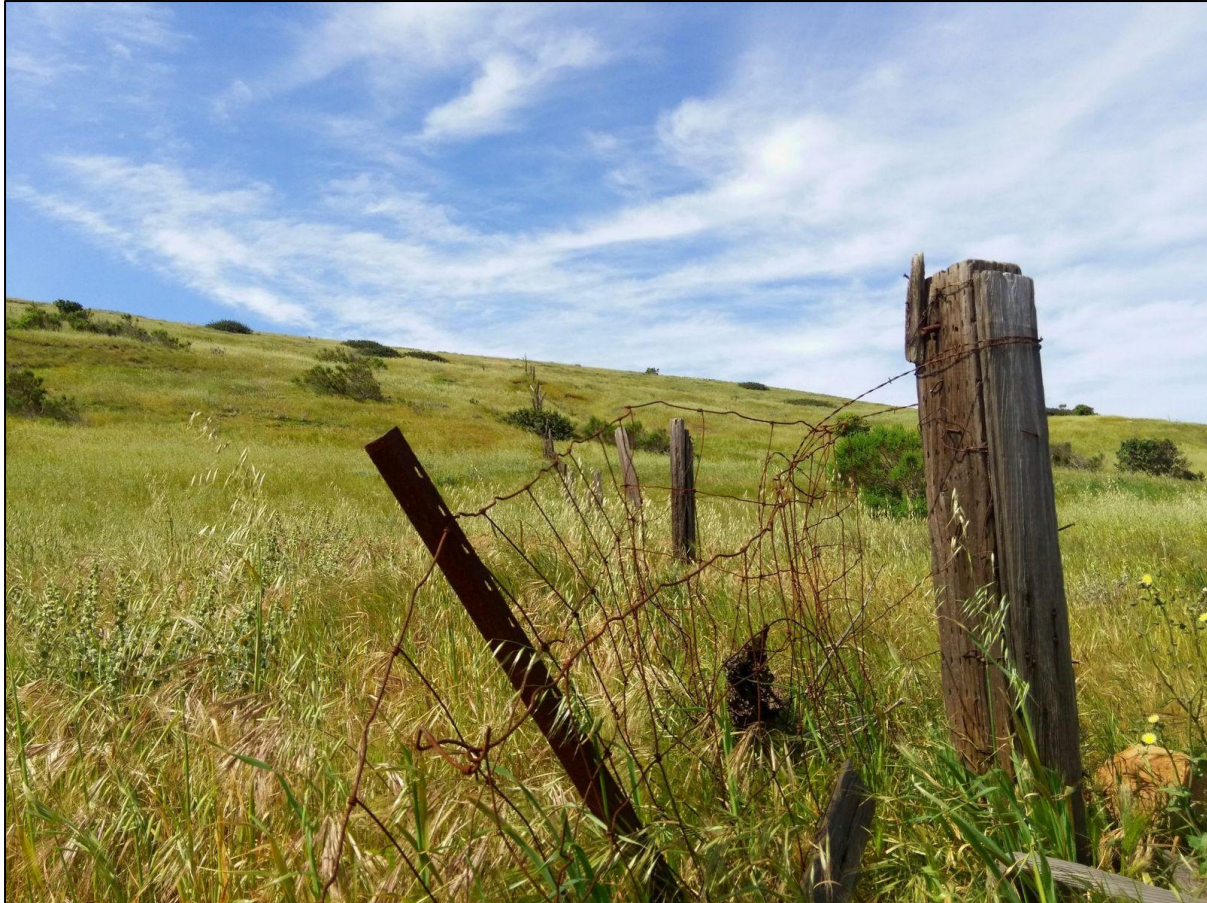
1. **How the animals reached the runway.** The investigation is examining the northern perimeter fence and the aerodrome's wildlife arrangements. Works register item WR-221 recorded the fence as failed in 04/2023, and its repair was deferred at three budget rounds. AS-139 10.4 does not require an aerodrome of this size to hold a documented wildlife plan. Both carcasses were recovered on the same side of the runway as an animal pad through the fence (Figure 1).

*Figure 1: The northern perimeter fence at the 1,050 m mark, photographed on the site visit: the fallen section and the animal pad through it. Site inspection photograph SV-2026-0417-07, northern boundary at the 1,050 m runway marker, taken 23/06/2026*

- **Perimeter fence.** The aerodrome operator installed a temporary electric wire on 25/06/2026. It has also funded works item WR-221 from its 2026 contingency and programmed the 140 m fence replacement for 09/2026, and this work is recorded as in progress.
