**PRE-PURCHASE  
PROPERTY & TIMBER PEST REPORT**

Report number: 955  
Inspection date: Friday 17th March 2017  
Property address: 22 Regent Close  
Taigum  
Qld 4018

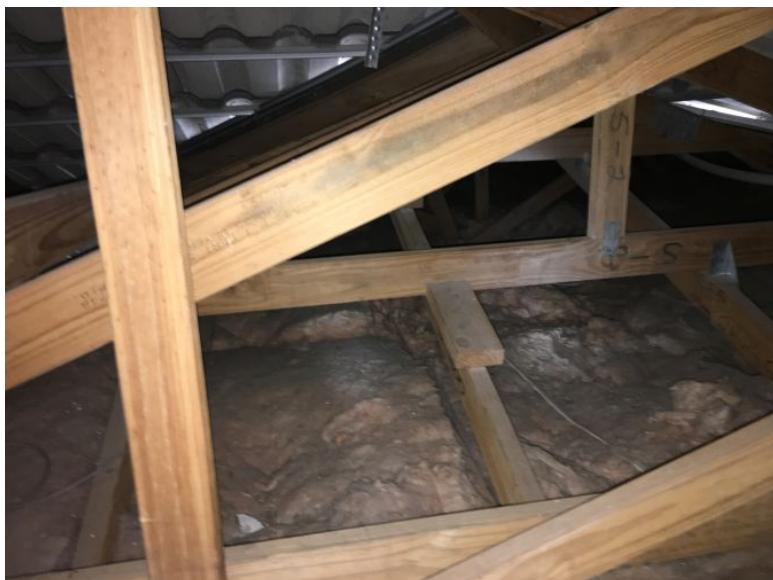
Image comments: Inadequate crawlspace into the main body of the roof.

A further inspection is strongly recommended of areas that were not readily accessible and of inaccessible or obstructed areas once access has been provided or the obstruction removed. This may require the moving, lifting or removal of obstructions such as floor coverings, furniture, stored items foliage and insulation. In some instances, it may also require the removal of ceiling and wall linings, and the cutting of traps and access holes. For further advice consult the person who carried out this report.

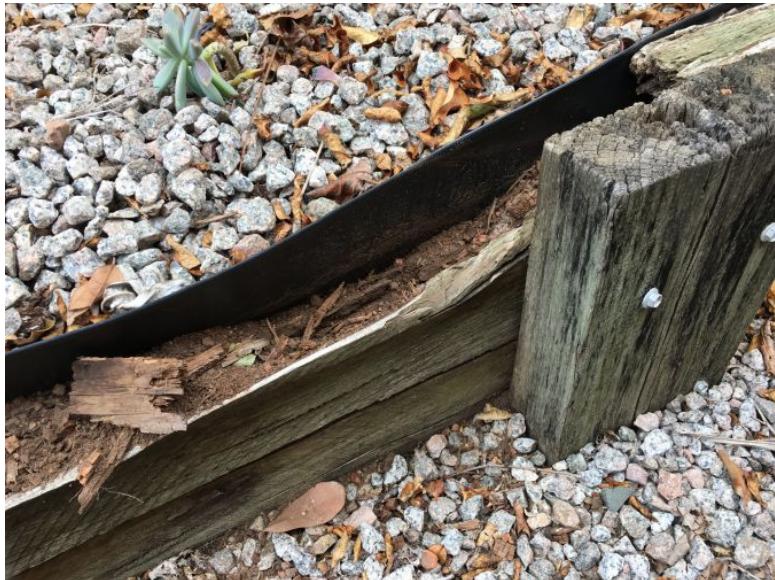
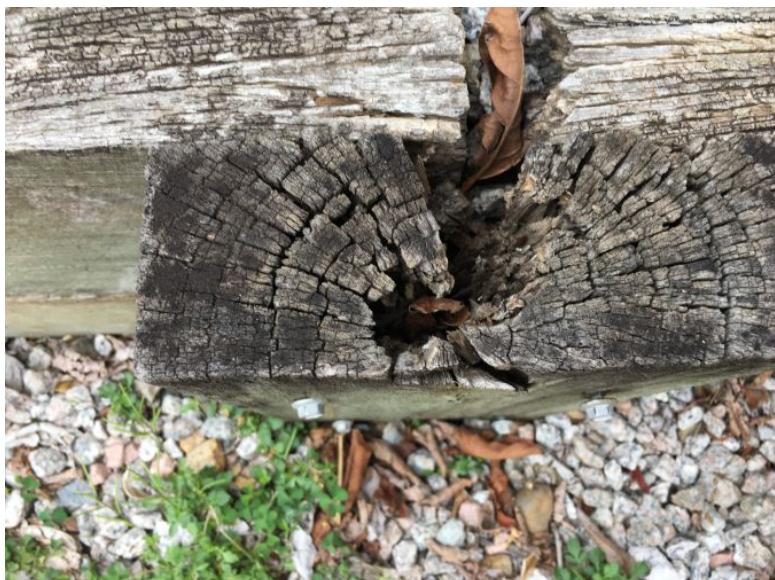
## E3 Termite workings and/or damage

Area	The Site
Location:	On the left-hand side of the property.
Affected element:	Garden boxes.
Signs of attack:	Damaged timbers.
Visible extent:	Localised.
Recommendation:	Where evidence of an inactive termite infestation exists, it is not possible, without benefit of further investigation and inspections over a period of time, to ascertain whether any infestation is active or inactive. Continued, regular, inspections are essential. For further advice consult the person who carried out this inspection.
Implementation:	The above recommendation should be implemented as soon as possible.

Proposal: Although a subterranean termite management proposal is recommended, this Consultant is not engaged to provide a proposal. Accordingly, the Client should contact a licensed pest control operator in respect to obtaining a proposal without delay.

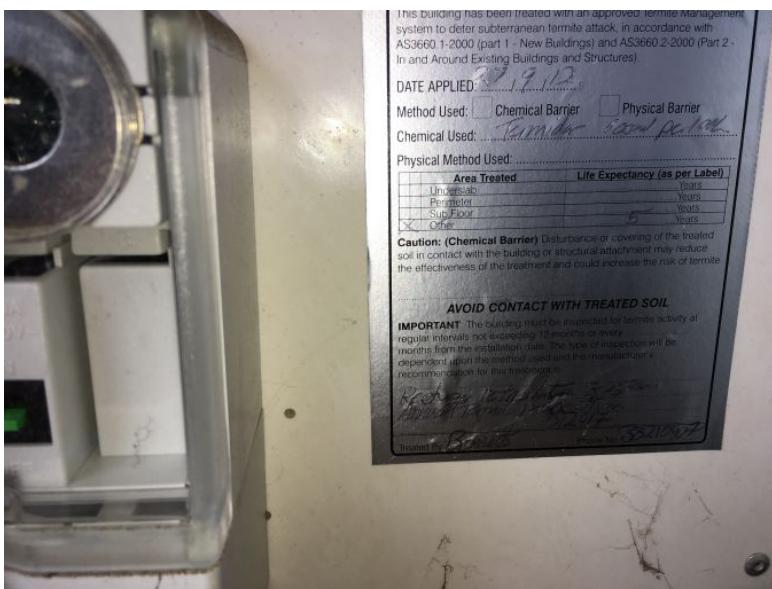
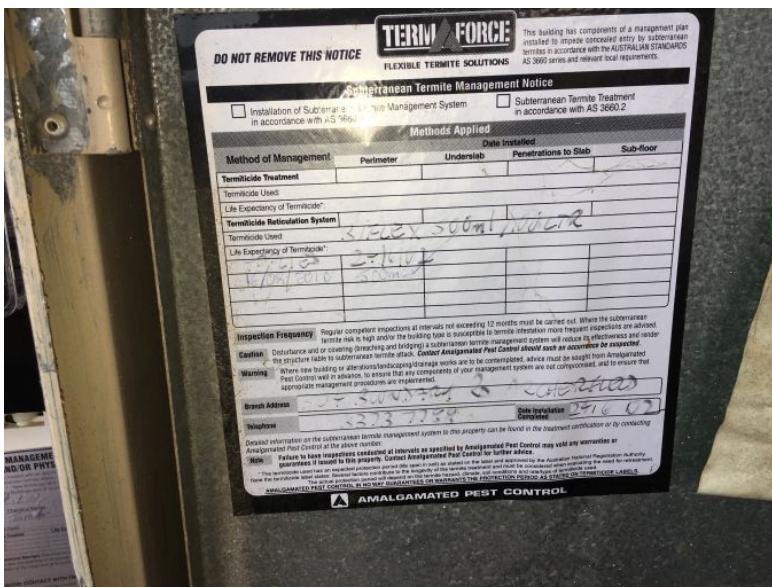
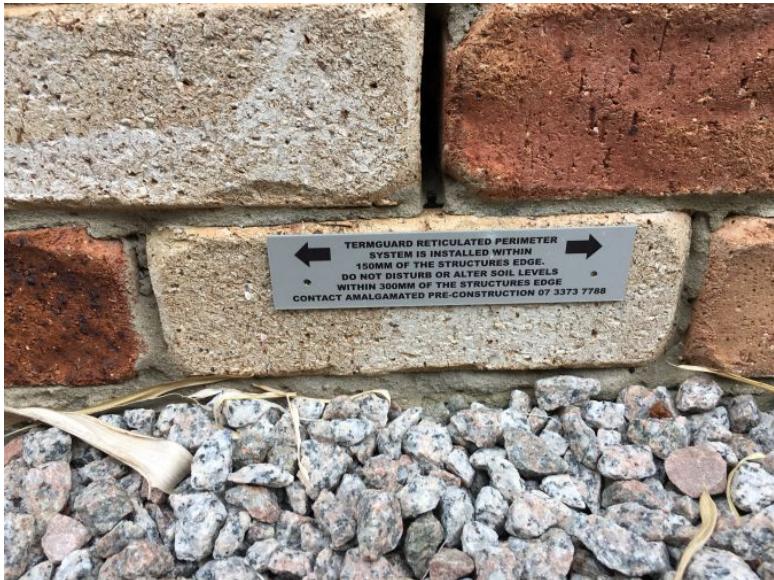
#### E4 Previous termite management program

Area	Building exterior
Location:	Perimeter of the building.
Previous Program:	Durable notice sighted in electrical meter box indicating a possible termite treatment. Durable notice sighted indicating the possible installation of a termite management system.
Recommendation:	The building owner should contact the pest controller that carried out the treatment ( see notices in meter box as photographed below)for further information pertaining to any service warranties and advice in regard to the building owner's obligation to maintain the treatment.

Implementation: The above recommendation should be implemented without delay.

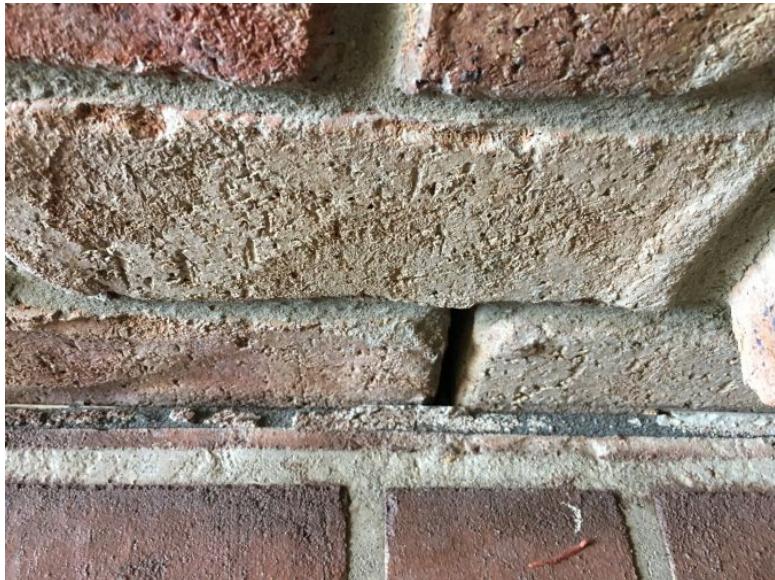
Area	Building exterior
Location:	Outside the garage.
Affected element:	Weep holes.
Defect or Sign:	Bridged by landscaping. Bridged by the path.
Visible extent:	Localised.
Recommendation:	Termite management systems are installed to impede concealed subterranean termite entry into buildings. However, termites may easily enter the building if the management system is breached. 'Breaching' is the passing of termites through a hole or gap in a termite management system. Australian Standard AS 3660 recognises that management systems shall not be breached unless alternative management systems are used to prevent access by termites to the structure. For further advice consult the person who carried out this inspection.
Implementation:	The above recommendation should be implemented without delay.

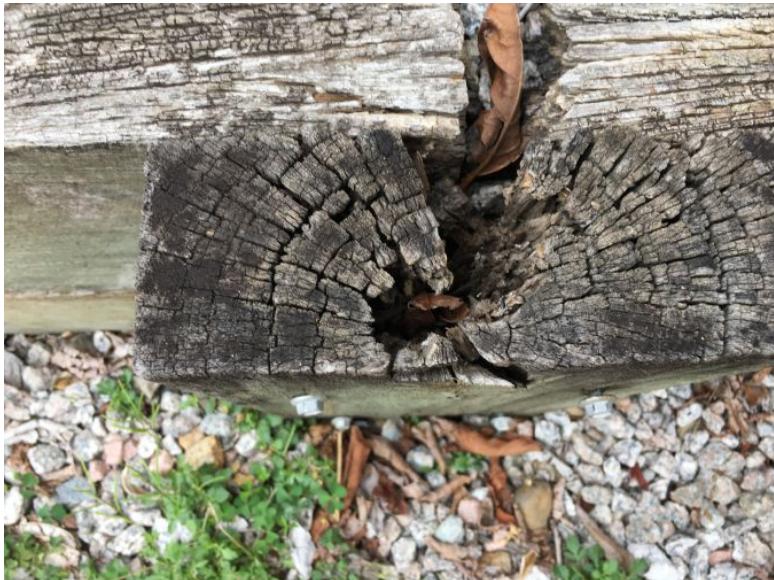
#### E12 Use of untreated or non-durable timber

Area	Building exterior
Location:	Perimeter of the building.
Affected element:	Unprotected railway sleepers used for landscaping.
Defect or Sign:	In direct contact with the ground.
Visible extent:	Widespread.
Recommendation:	Untreated or non-durable timber used in a hazardous environment is susceptible to timber pest activity and damage. It is essential that timber used in a hazardous environment is of sufficient natural durability and/or is adequately preservative treated with no untreated cut ends.
Implementation:	The above recommendation should be implemented without delay.

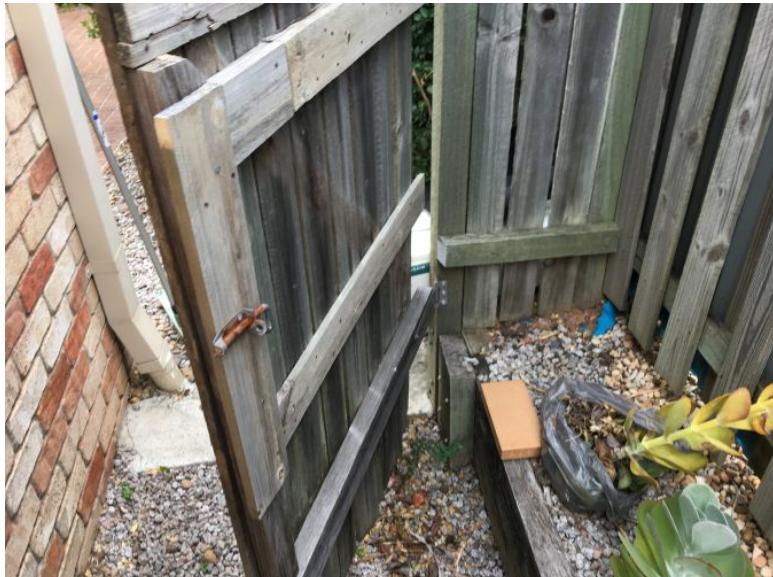
Many minor defects were observed including a poorly fitting timber gate outside garage,damaged power box and two slight cracks to roof tiles.

Image comments: Poorly fitting gate.

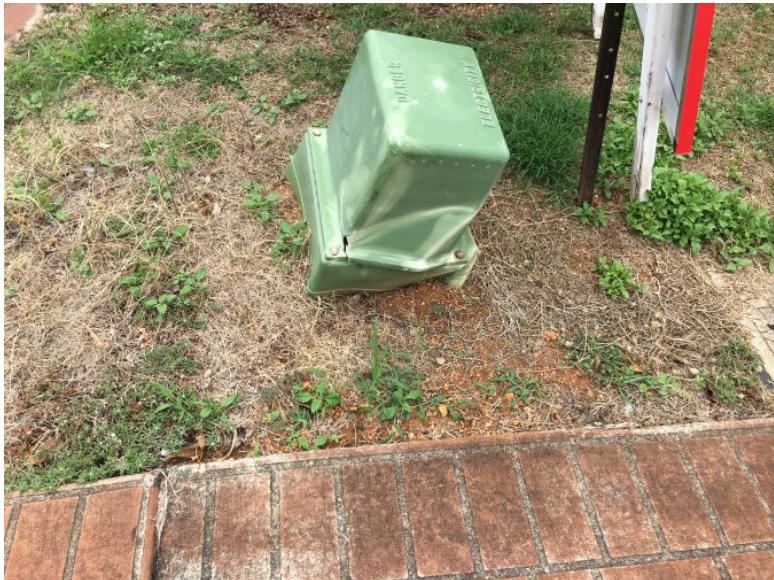
Image comments: Tilted power box.... probable impact damage.
