## SEC Railway

### Inspection of "SAL" station conducted by Pankaj sharma, Sr.DSTE/NGP in connection with 3<sup>rd</sup> line work on 11/10/2022

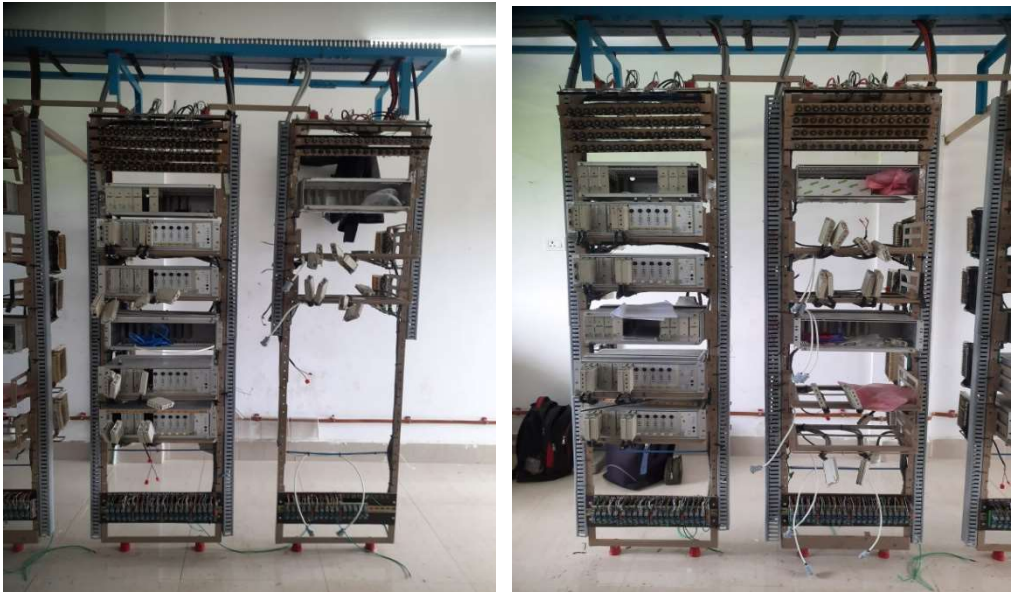
| Sr. | Observations | Complied by |
|---|---|---|
| 22 | Old type MSDAC Rack has been used for EC of MSDAC instead of pre-wired Rack. As not to repeat problem faced in KWN, Pre-wired MSDAC with new EC to be provided in all the new installations. | Dy.CSTE/C/NGP |

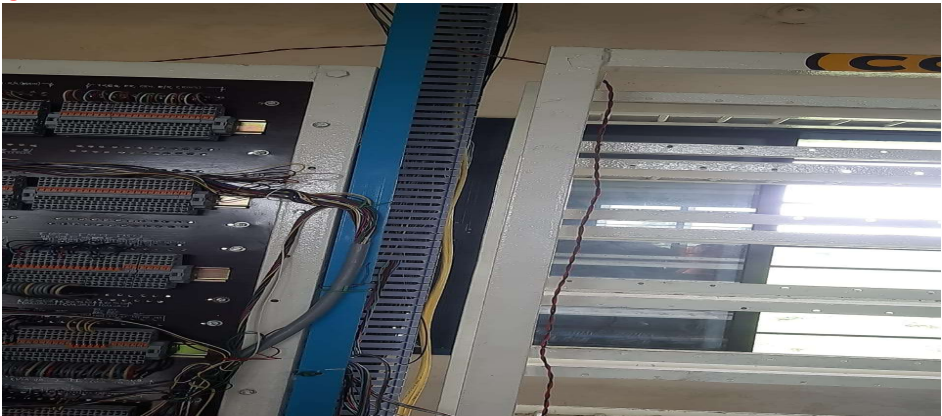
| Sr. | Observations | Complied by |
|---|---|---|
| 25 | Inter distance between Relay Racks (trough to ladder of Rack) is found only 80mm. Distance to be increased up to 150 mm for maintenance point of view. | Dy.CSTE/C/NGP |

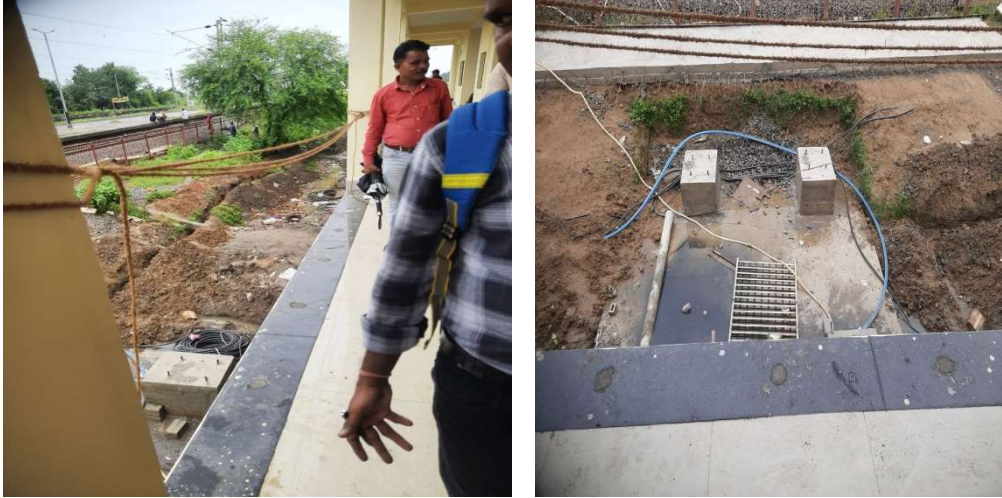
| Sr. | Observations | Complied by |
|---|---|---|
| 26 | In front of SM Panel room, Railing not provided at boundary of terrace due to Engg. work. This is very unsafe for S&T & Operating staff working at Central building. | |

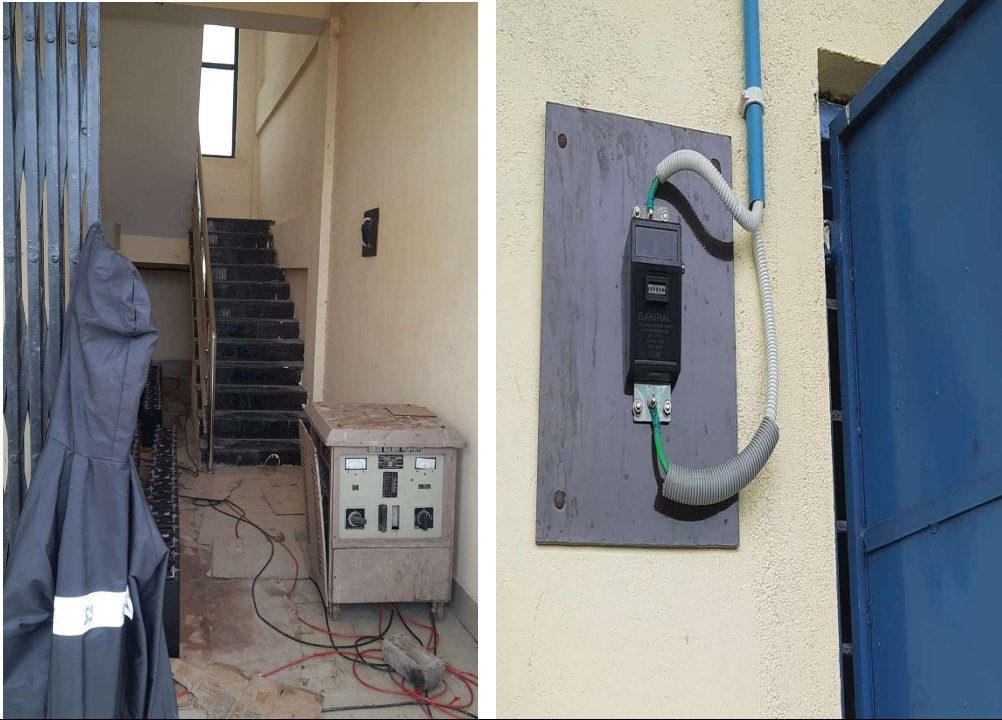
| Sr. | Observations | Complied by |
|---|---|---|
| 27 | Counter of “A” type SPD is provided at front wall of East & west goomty and near stairs at Centre. Same to be provided inside of IPS room just like earlier stations. | |

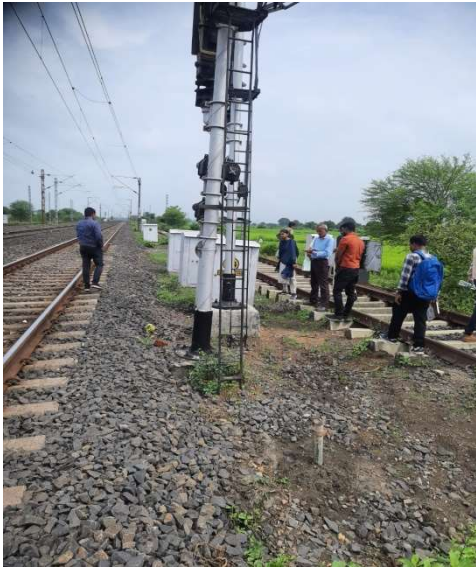
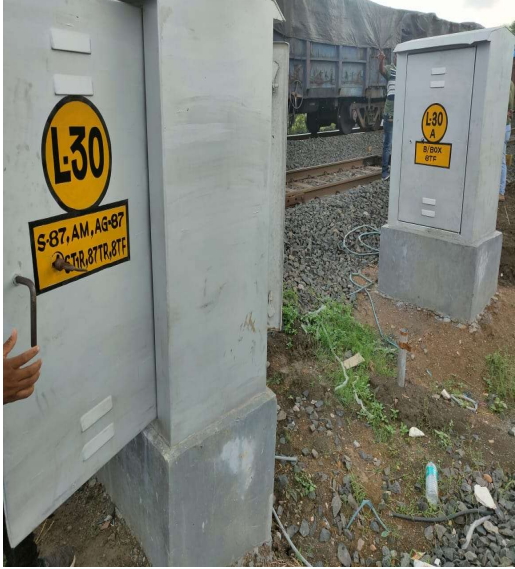
| Sr. | Observations | Complied by |
|---|---|---|
| 29 | Earthing is not connected in any of the Location boxes, signals etc. Earth enclosure is also not provided. | Dy.CSTE/C/NGP |

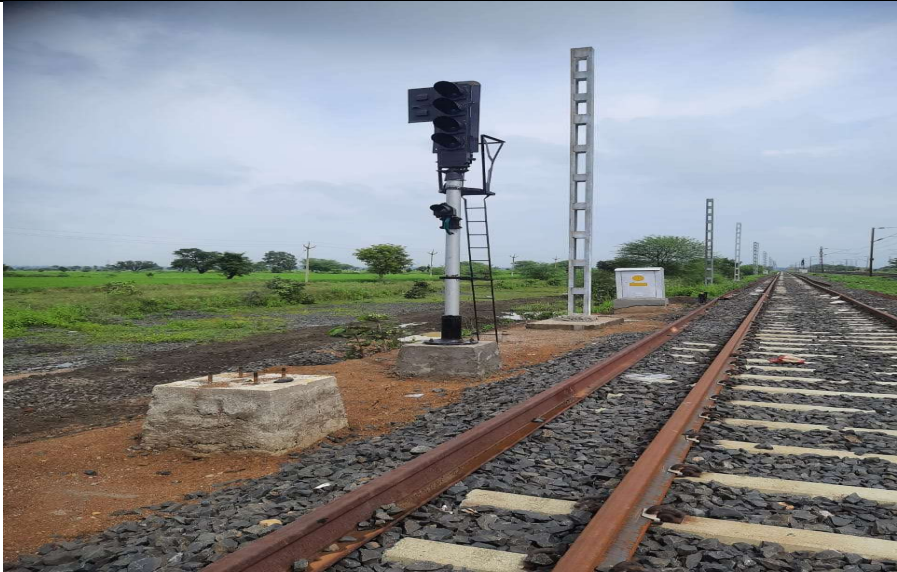
| Sr. | Observations | Complied by |
|---|---|---|
| 33 | Distance between Dn. Advance str Signal S-88 and OHE mast is found only 6 meters. | CEE/Con/NGP |

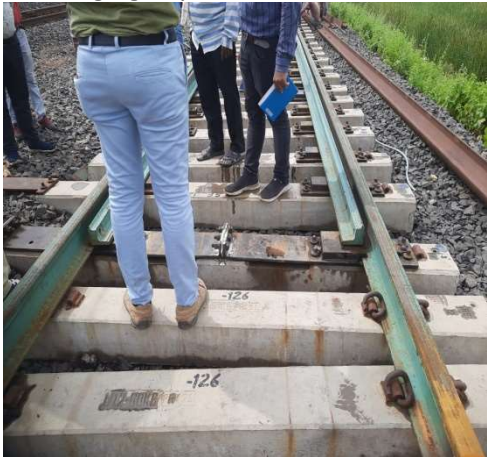
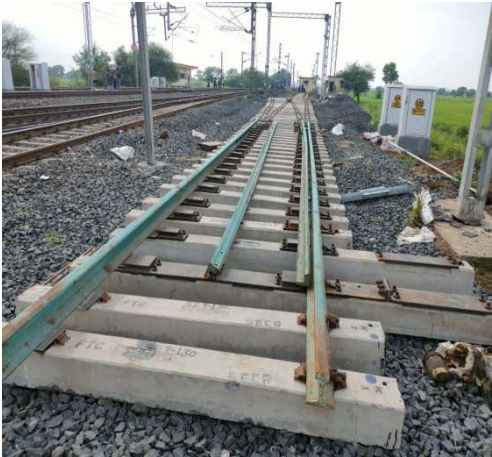
| Sr. | Observations | Complied by |
|---|---|---|
| 34 | Installation of New Point no. 101A & 153A on ground (3 <sup>rd</sup> line) is not completed. Also staging of point no. 101B & 153B is not done. | CE/Con/NGP<br>Dy.CSTE/C/NGP |

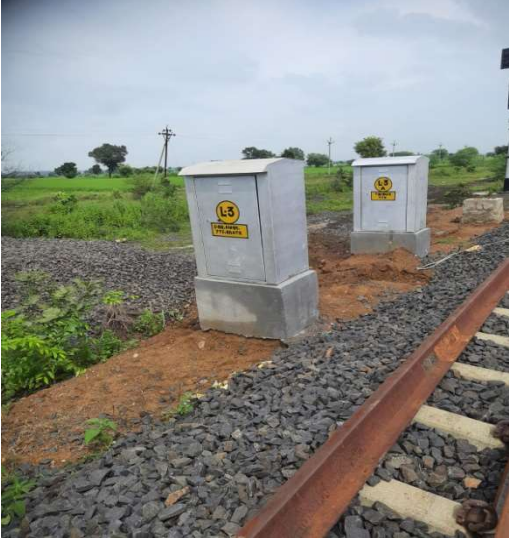
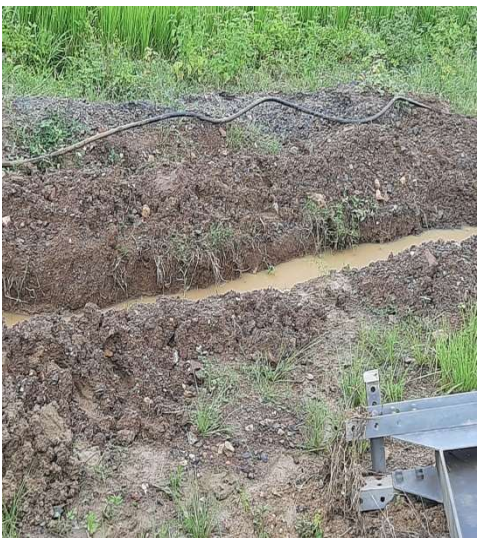
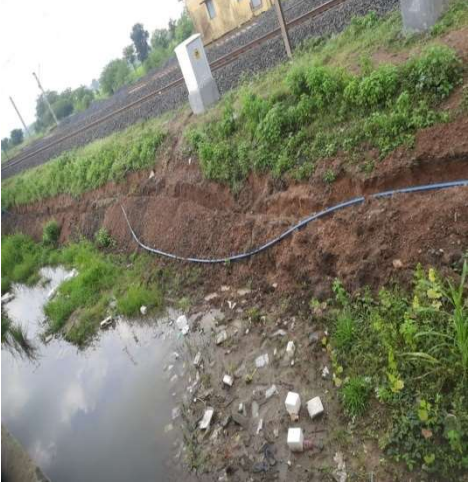
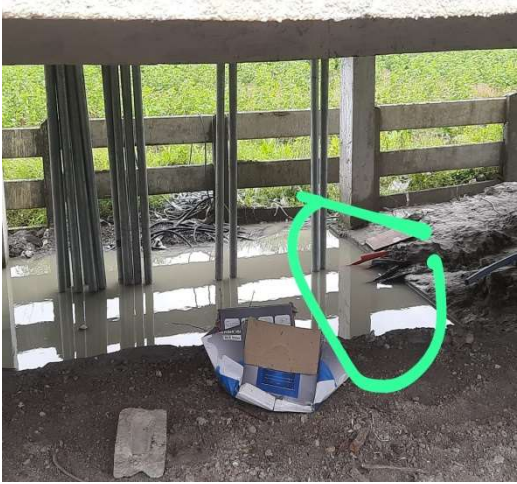
| Sr. | Observations | Complied by |
|---|---|---|
| 37 | <p>Trench and cables is opened at many places at East &amp; west yard.<br/> <b>OFC cable &amp; quad cable is open condition below the East Goomty. Same to be covered by provision of Half round RCC pipe with concreting.</b></p> <div data-bbox="244 481 754 1019"> </div> <div data-bbox="770 481 1249 1019"> </div> | Dy.CSTE/C/NGP |

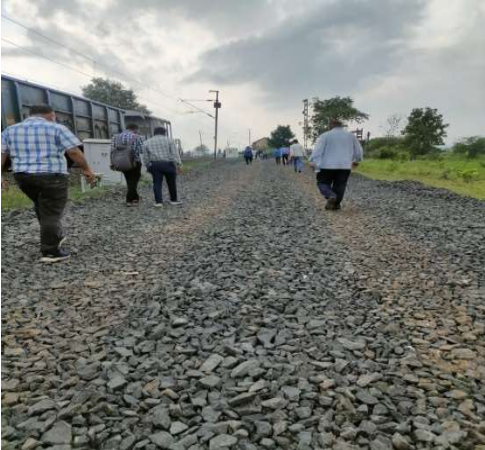
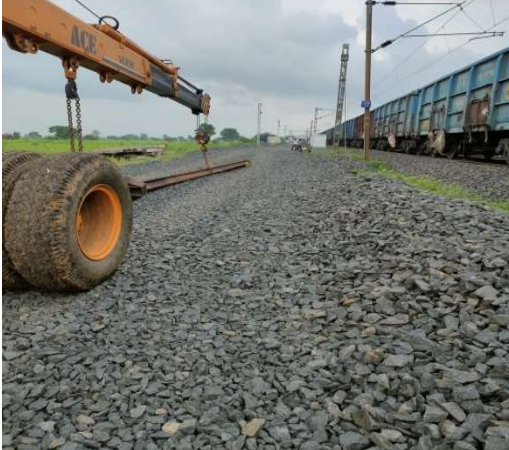
| Sr. | Observations | Complied by |
|---|---|---|
| 38 | <p>3<sup>rd</sup> line formation at "SAL" west yard is in progress.</p> <div data-bbox="244 1653 730 2101"> </div> <div data-bbox="746 1653 1257 2101"> </div> | CE/Con/NGP |

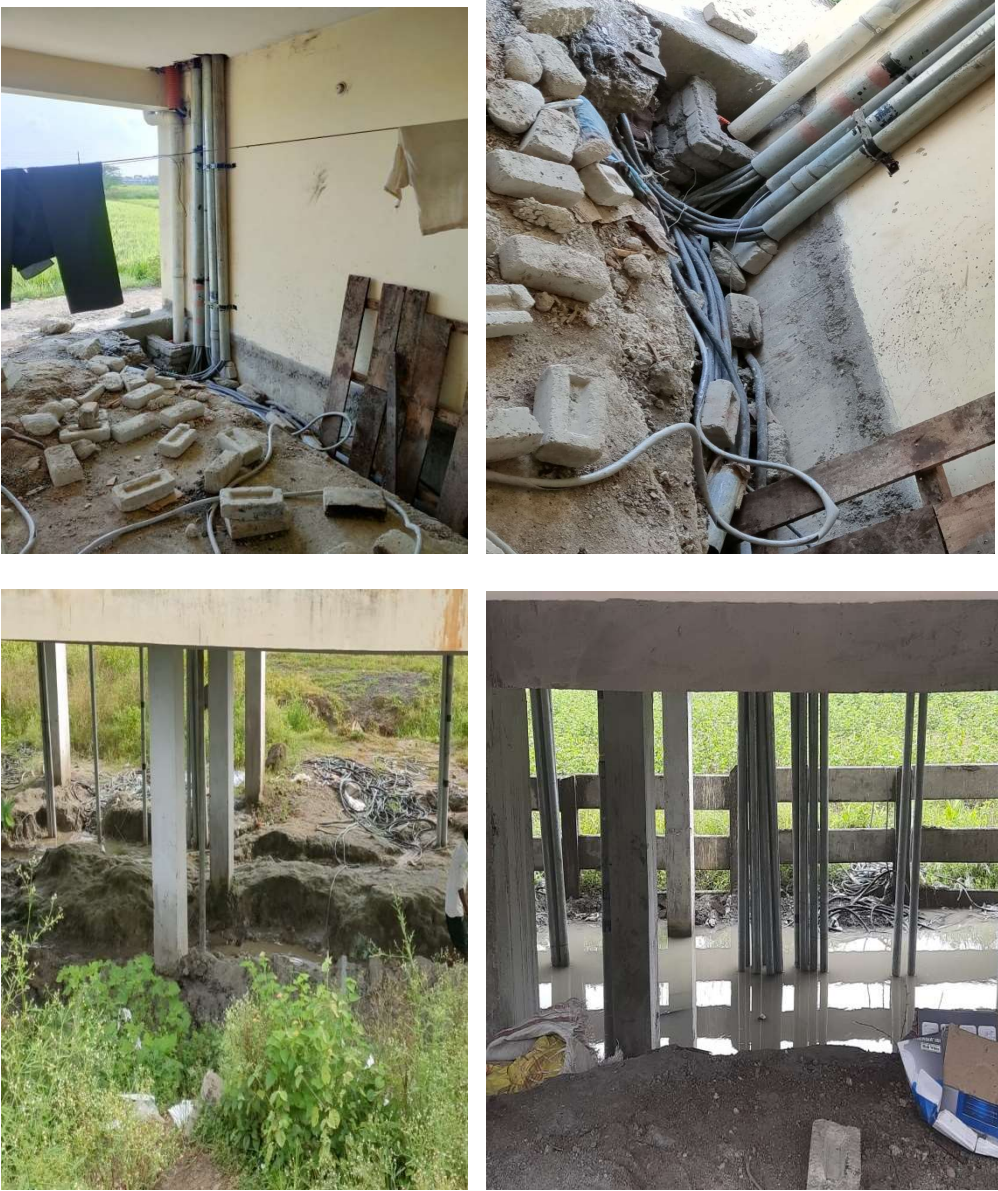
| Sr. | Observations | Complied by |
|---|---|---|
| 39 | <p>GI Pipes is provided at Centre, East &amp; West goomty for cable entries in the relay room. Same to be protected by brick wall around the pipe. This will also protect cables from the miscreant's activities.</p> | <p>Dy.CSTE/C/NGP</p> |

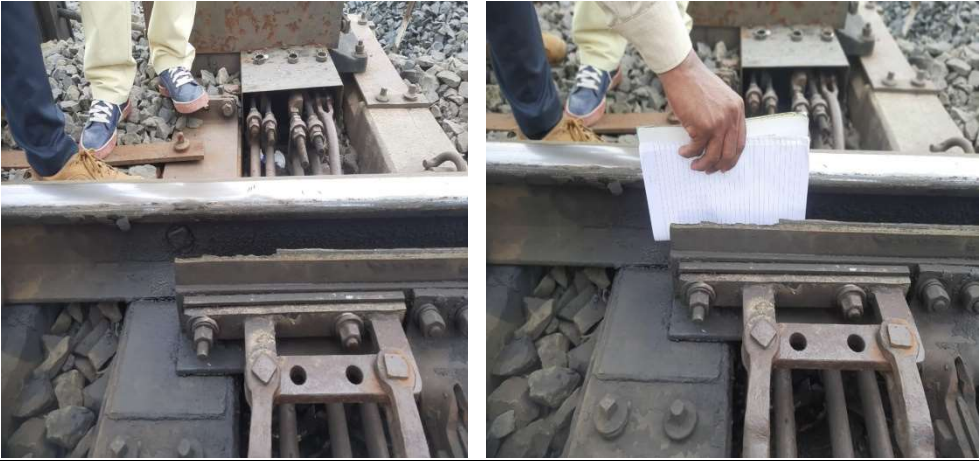
| Sr. | Observations | Complied by |
|---|---|---|
| 41 | <p><b>Pt. No. 41B:</b> checked &amp; Tested Point with 5 mm &amp; 1.6 mm obstruction test piece and found respond correctly.</p> <p><b>LHTR Chipped off, Out of square about 20mm.</b><br/>Last maintenance of point was done on 24/09/2022 by SSE/Sig/KP.</p> | <p>Sr.DEN/C/NGP<br/>DSTE-I/NGP</p> |
