# Valuation Report

Rural Property

“LDR2” 89 Missingham Road, Dunoon, NSW 2480

| <b>As at</b> | 26 August 2019 |

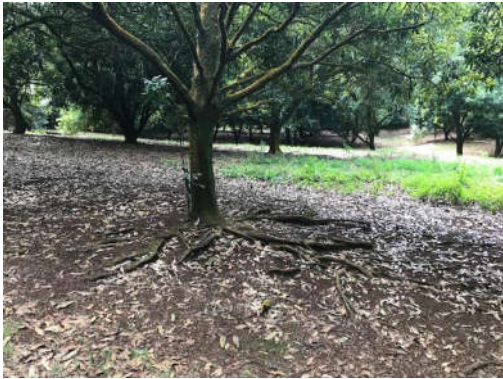
Exposed roots

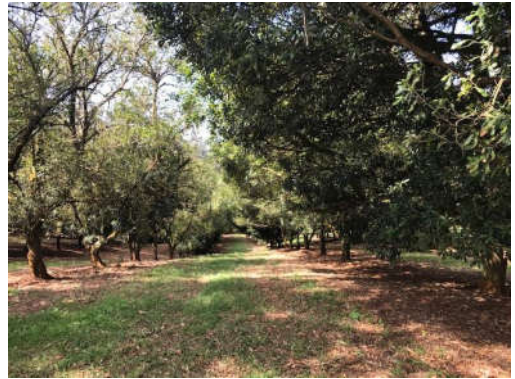
- This orchard does have some shading & phytophthora problems that cause yield reductions in some macadamia orchards. Shading can be overcome by selective limb removal. Phytophthora requires specific management to restore tree health.

Orchard & phytophthora affected trees
