Your Inspection Report

20 Hoover St
Toronto, ON M2N 5F6

INSPECTION DATE:
Wednesday, December 15, 2021

RE: Report No. 1786, v.3
20 Hoover St
Toronto, ON
M2N 5F6

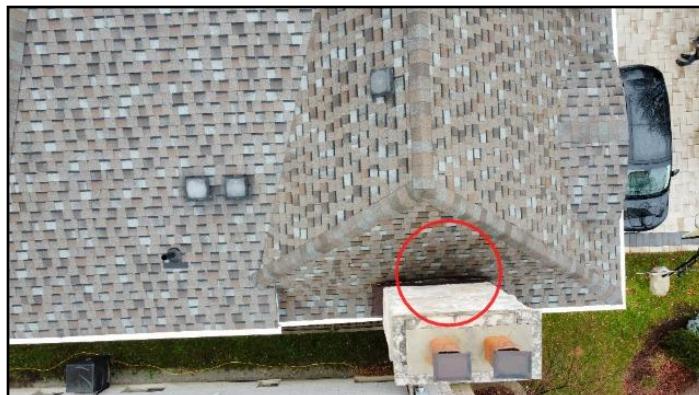
3. Cricket (Saddle) missing

1. Condition: • [Cricket \(Saddle\) missing, loose, damaged](#)

There was no cricket observed at the chimney. A cricket or saddle is a ridge structure designed to divert water on a roof around the high side of a chimney or the transition from one roof area to another, the cricket is normally the same pitch as the rest of the roof, but not always. Cricket must be built to certain specifications on the high side of the chimney next to the roof if it is 30" or more in width. Contact a professional roofing contractor for a cricket installation.

Implication(s): Chance of water damage to structure, finishes and contents

Task: Further evaluation and repair

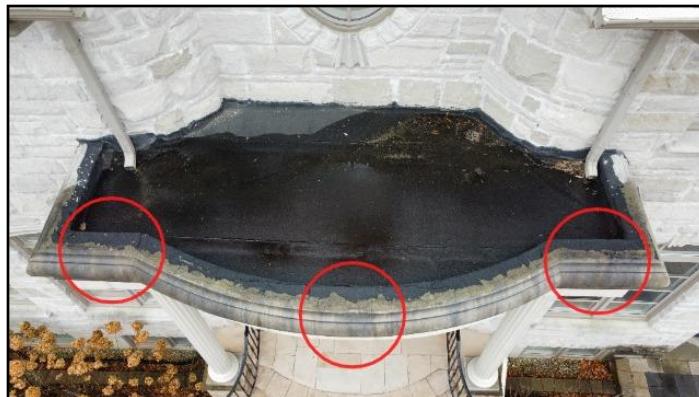
4. Missing flashing

2. Condition:

- [Missing, too short](#)

Implication(s): Chance of water damage to structure, finishes and contents

Task: Install

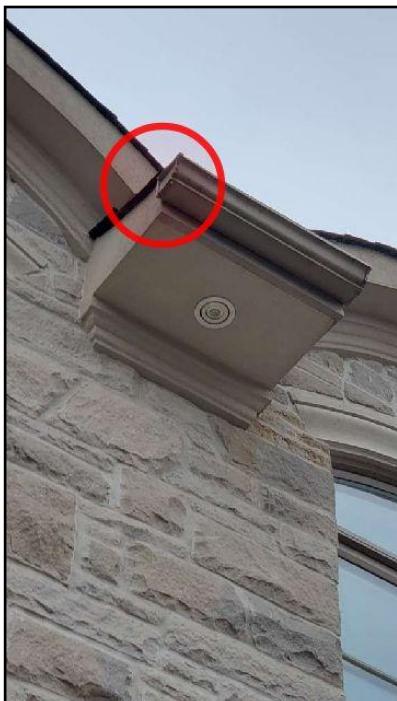
5. Leak

3. Condition: • [Leak](#)

There was no downspout on the small gutter, which caused water pooling, leaking and overflowing since this gutter collects rainwater from a significant area of the front roof. The water overflow caused discoloration of the exterior wall below. It is recommended to contact an eavestroughing contractor for downspout installation.

Implication(s): Chance of water damage to structure, finishes and contents

Task: Improve

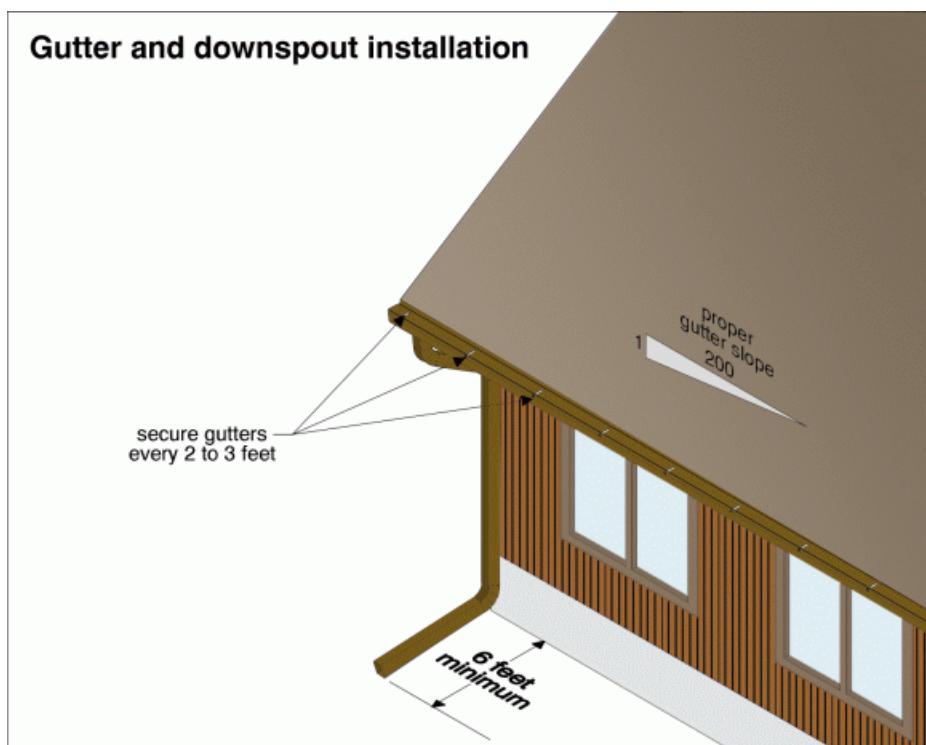
4. Condition: • [Discharge too close to building](#)

Downspout extension too short

Task: Improve

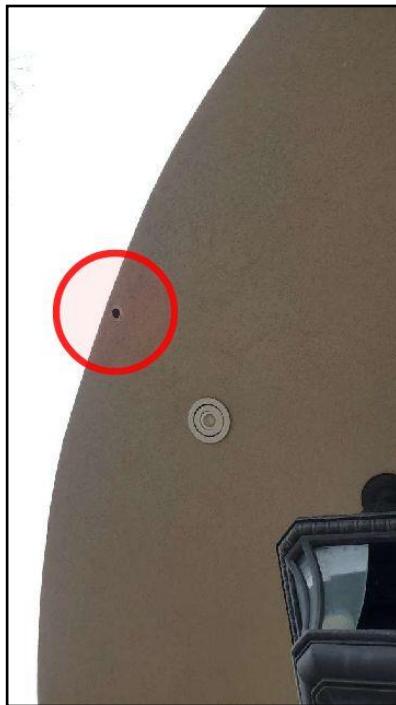
11. Mechanical damage

5. Condition: • [Mechanical damage](#)

Implication(s): Chance of water damage to structure, finishes and contents | Material deterioration

Task: Repair

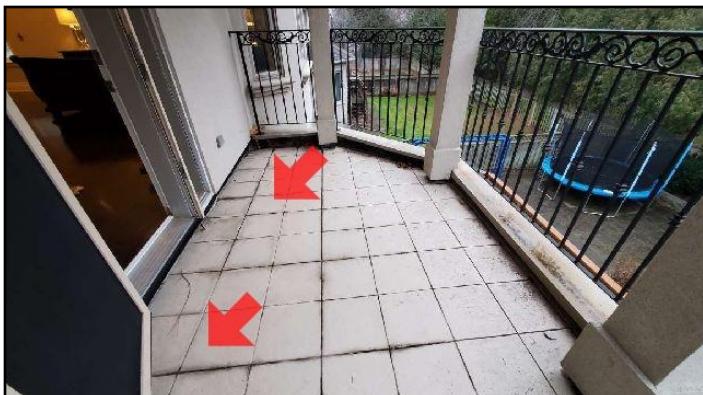
13. Slope toward building

7. Condition: • [Slope toward building](#)

The balcony floor was sloping towards the wall to direct rainwater towards scupper drain that was repaired and clogged with foam. It is advisable to contact a qualified contractor for further evaluation and possible re-sloping of the balcony and relocation of the drain away from the wall to prevent any potential water damage.

Task: Correct

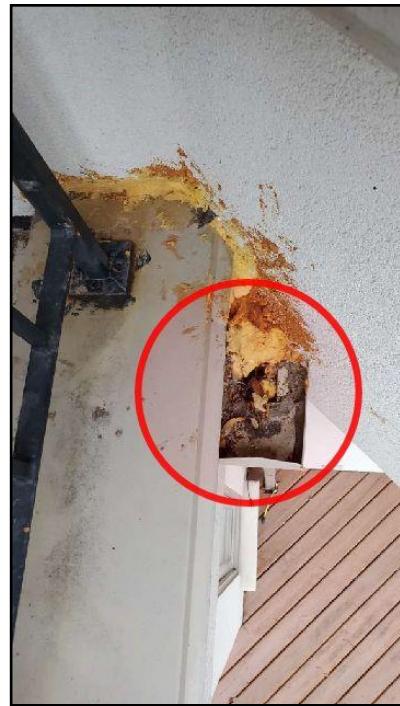
15. Blocked drain

Implication(s): Chance of water damage to structure, finishes and contents

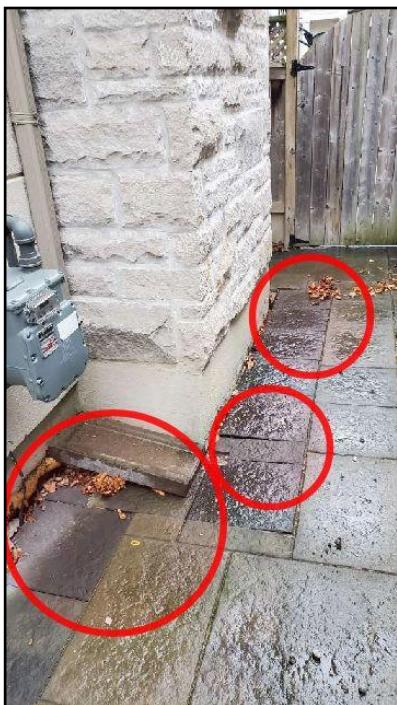
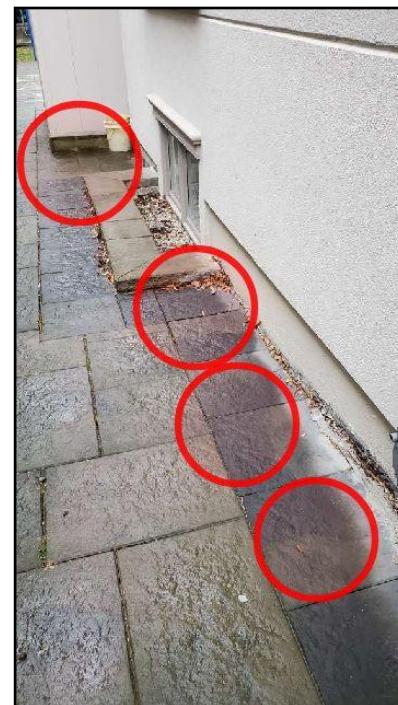
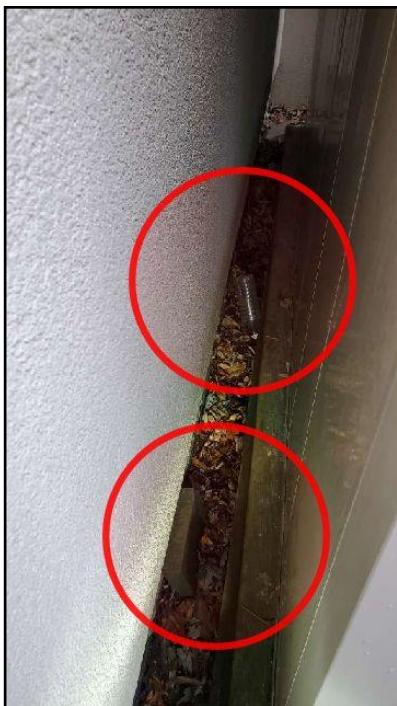
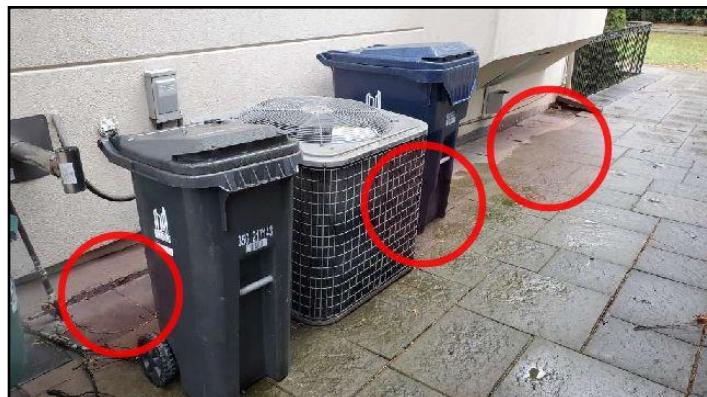
8. Condition: • Improper slope or drainage

Implication(s): Chance of water damage to structure, finishes and contents

16. Improper slope or drainage

Task: Improve

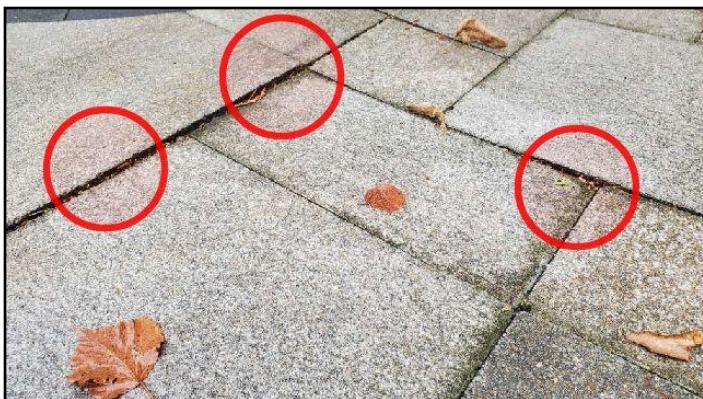
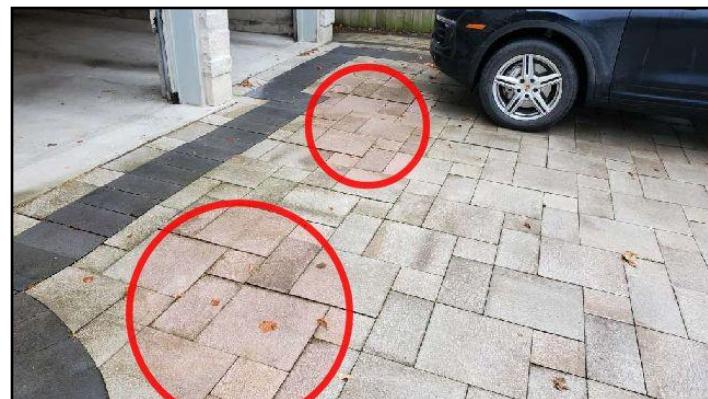
9. Condition: • [Uneven \(trip hazard\)](#)

Implication(s): Physical injury

20. Uneven (trip hazard)

Task: Repair

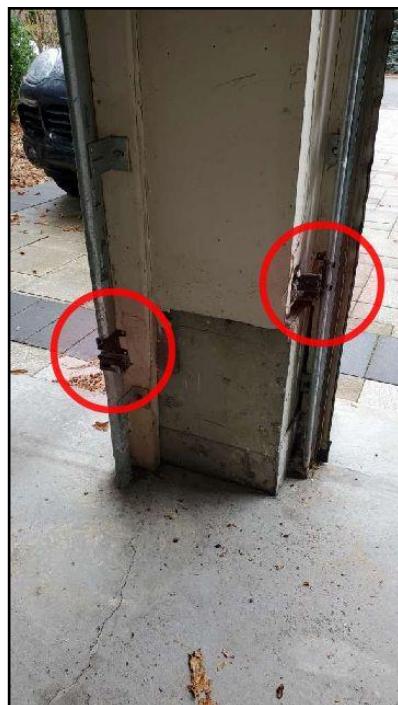
22. Photoelectric sensor more than 6 inches...

10. Condition: • Photoelectric sensor more than 6 inches above the floor

Task: Correct

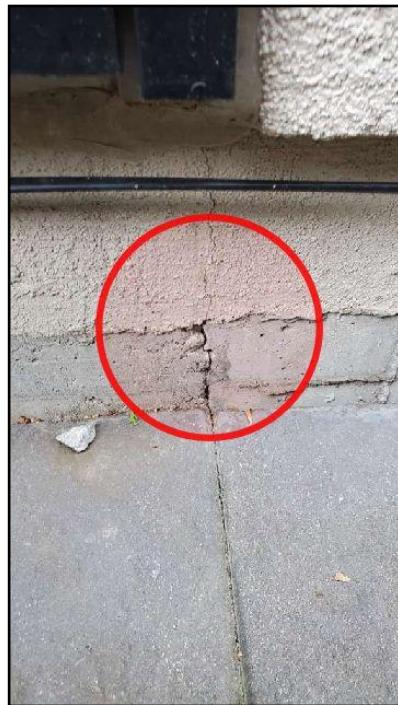
25. Cracked

11. Condition: • Cracked

There was a vertical crack observed on the foundation wall. The crack was not visible from the interior.

Implication(s): Chance of water damage to structure, finishes and contents | Weakened structure

Task: Monitor/Repair

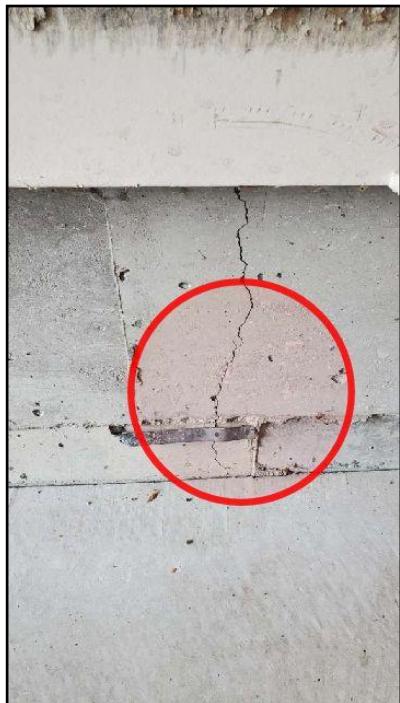
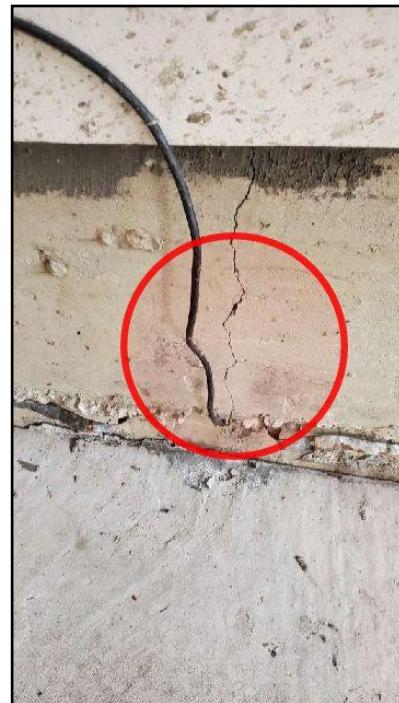
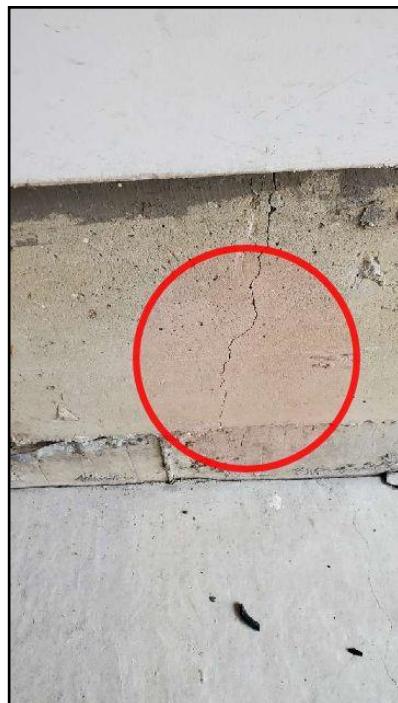
12. Condition: • Cracked

There were typical vertical cracks observed on the foundation wall. The cracks were not visible from the interior. There was no evidence of moisture penetration observed at the time of inspection.

Implication(s): Chance of water damage to structure, finishes and contents | Weakened structure

Task: Monitor/Repair

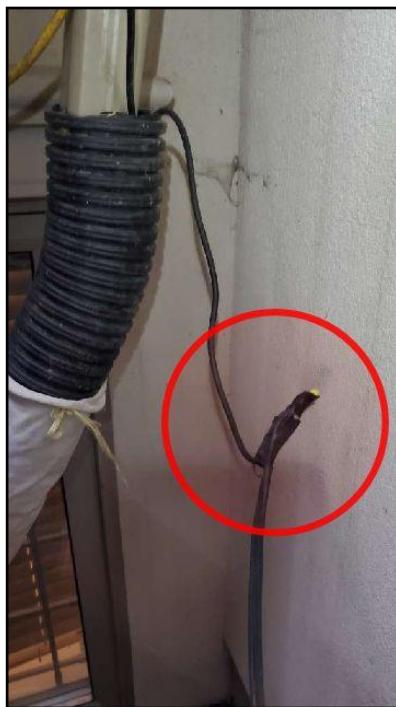
30. Open splices

13. Condition: • [Open splices](#)

Implication(s): Fire hazard | Electric shock

Task: Correct

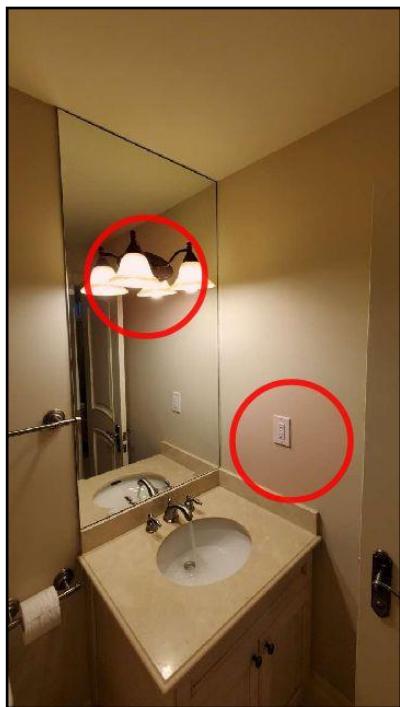
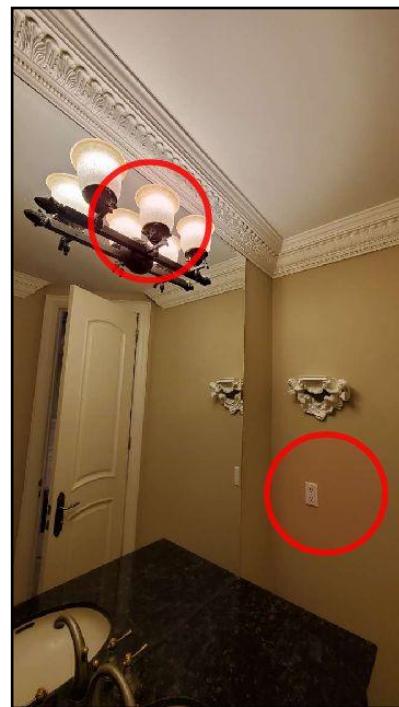
14. Condition: • GFCI is on the same circuit with bathroom lights.

It was observed at the time of inspection that all bathroom lights fixtures on the first floor are connected to the same circuits as GFCI receptacles. Potentially this represents a health and safety hazard due to sudden GFCI tripping and lights going dark when a person is taking a bath or a shower (slip and fall in the dark).

Task: Correct

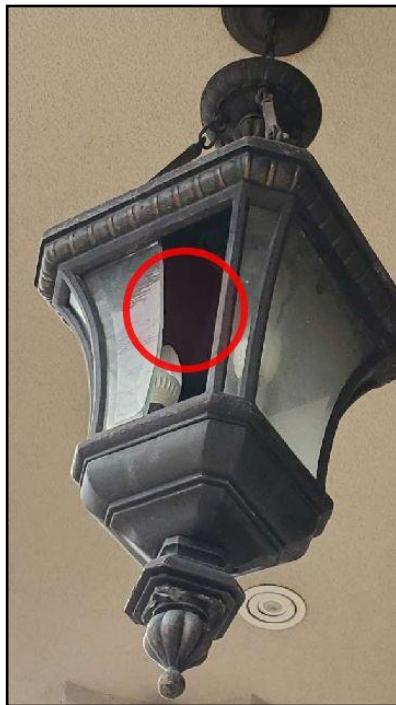
33. Damage

15. Condition: • Damage

Implication(s): Electric shock | Fire hazard

Task: Replace

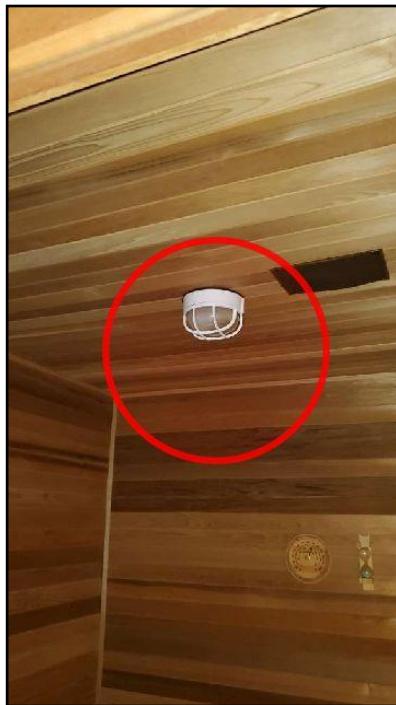
34. Inoperative

16. Condition: • Inoperative

Implication(s): Inadequate lighting

Task: Repair or replace

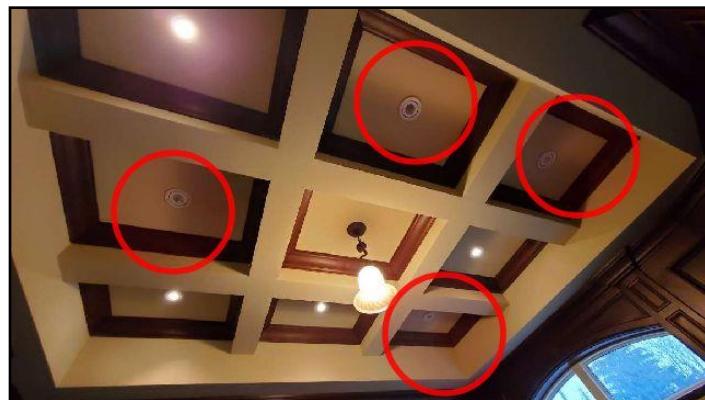
35. Inoperative

17. Condition: • Inoperative

Implication(s): Inadequate lighting

Task: Repair or replace

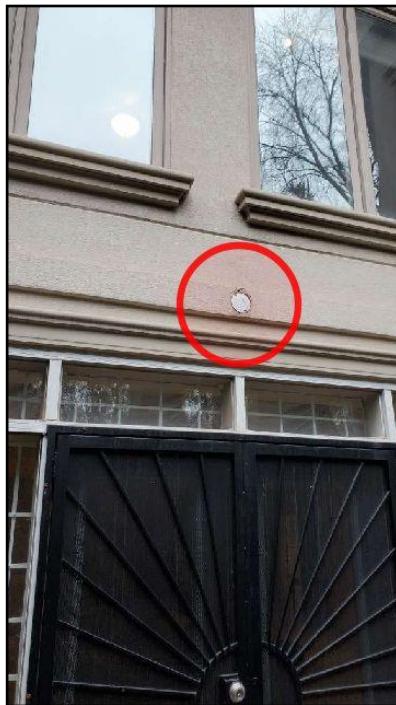
36. Missing

18. Condition: • Missing

Implication(s): Inadequate lighting

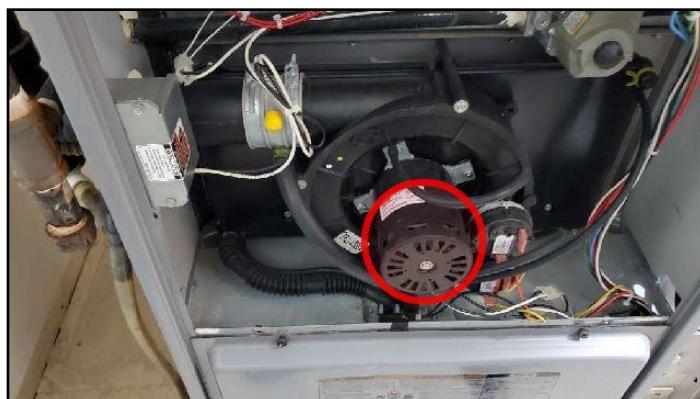
40. Combustion exhaust fan noisy

19. Condition: • Combustion exhaust fan noisy

Task: Service

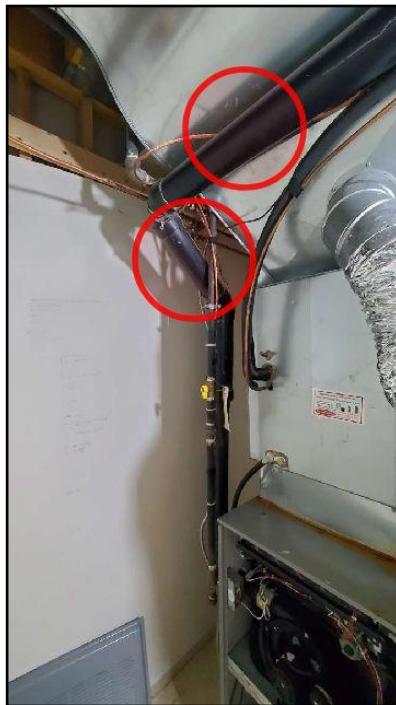
41. ABS plastic used for the combustion exhaust...

20. Condition: • ABS plastic used for the combustion exhaust system.

Contact a licensed gas contractor/local gas utility for further evaluation and replacement with PVC pipes.

Task: Replace

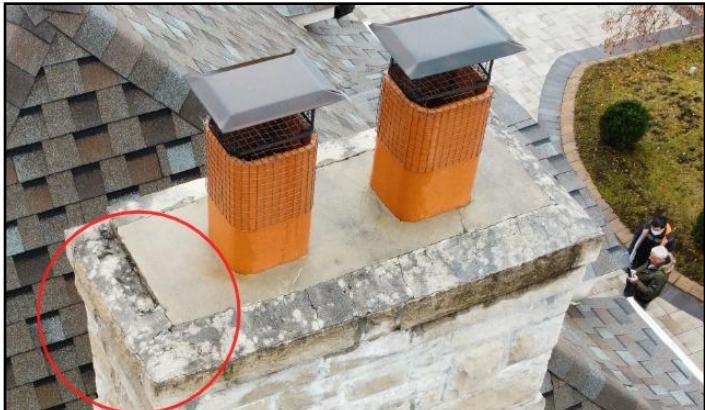
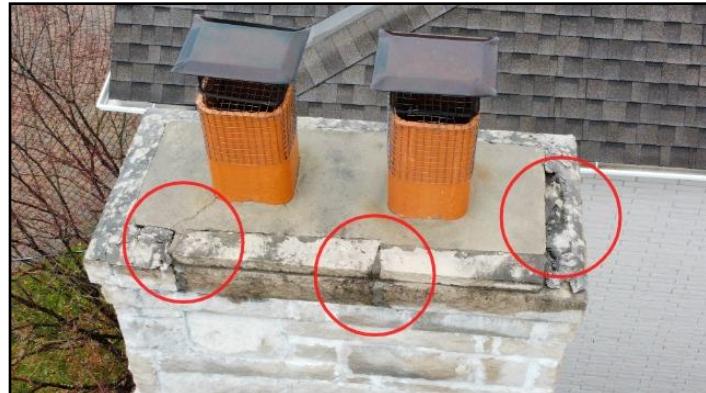
21. Condition: • Cracked

Implication(s): Shortened life expectancy of material | Chance of water damage to structure, finishes and contents

42. Cracked

It is recommended to repair the cracks and caulk the gap between the terracotta chimney channel and the chimney cap to prevent potential water penetration inside the chimney.

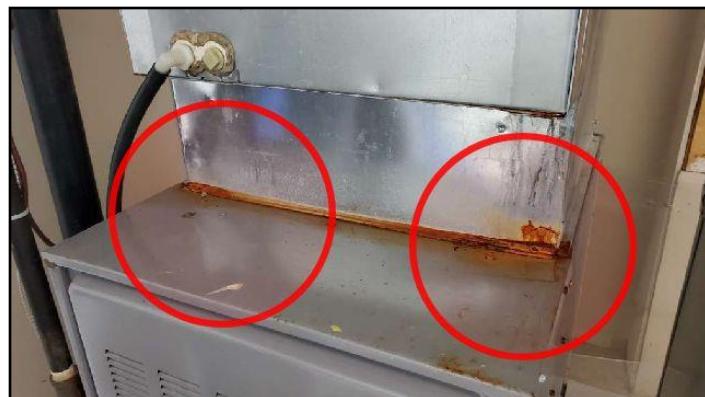
44. Pan leaking

24. Condition: • [Pan leaking](#)

There was evidence of rust on the furnace, in combustion, and in blower compartments of the furnace due to condensate leakage from the AC evaporator pan. There was no active leak observed at the time of the inspection.

Implication(s): Damage to equipment | Chance of water damage to structure, finishes and contents

Task: Repair

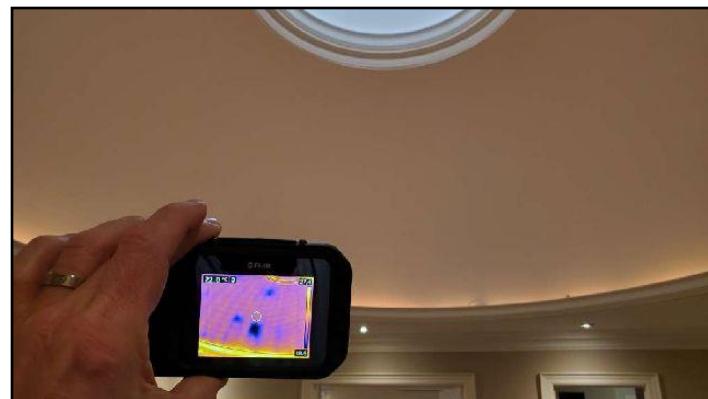
25. Condition: • [Gaps or voids](#)

There were gaps in the insulation observed visually and with infrared camera in the attic. Re-distribute, or add the insulation to improve performance and reduce heat loss.

49. Gaps or voids

Task: Further evaluation and repair

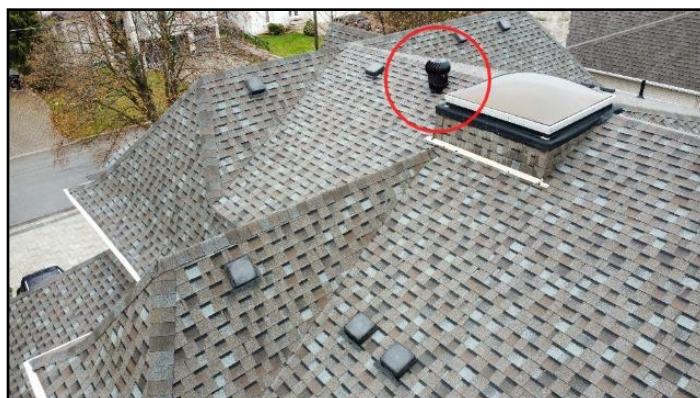
57. Turbine vent seized

27. Condition: • [Turbine vent seized](#)

Task: Repair or replace

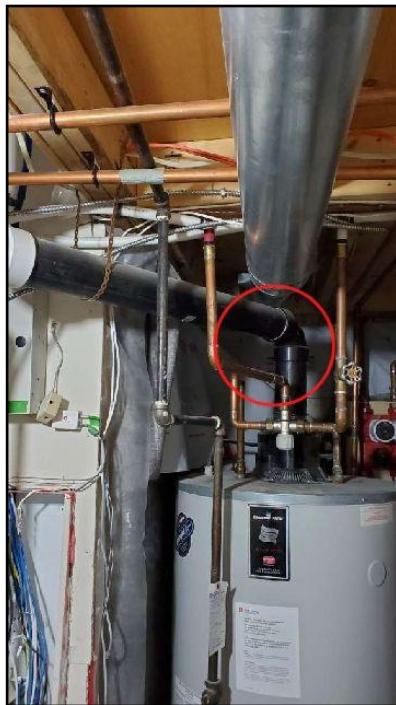
58. ABS plastic used for the combustion exhaust...

28. Condition: • ABS plastic used for the combustion exhaust system.

Contact a licensed gas contractor/local gas utility for further evaluation and replacement with PVC pipes.

Task: Replace

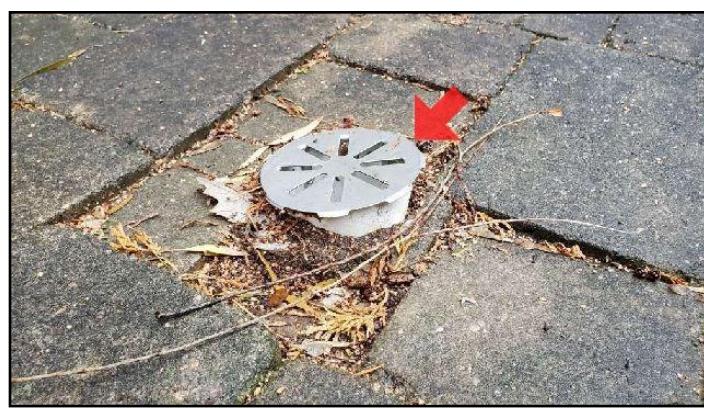
29. Condition: • [Poor location](#)

Implication(s): Chance of water damage to structure, finishes and contents

59. Settlement around drain

Task: Improve

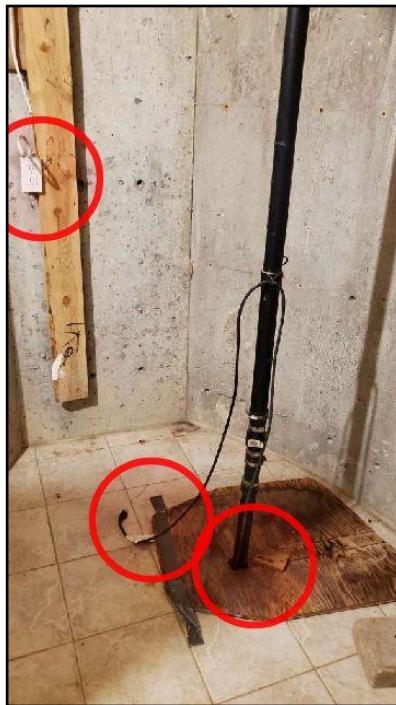
60. Short cycling or running continuously

30. Condition: • [Short cycling or running continuously](#)

The sump pump was disconnected from the power at the time of inspection. During the testing it was intermittently short cycling or not fully stopping at the end of the cycle. It was recommended to contact a qualified plumber for service and

Implication(s): Equipment failure | Reduced system life expectancy

repair/replacement, if required.

Task: Further evaluation and repair/replace

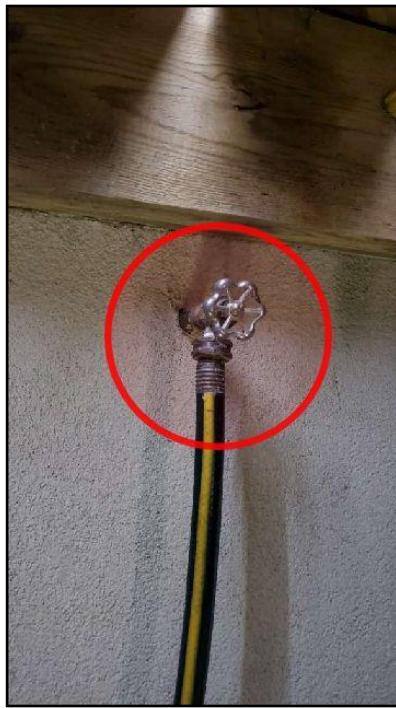
62. Not shut-off for winter.

32. Condition: • Not shut-off for winter.

All external water outlets should be shut off from inside during the winter period to prevent potential damage and flooding.

Task: Correct

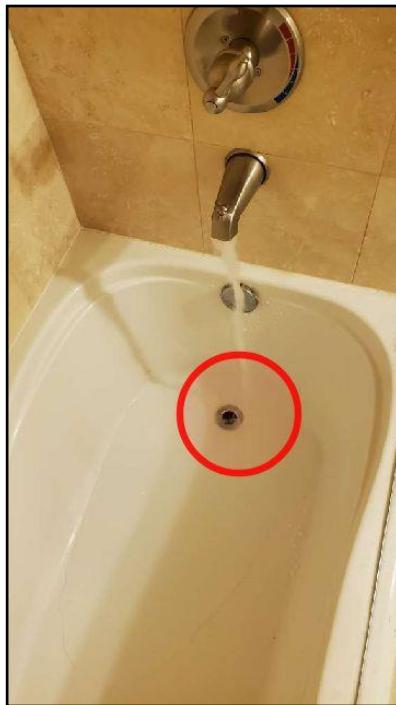
63. Drain stop missing

34. Condition: • Drain stop missing

Task: Install

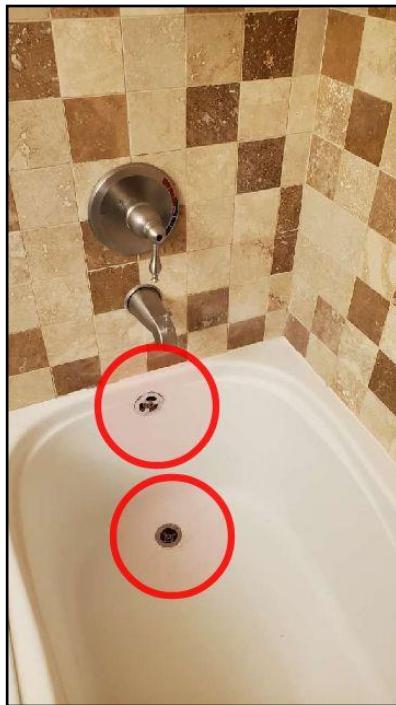
64. Drain stop missing

35. Condition: • Drain stop missing

Task: Repair

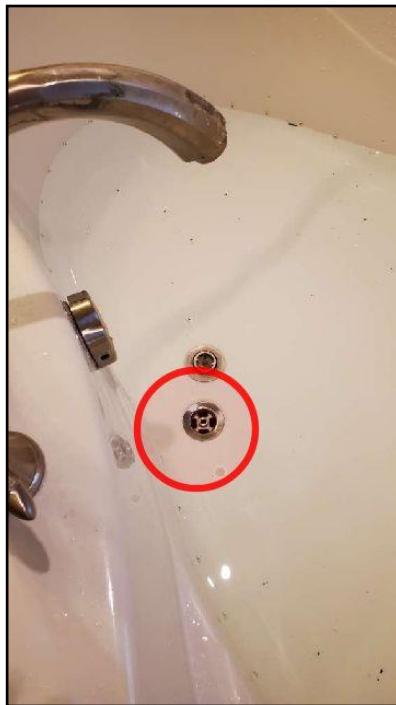
65. Drain stop ineffective

36. Condition: • Drain stop ineffective

Task: Repair or replace

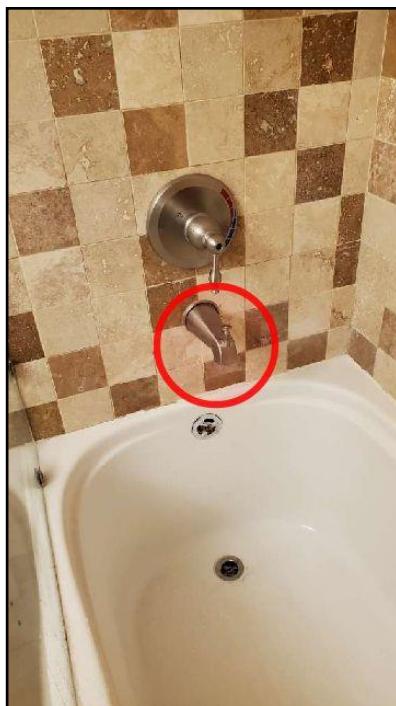
66. Shower diverter ineffective

37. Condition: • Shower diverter ineffective

Task: Replace

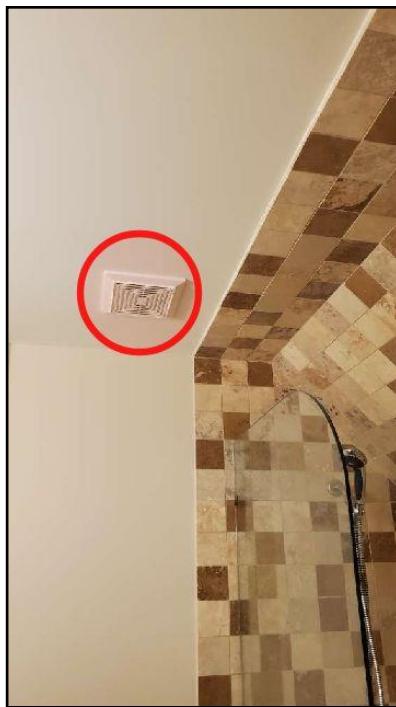
67. *Inoperative*

38. Condition: • Inoperative

Switch defective

Task: Repair

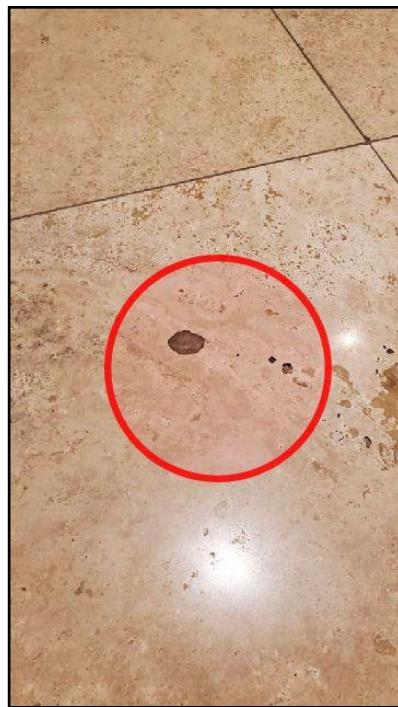
68. Tiles defective

39. Condition: • Tiles defective

Task: Repair or replace

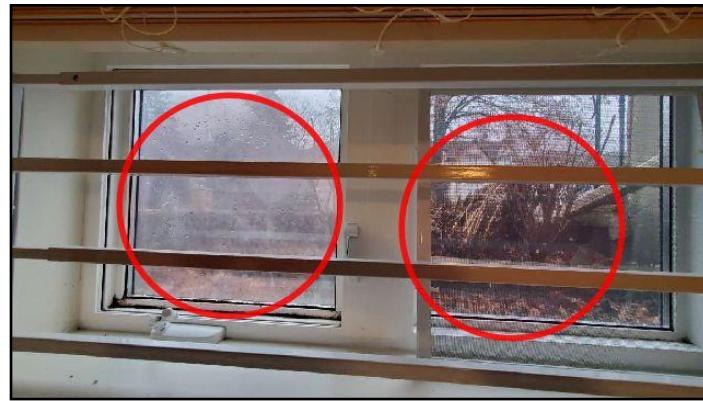
69. Lost seal on double or triple glazing

40. Condition: • Lost seal on double or triple glazing

Task: Replace

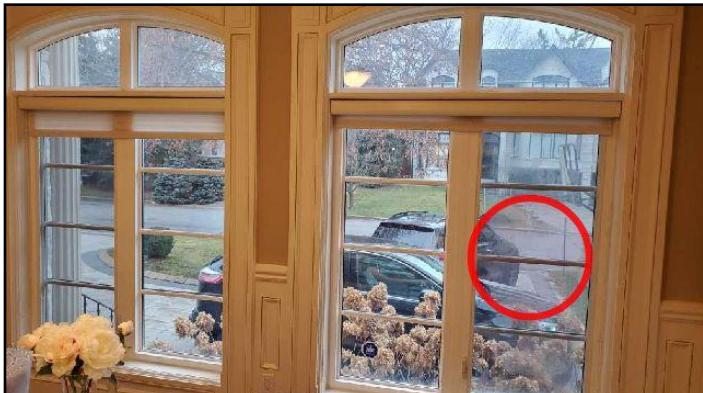
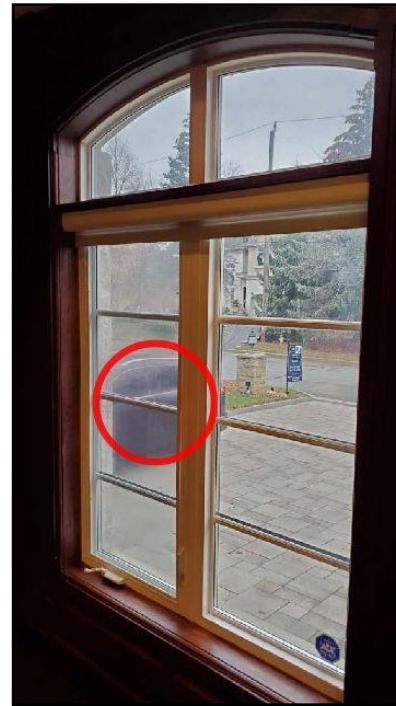
41. Condition: • Lost seal on double or triple glazing

Task: Replace

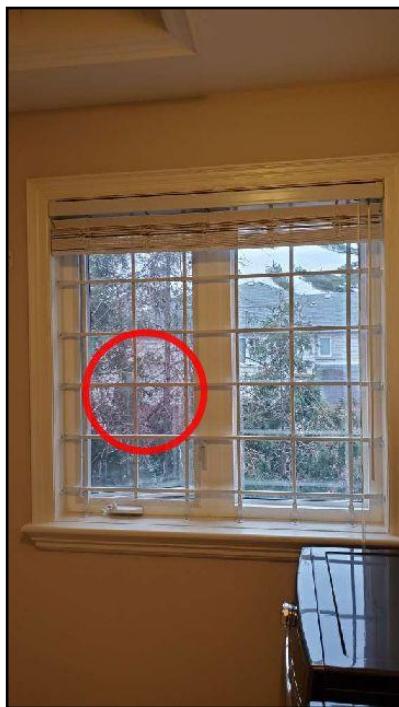
42. Condition: • Lost seal on double or triple glazing

Task: Replace

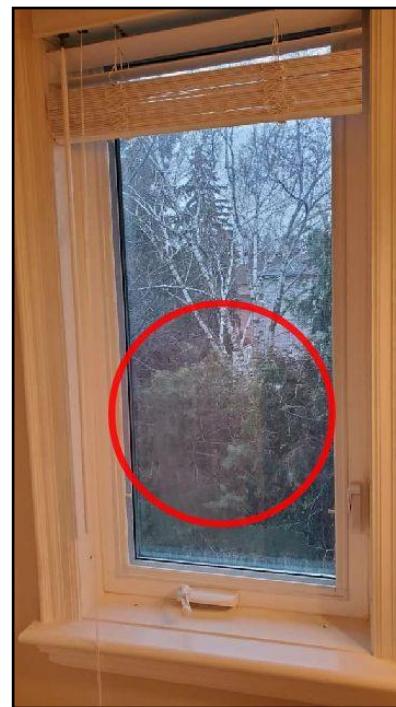
73. Lost seal on double or triple glazing

Condition: • Lost seal on double or triple glazing

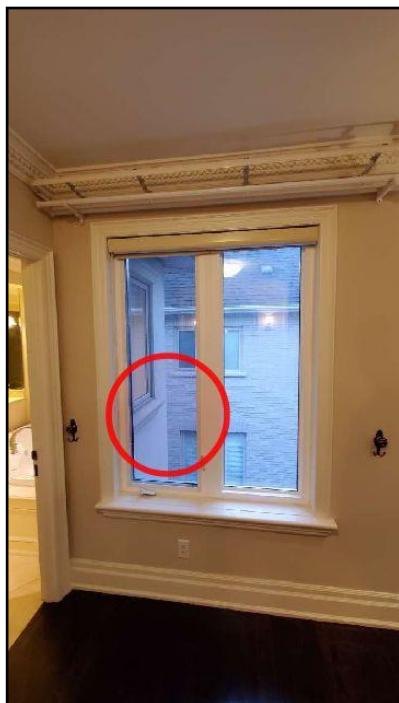
75. Lost seal on double or triple glazing

43. Condition: • Lost seal on double or triple glazing

Task: Replace

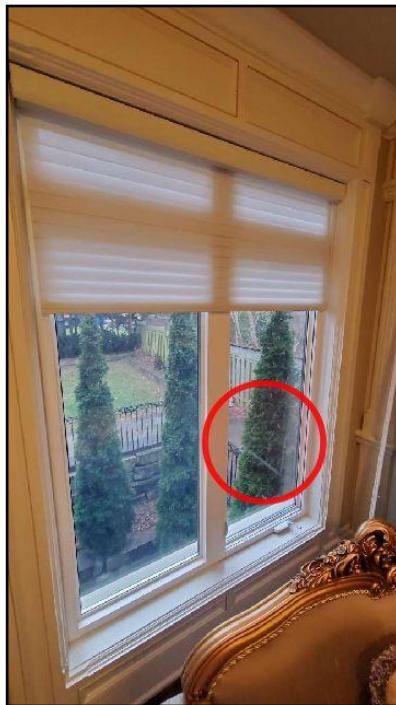
78. Inoperable

44. Condition: • Inoperable

Task: Repair

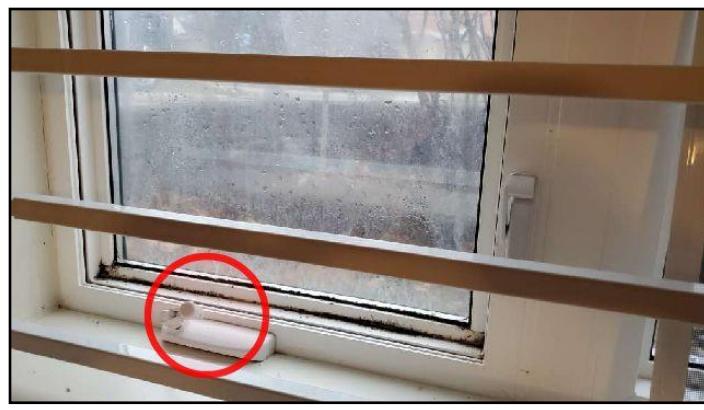
79. Inoperative

45. Condition: • [Inoperative](#)

Task: Repair or replace

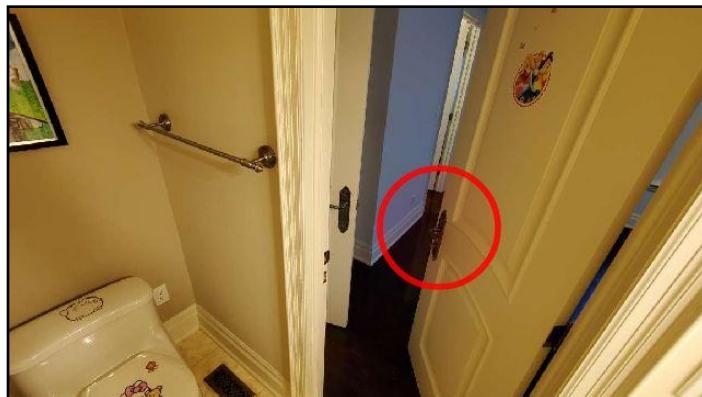
80. Does not latch properly

46. Condition: • Does not latch properly

Task: Repair

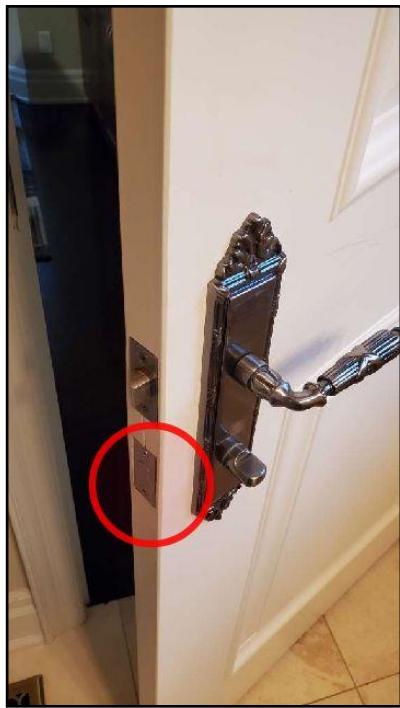
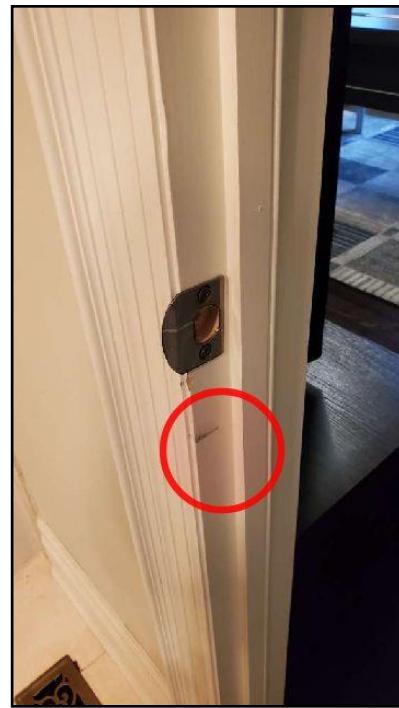
47. Condition: • Door not lockable

Task: Improve

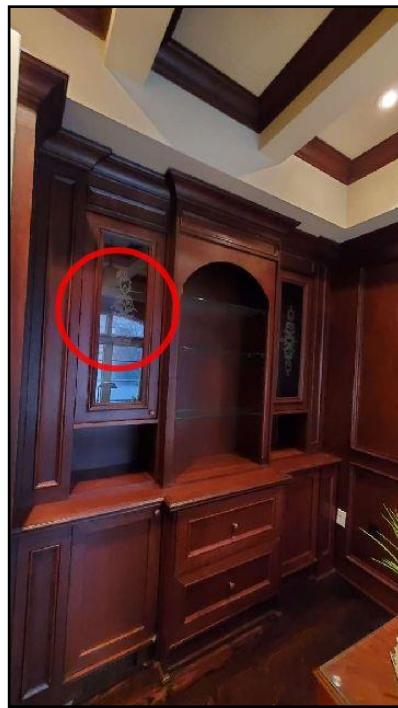
83. Door loose

48. Condition: • [Doors or drawers missing or loose](#)

Implication(s): Damage or physical injury due to falling materials | Nuisance

Task: Repair
