| <b>PAXAR Bangladesh Ltd.</b><br>A subsidiary of Avery Dennison Corporation<br>Plot#167-169, Dhaka-EPZ-Ext. Area<br>Savar, Dhaka-1349, Bangladesh | <b>BD LAB</b><br><b>Test Report</b> | <b>DHK26P063</b> | | |
| <b>Order informations details: The following samples is identified on behalf of the customer</b> | | | | |
| Sample description(Item code) | AW-005328-152-85-14 | Sample description(Item Color) | N/A | |
| T1 name and Fabric Mill | PUMA | SO +Line | S4228738-1 | |

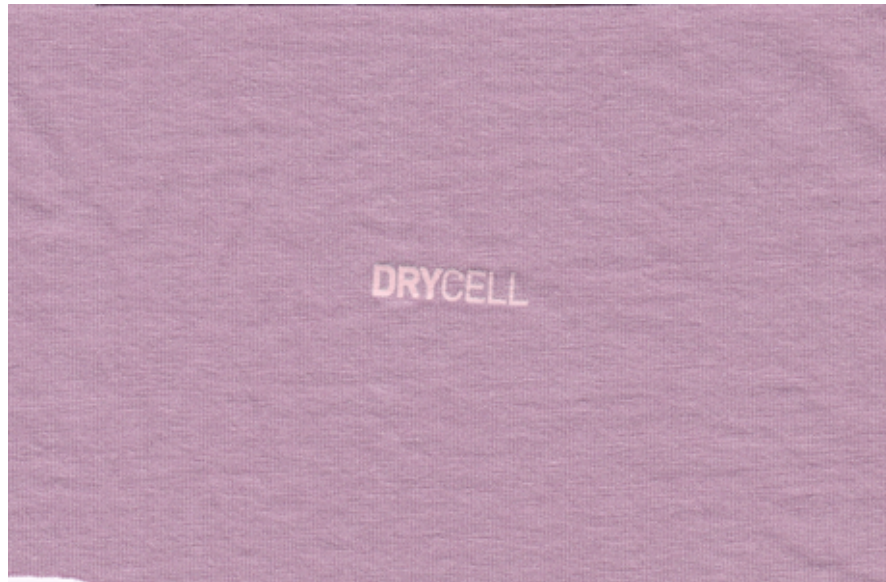
**Print Durability Test – Appearance after washing/drying**

| Print Durability Test – Appearance after washing/drying | (PT65, ISO 5077/ ISO 3759/ ISO 6330/ ISO 16322-1/-2/-3 + ISO 16322-2 Amd. 1 modified) | Fail | Peeling off | |

| 3.2 | | Peeling off appearance of prints | | Peeling off | | | No peeling off | | |
| <b>Conclusion</b> | | Pass | | <input type="checkbox"/> Fail | | <input checked="" type="checkbox"/> N/A | | <input type="checkbox"/> | |

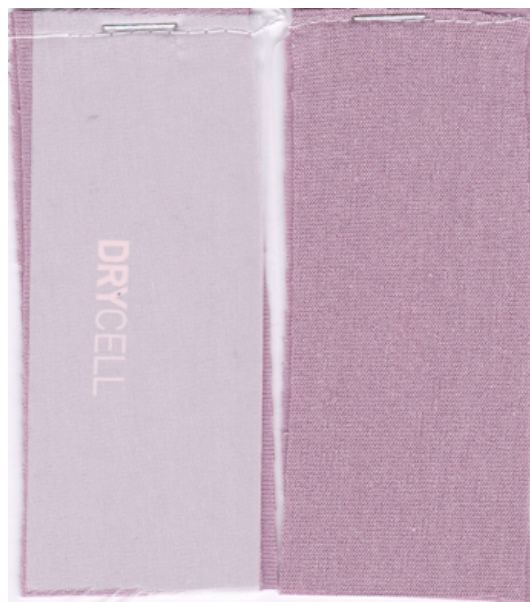
**Oven Migration Test**

| <b>Colour Change (body &amp; print)</b> | | 4-5 | | Min. 4-5 |
| <b>Colour Staining onto polyester (body &amp; print)</b> | | 5 | | Min. 4-5 |
| <b>Cross staining (dk to Lt.)</b> | | 5 | | Min. 4-5 |
| <b>Conclusion</b> | Pass | <input checked="" type="checkbox"/> | Fail | <input type="checkbox"/> |

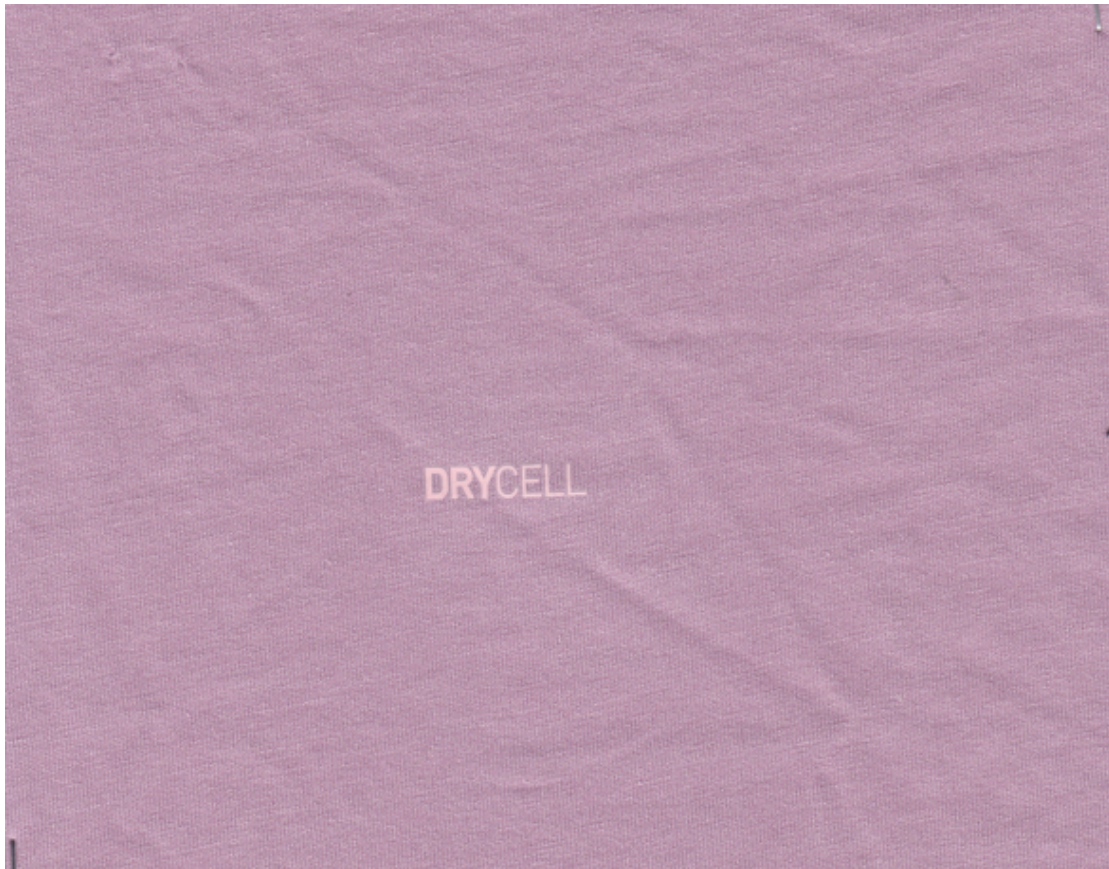
**Print Hand Stretch Test**

| Same visual appearance | | | | No Change | | | Print must retain same visual appearance | | |
| No crack when stretching | | | | No crack observed | | | No crack when stretching | | |
| No peel off | | | | No peel off | | | No peel off | | |
| <b>Conclusion</b> | | Pass | | <input checked="" type="checkbox"/> Fail | | <input type="checkbox"/> N/A | | <input type="checkbox"/> | |
