## Site Visit

Date	2025-05-21
Time-in	09:48 (-7 GMT)
Field crew members	DB, MT, KP, LP
Station code	Cheslatta Lake-02FW005-WX
Enter station name	
Elevation	877m
Latitude	53.721712N
Longitude	125.641697W
Site conditions (skyview, slope, vegetation, flow/depth/geomorphology, local impacts)	Open sky view. Wide clearing around station at least 30 foot radius. Clearing dominated by 3ft tall grasses, now mostly dry and flattened. No visual evidence of tampering or disturbances.

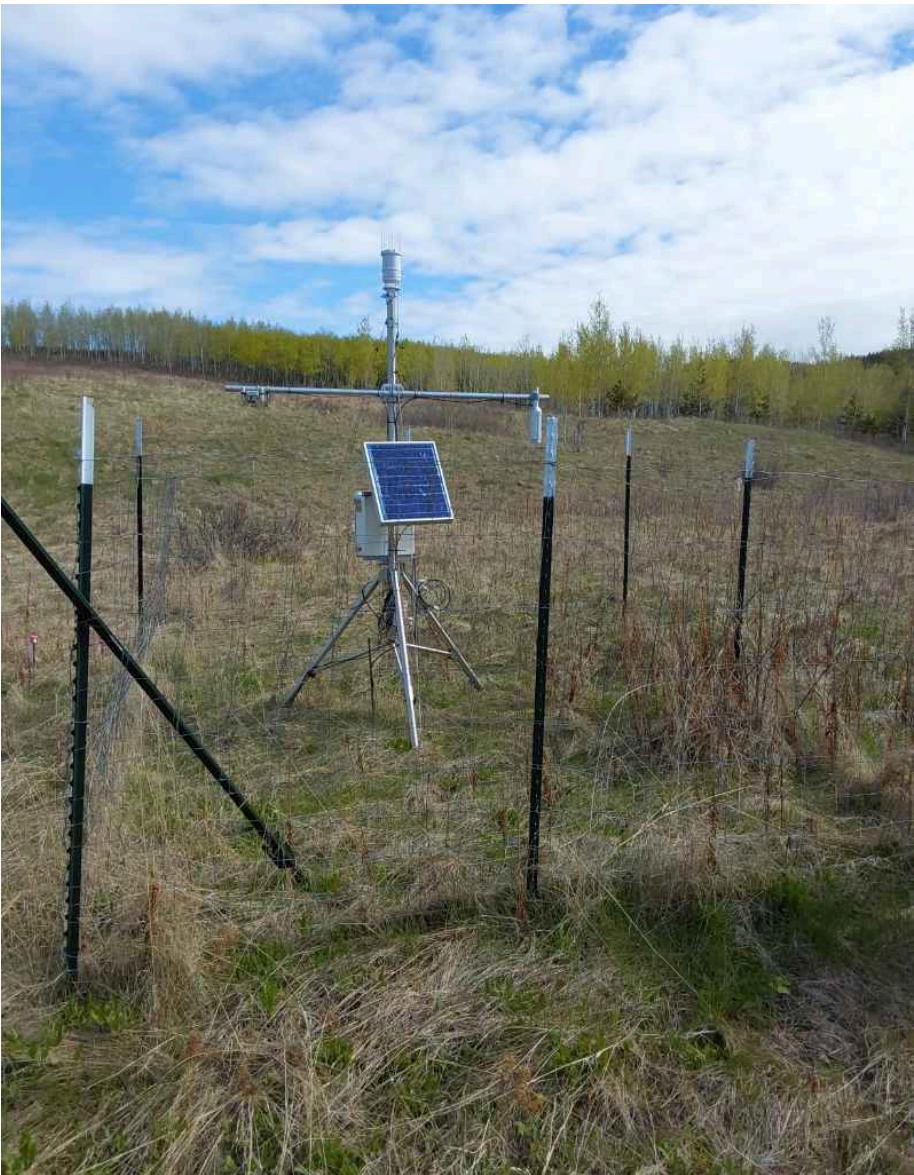
Photo of site upon arrival
