AGRICULTURAL MACHINERY TESTING AND EVALUATION CENTER

## Test Report No. 2023 – 0030

### Agricultural Machinery – Walking-Type Agricultural Tractor HG AIM HG-TUT-YD16

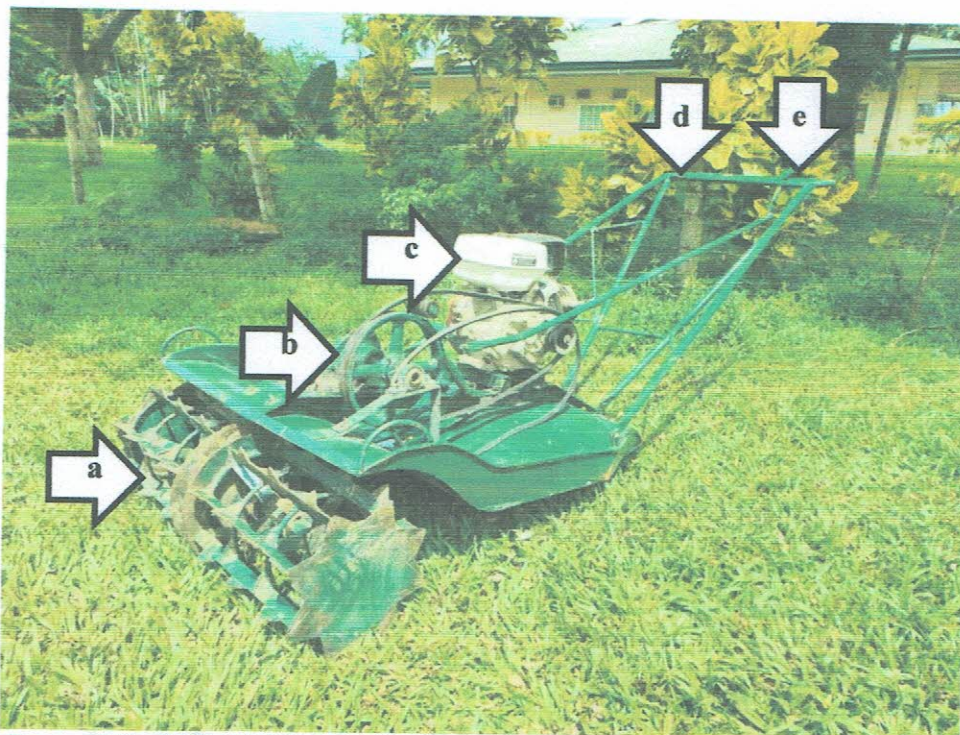
Figure 1. Parts of the HG AIM HG-TUT-YD16 Walking-Type Agricultural Tractor powered by an 11.94 kW YAMADA Gasoline Engine include the following: (a) Tilling wheel, (b) V-belt and pulley transmission system, (c) Prime mover, (d) Handle, and (e) Main clutch lever.

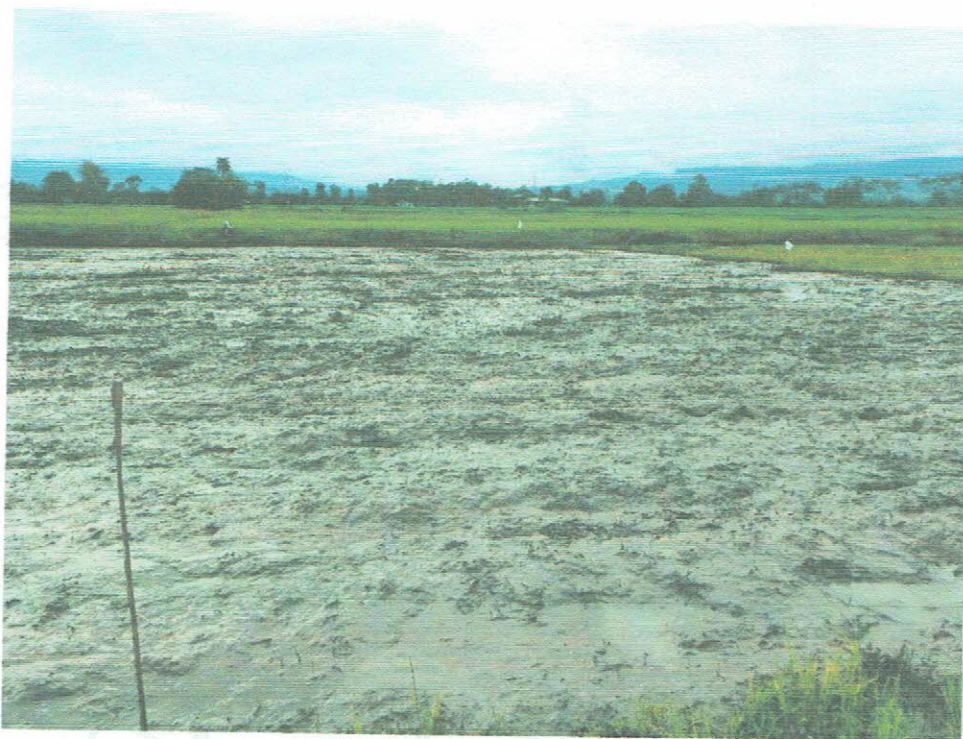
Figure 2. Quality of work.

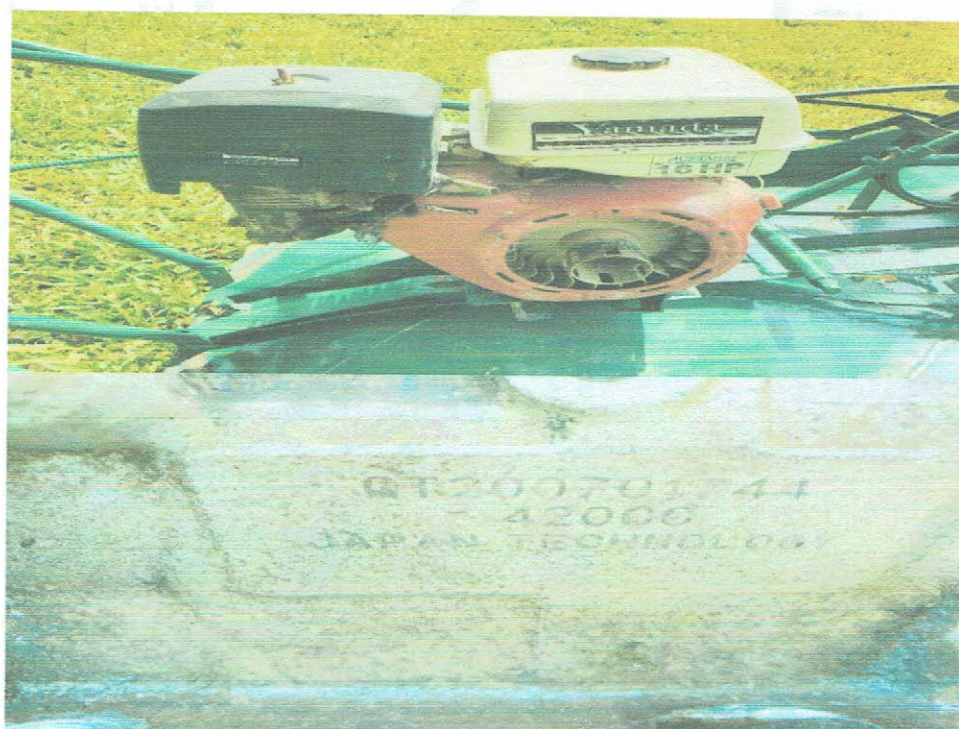
Figure 3. Markings on the prime mover.
