AGRICULTURAL MACHINERY TESTING AND EVALUATION CENTER

## Test Report No. 2023 – 0060

## Agricultural Machinery – Front Loader HANIL HL25

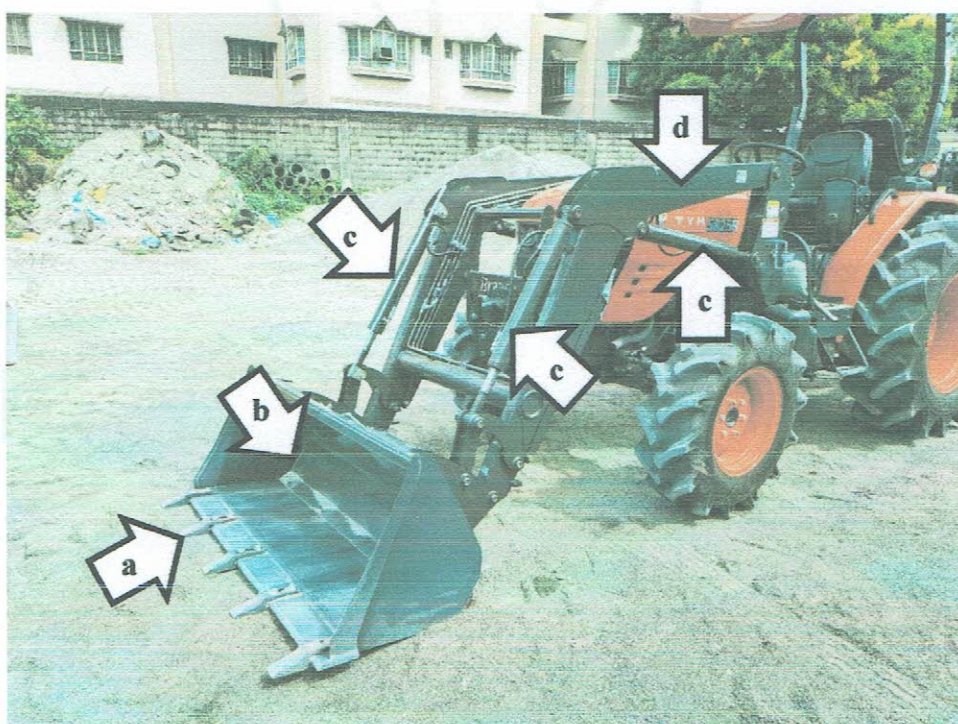
| 14. Presence of sharp edges and rough surfaces | No sharp edges or rough surfaces were observed on the machine except for the ground-engaging tool during the test operation. |

Figure 1. Parts of the HANIL HL25 Front Loader mounted to 40.5 kW TYM 5825R Four-Wheel Tractor include the following: (a) Ground-engaging tool, (b) Bucket, (c) Hydraulic cylinders, and (d) Arm.

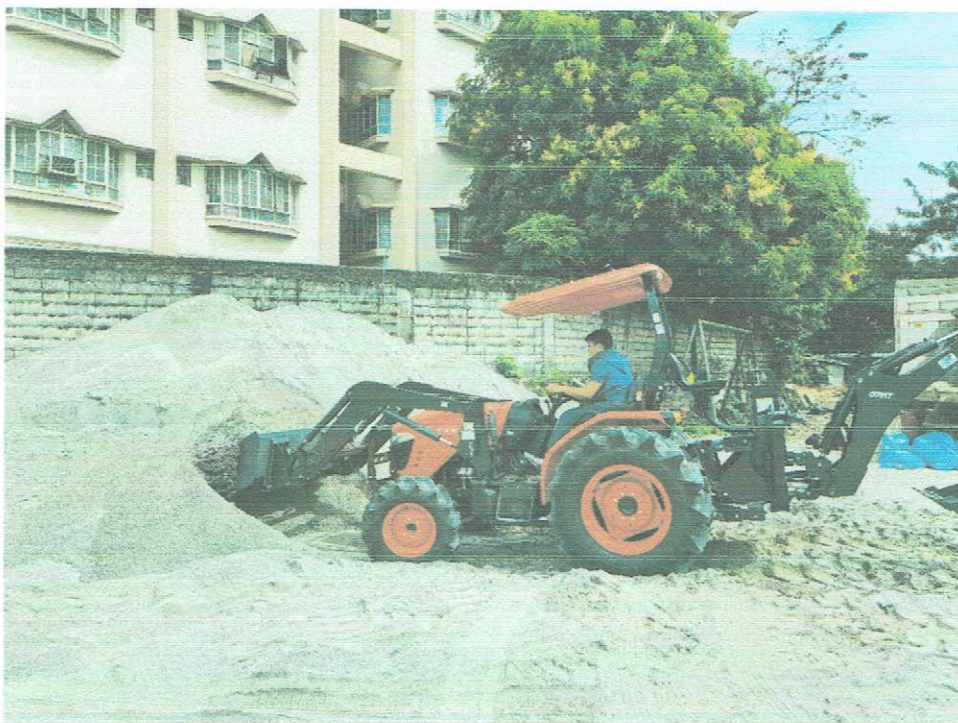
| 10. Loading and unloading of soil | The operator controlled the front loader through its remote hydraulic system. The soil was scooped from the ground using the bucket and then lifted during transport going to the truck. The bucket is then shifted to dumping position for unloading soil to the truck. |

| 11. Failures or abnormalities that may be observed on the implement or its component parts during and after the operation | No failure or abnormalities were observed on the machine or its component parts during and after the test operation. |

Figure 2. Front loader during operation.

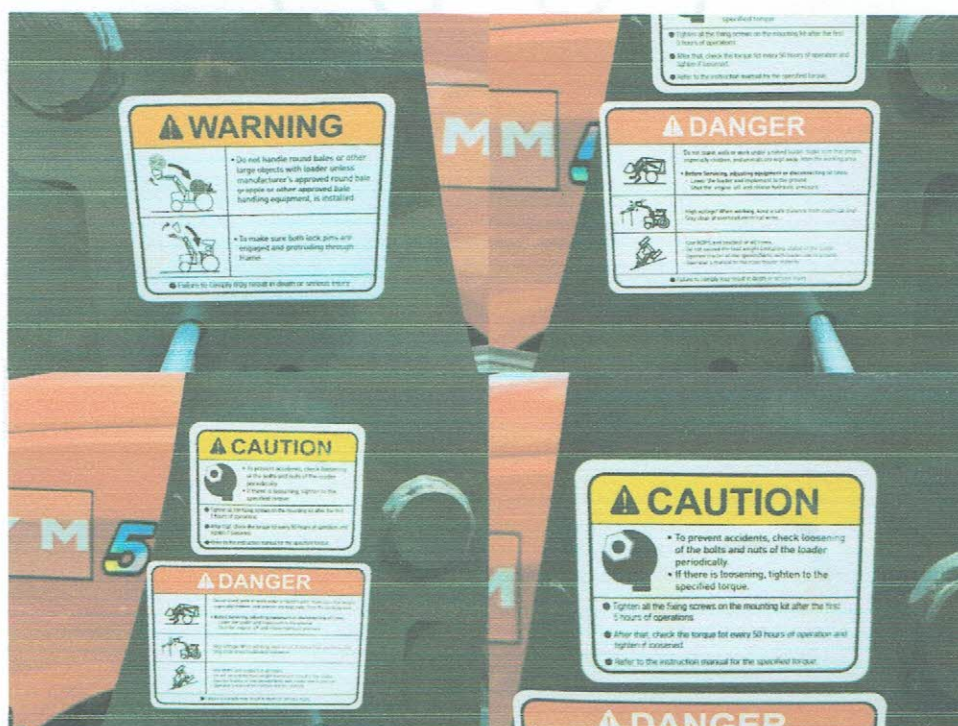
| 15. Provision for the operator's safety | Warning notices are provided on the front loader. |

Figure 4. Marking and warning signs on the HANIL HL25 Front Loader.
