## Test Discontinuity Report

No. 2026 – 0003

**Agricultural Machinery –  
Agricultural Trailer  
SUPER STD-5**

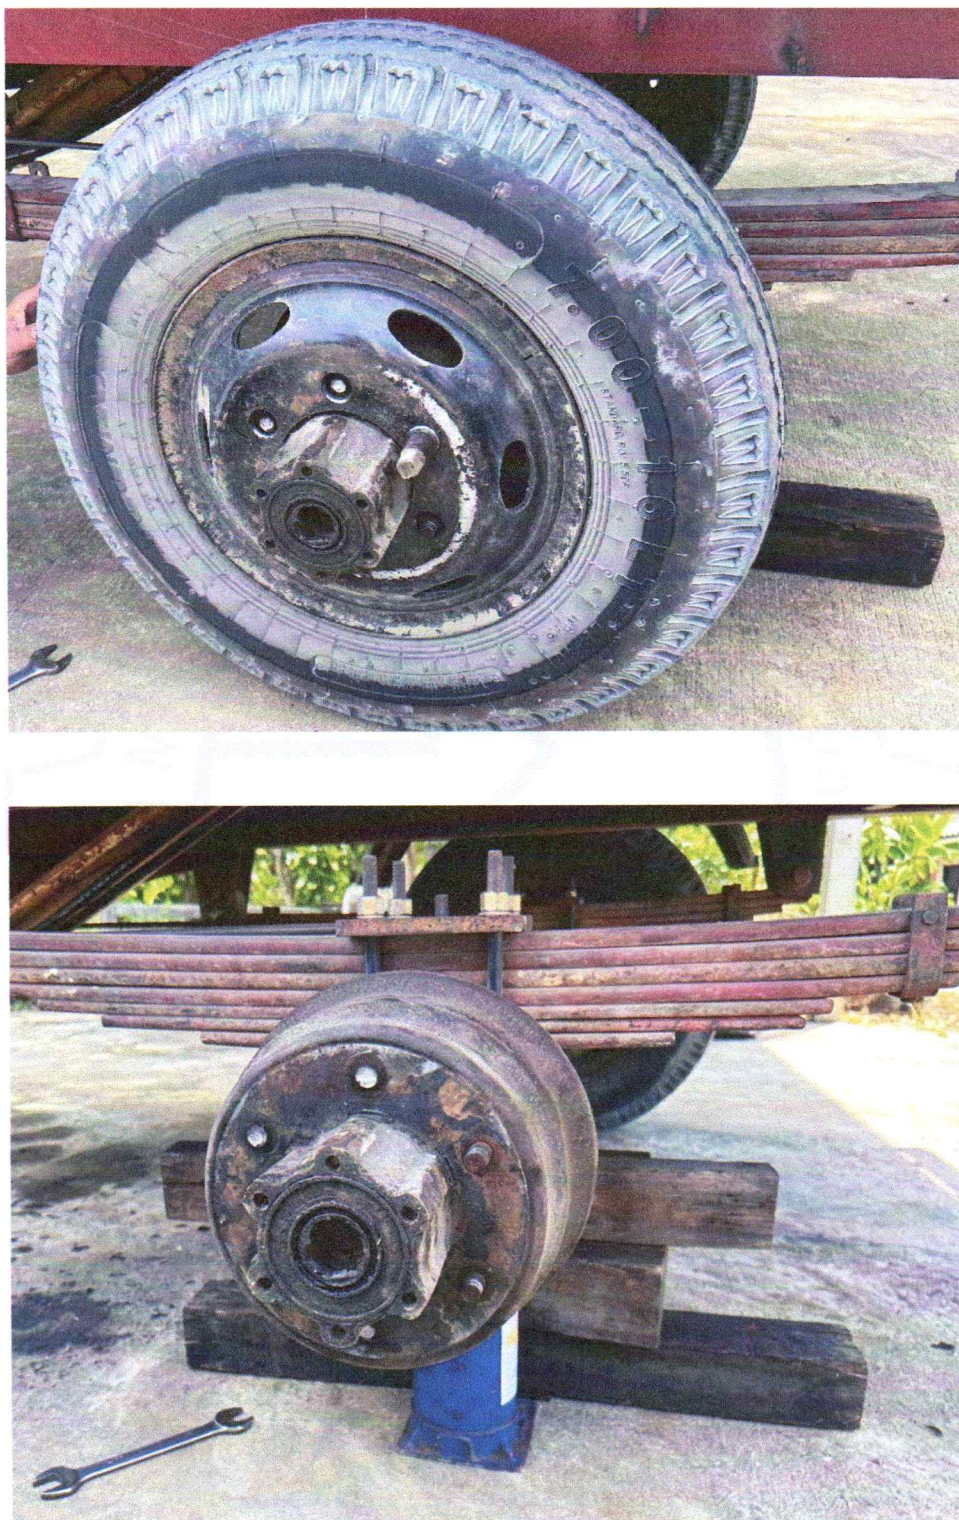
| Description | <p>The test applicant decided to terminate the ongoing paved road trial of the field performance test of their agricultural trailer.</p> <p>During the payload test on a paved road, five out of six wheel studs on the left wheel of the trailer, as shown in (Figure 1), were sheared, after 48 minutes of testing. Since the machine cannot continue its operation due to major breakdown, hence, the test was terminated.</p> |

Figure 1. Machine breakdown of SUPER STD-5 Agricultural Trailer during the performance test on paved road.

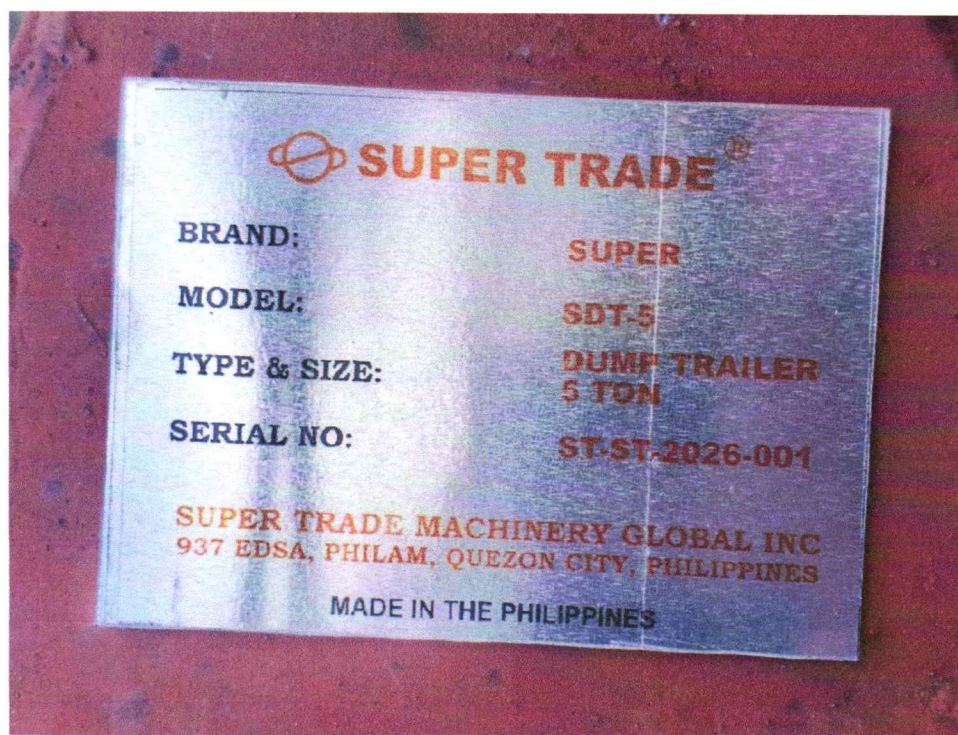
Figure 2. Nameplate of the SUPER SDT-5.
