AGRICULTURAL MACHINERY TESTING AND EVALUATION CENTER

## Test Discontinuity Report

**No. 2026 – 0005**

**Agricultural Machinery –  
Agricultural Trailer  
SUPER STD-5**

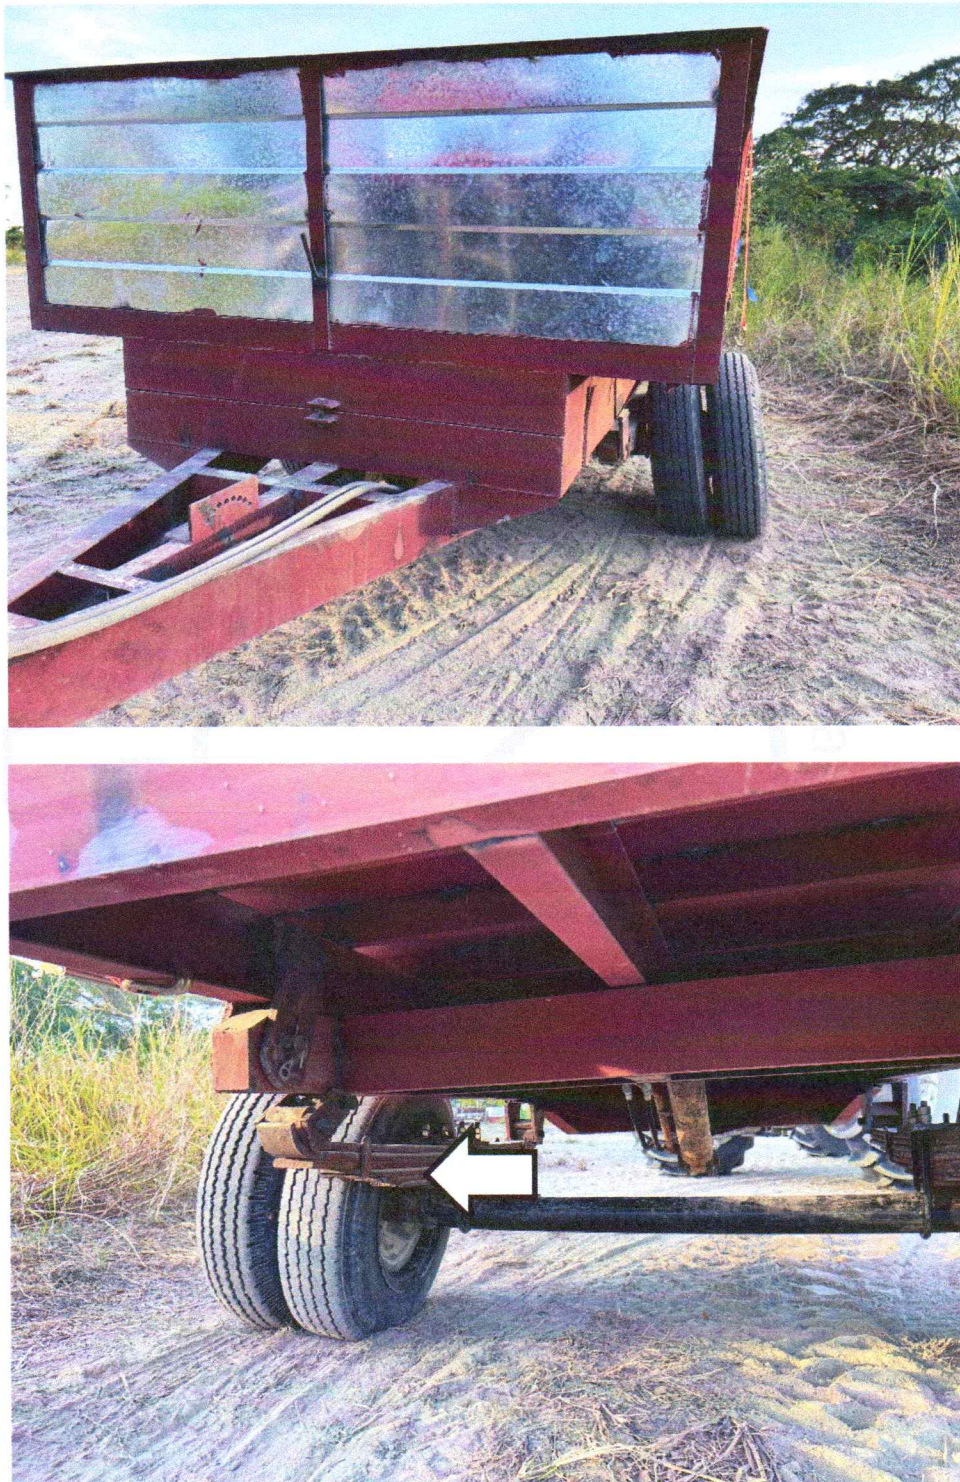
| Description | <p>The test applicant decided to terminate the ongoing bare dirt road trial of the field performance test of their agricultural trailer.</p> <p>During its payload test on bare dirt road, the leaf spring (the layered metal bars) has disconnected from its mounting bracket on the trailer frame (Figure 1), after 10 minutes of testing. Since the machine cannot continue its operation due to major breakdown, hence, the test was terminated.</p> |

Figure 1. Machine breakdown of SUPER STD-5 Agricultural Trailer during the performance test on bare dirt road.

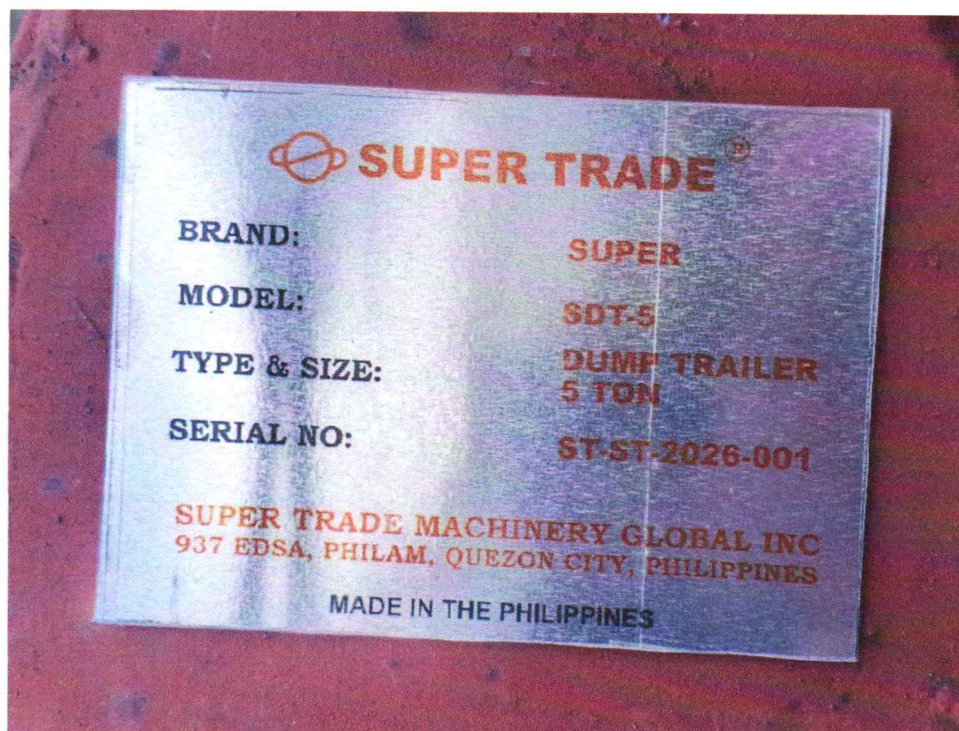
Figure 2. Nameplate of the SUPER SDT-5.
