Project #103-14: Thermal Compression Testing of EVRlock QB1-HT and API Buttress Connections

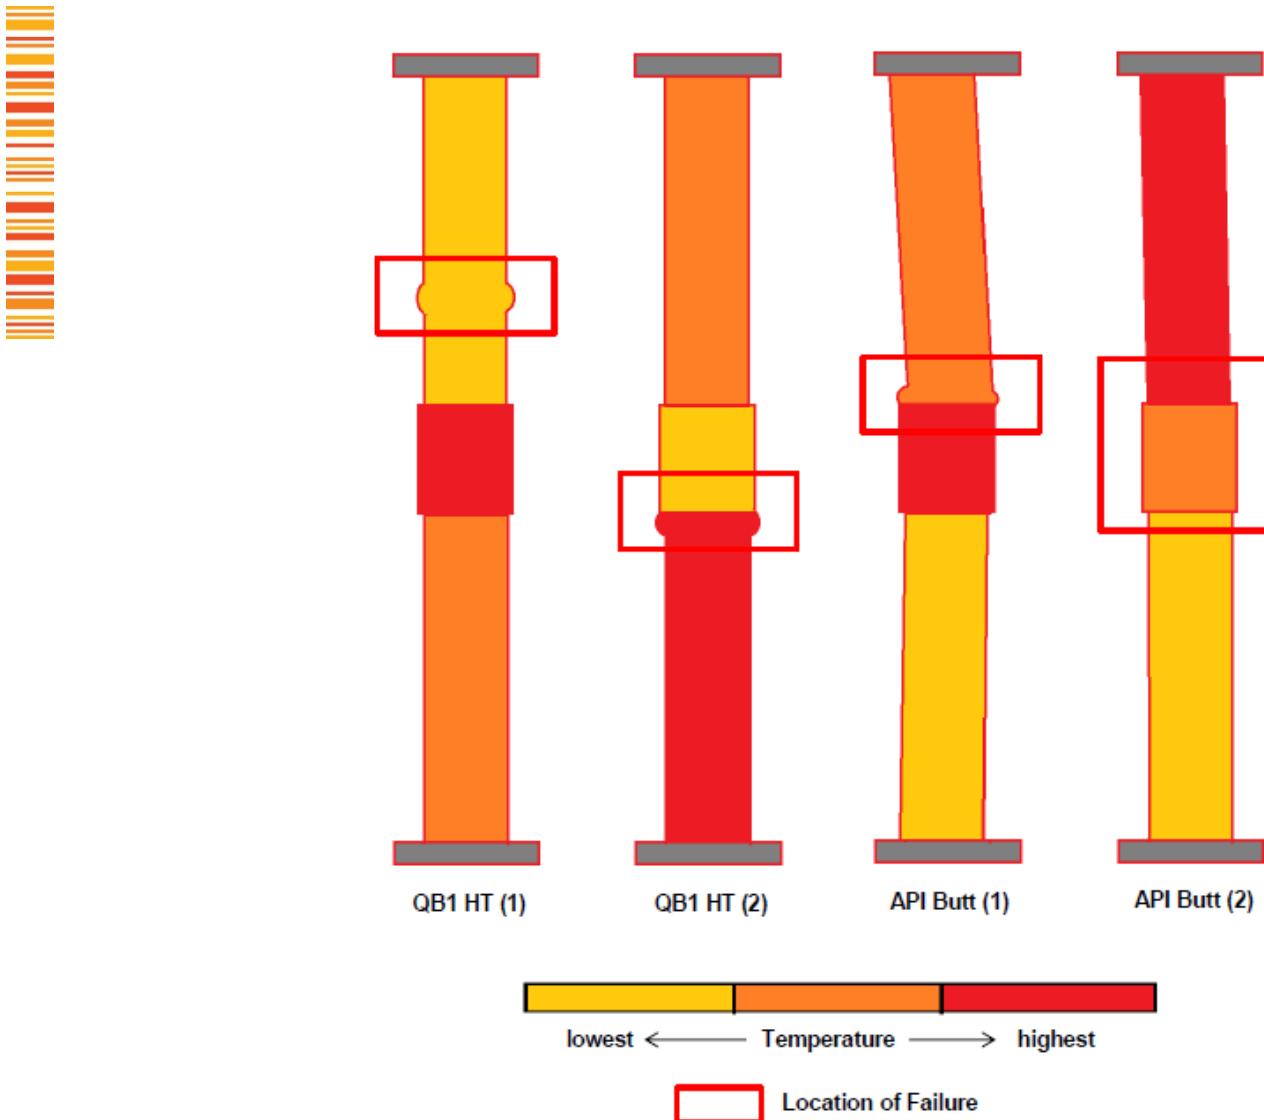
Table 1 compares the peak loads to temperatures at different specimen locations. Due to reduced yield strength with increasing temperatures, plastic deformation is expected to occur at locations with the highest temperature readings. When specimens are compressed, the casing will attempt to equalize load by shedding strain into weaker locations. As a result, locations of higher temperature fail due to lower resistance to strain. Of the four trials, two results were inconsistent with these hypotheses: the QB1-HT (1) and API Buttress (2). The resulting locations of failure for all trials, with respect to temperature, are presented in Figure 2.

In the case of the QB1-HT, failure occurred on the pipe body rather than the connection. Since the casing and connection are composed of the same material, the ability of the QB1-HT to withstand failure at higher temperatures, and lower yield strength, demonstrates a stronger structural geometry. The design of the QB1-HT ensured that stresses were localized on the pipe body; therefore, failure was prevented at the connection despite the weakened material.

The opposite is true for the API Buttress, with failure occurring on the connection rather than the upper pipe body. Given that failure occurred at the location of higher strain resistance, it is indicative that stresses localized in the Buttress connection. Therefore, while the actual strength of the QB1-HT is inconclusive, it is suggested to be greater than the L80 casing and API Buttress due to a more optimized geometry.

Figure 2: General comparison of temperature to location of failure

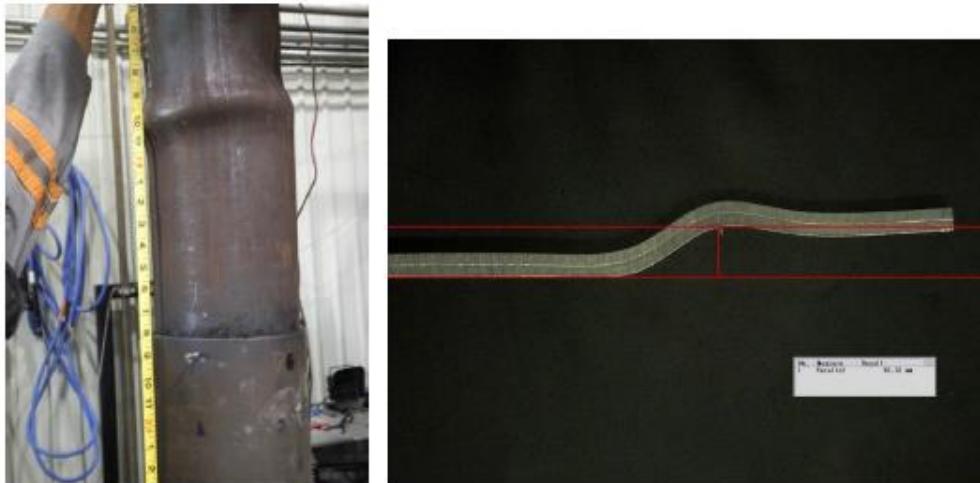
The failure geometry of the QB1-HT specimens is a “rolled-over” structure as seen in Figures 3 and 4. Uniform axial collapse suggests that failure occurred as a result of high strain, but with even stress distribution. Moreover, results agree with Euler’s hypothesized behavior for a column with both ends fixed. While API Buttress (1) also had a rolled structure above the connection, there was an evident lack of symmetry overall which suggests failure at a point.

Figure 3: Plastic deformation for QB1-HT trial 1

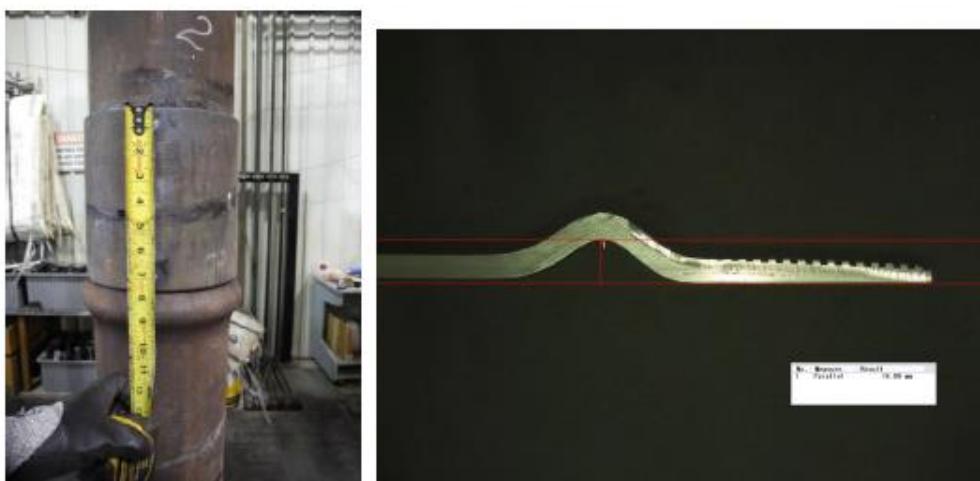
Figure 4: Plastic deformation for QB1-HT trial 2

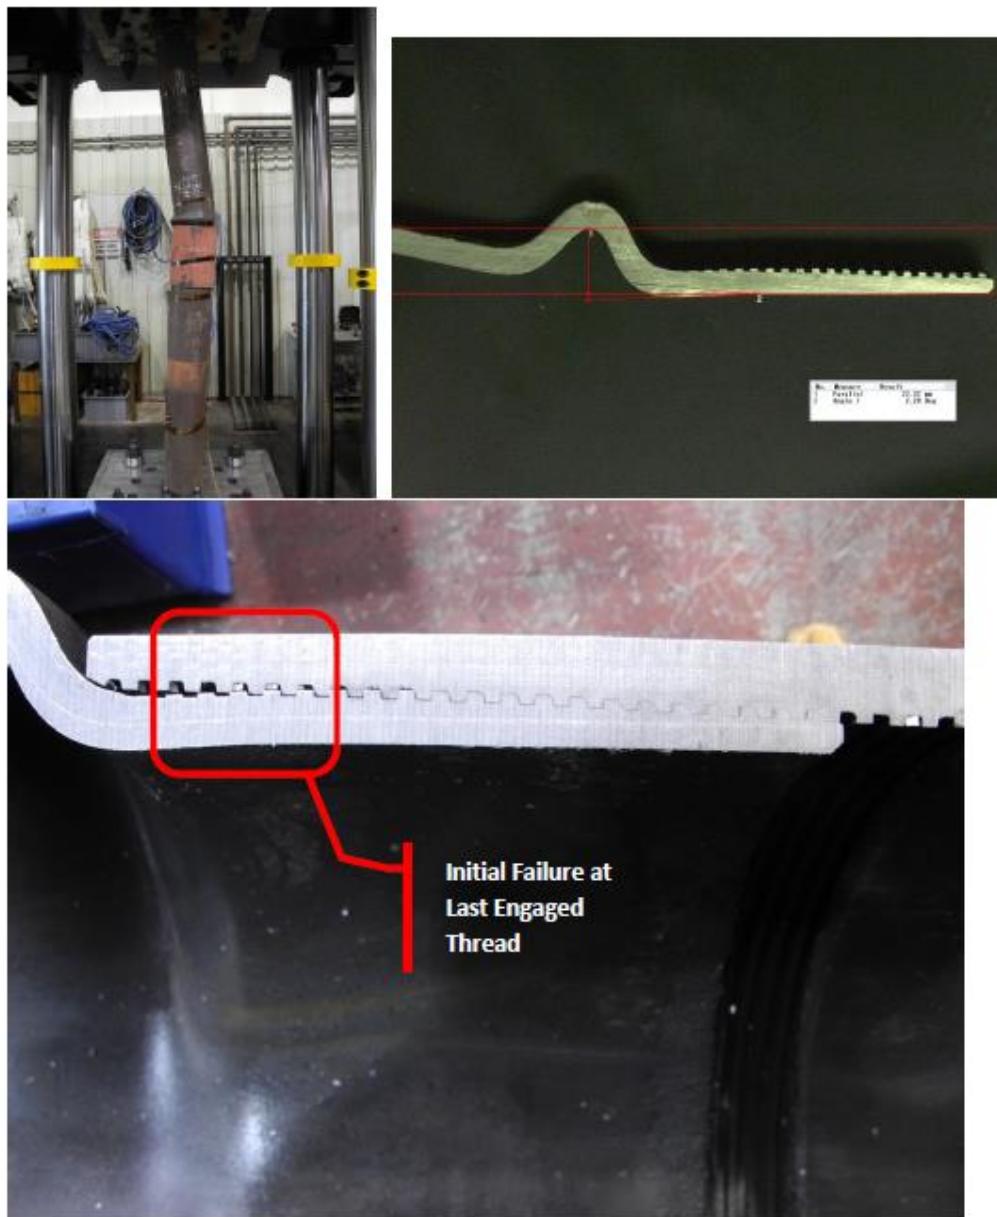
When comparing the failed sections near the connection, both API Buttresses showed signs of deflection. As seen in both Figure 5 and Figure 6, the API Buttress appears to angle slightly when compared to the QB1-HT in Figure 4. Closer inspection also reveals that deflection becomes increasingly evident along the last few threads. Based on this observation it is possible that the point of failure, noted from the geometric comparison, initiated from the connection on the last engaged thread.

Figure 5: Plastic deformation for API Buttress trial 1

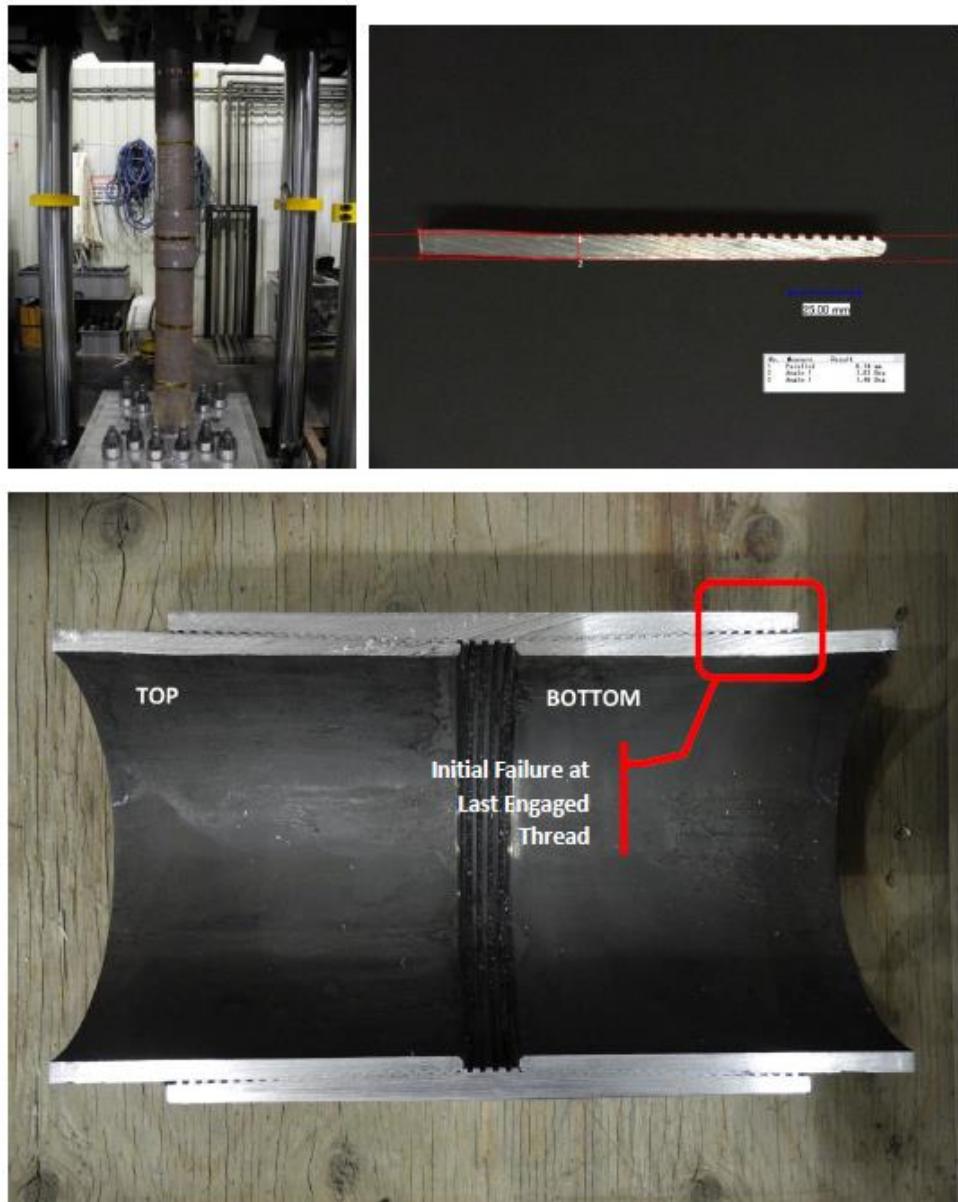
Figure 6: Plastic deformation for API Buttress trial 2

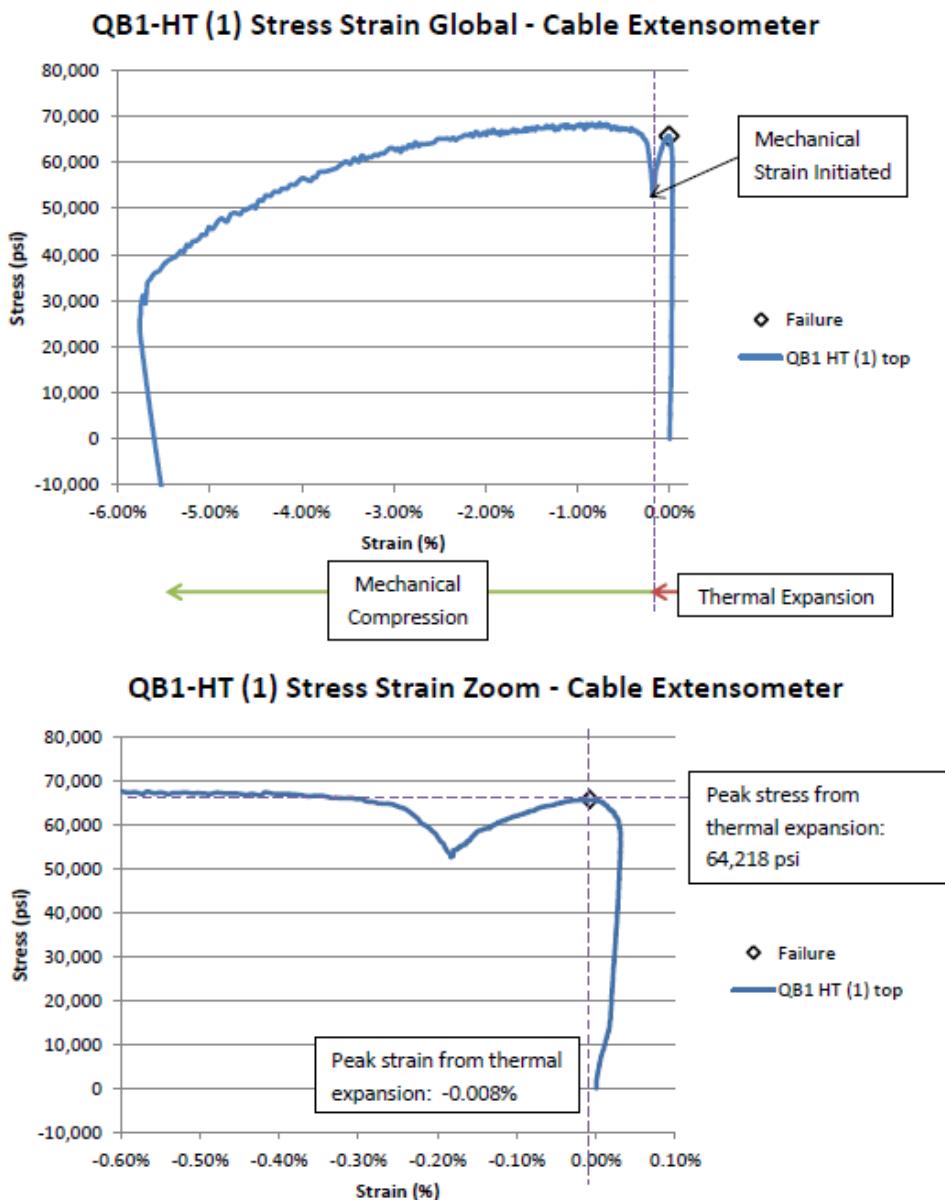
To further understand the deformation, particularly with API Buttress (2), stress strain graphs were analyzed. An analysis of QB1-HT (1) is shown in Figure 7 and graphs for all trials can be seen in Figures 8 and 9.

Figure 7: Analysis of a Stress vs. Strain graphs for QB1-HT (1)

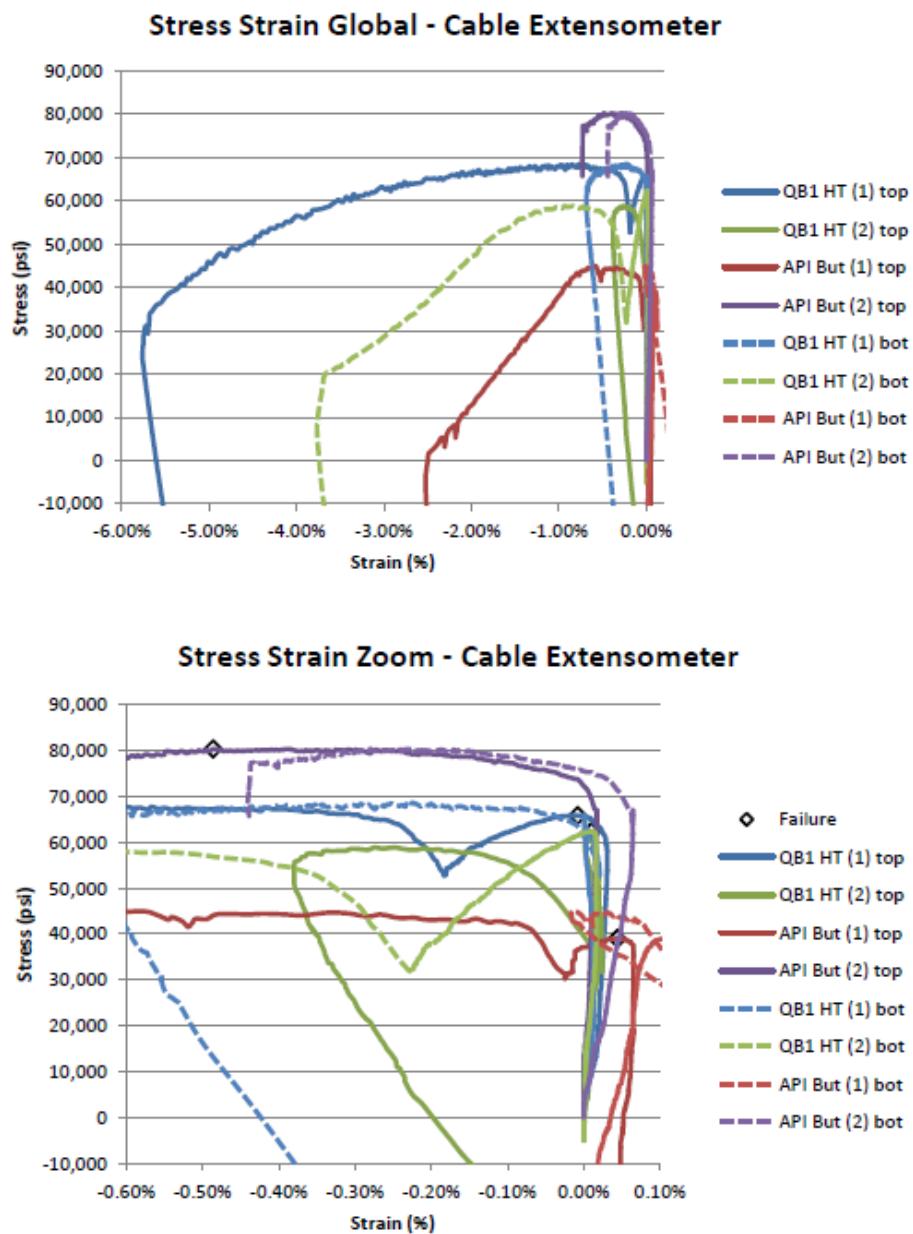
Table 2 summarizes the values of strain at failure- determined from the graphs. Since the specimens are under compression, greater negative strain corresponds to greater plastic deformation. With the API Buttress (2), the strain for both top and bottom coincide, indicating deformation occurring at both locations. In contrast, there is an inclination for deformation at either the top or bottom for the remaining specimens.

When comparing specific values of stress and strain at failure, an anomaly was observed in results for API Buttress (2). While both the QB1-HT and Buttress (1) failed elastically (<0.05% strain), Buttress (2) failed in the elastic/plastic transition zone of ~0.5% strain. This disparity is most likely due to discrepancy in test setup. As noted in Table 1, API Buttress (2) had issues in maintaining a consistent temperature across the test string, with a temperature difference of ~100 °C between the top and the remaining points. Aside from this variance, the remaining tests agree with expectations, with both QB1-HT test strings surpassing the API Buttress (1) in strain and stress capacity at failure.

Figure 8: Stress-strain graphs from cable extensometers

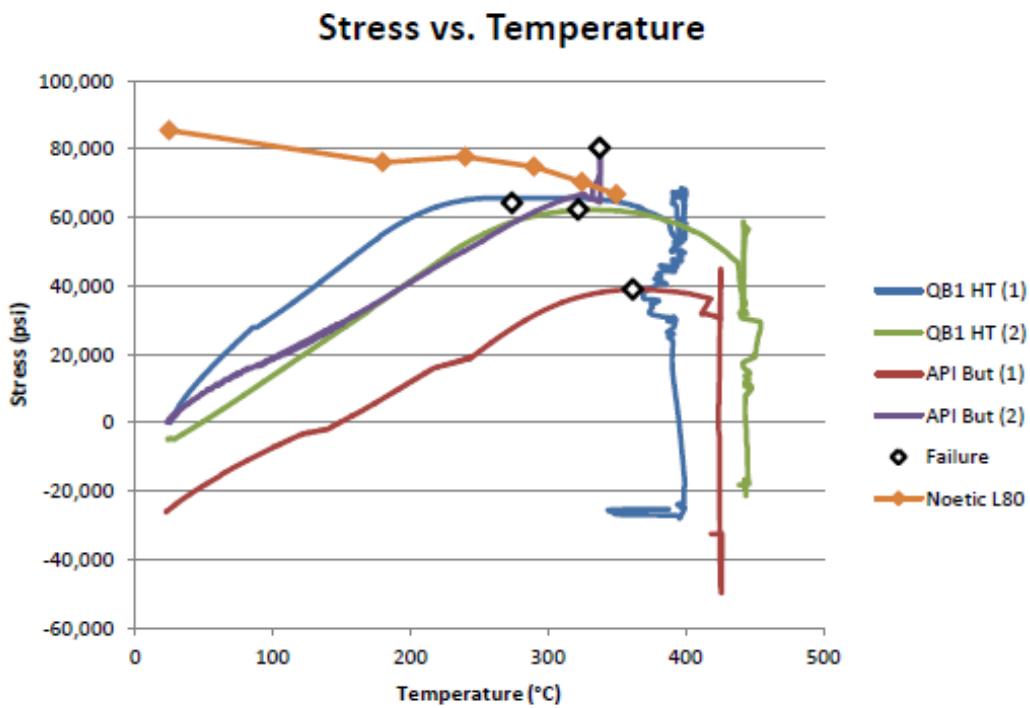
Stress was also plotted relative to temperature and compared to a previous high temperature characterization of EVRAZ standard Grade L80 casing by Noetic Engineering. A total of six data points were plotted using the yield stress of the L80, and a polynomial trend line was used to determine theoretical stresses at corresponding temperatures of the connections. As shown in Table 3 and Figure 9, all results were relatively close to the theoretical values: QB1-HT (1) and (2) failed at 84.5% and at 87.2% of the hypothetical L80 yield strength, while AP1 Buttress failed at 62.3% and 116.8% respectively. These values confirm that the performance of the

QB1-HT is consistent with the expected yield strength of the L80; whereas, the API Buttress (1) had significantly lower strength.

Figure 10: Stress vs. temperature comparison to L80 trials conducted by Noetic
