## Service Bulletin

Reference #052

### Chicago Blower Quench Fan Hub Failures

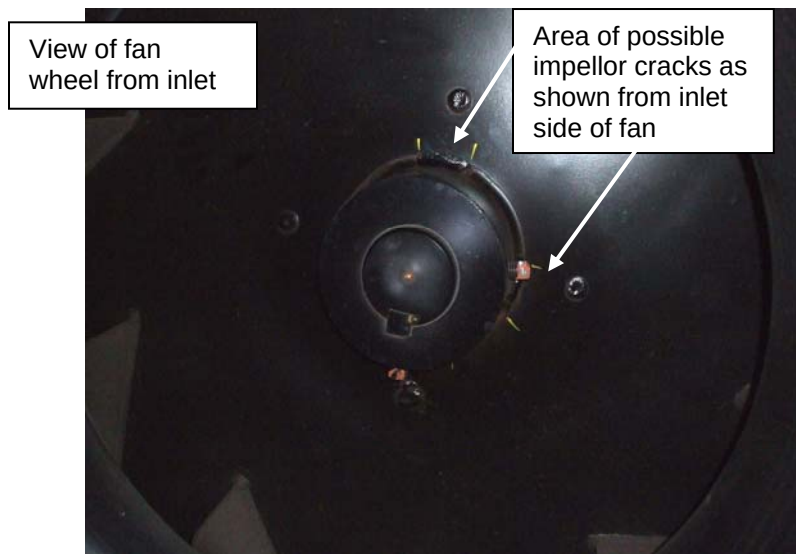
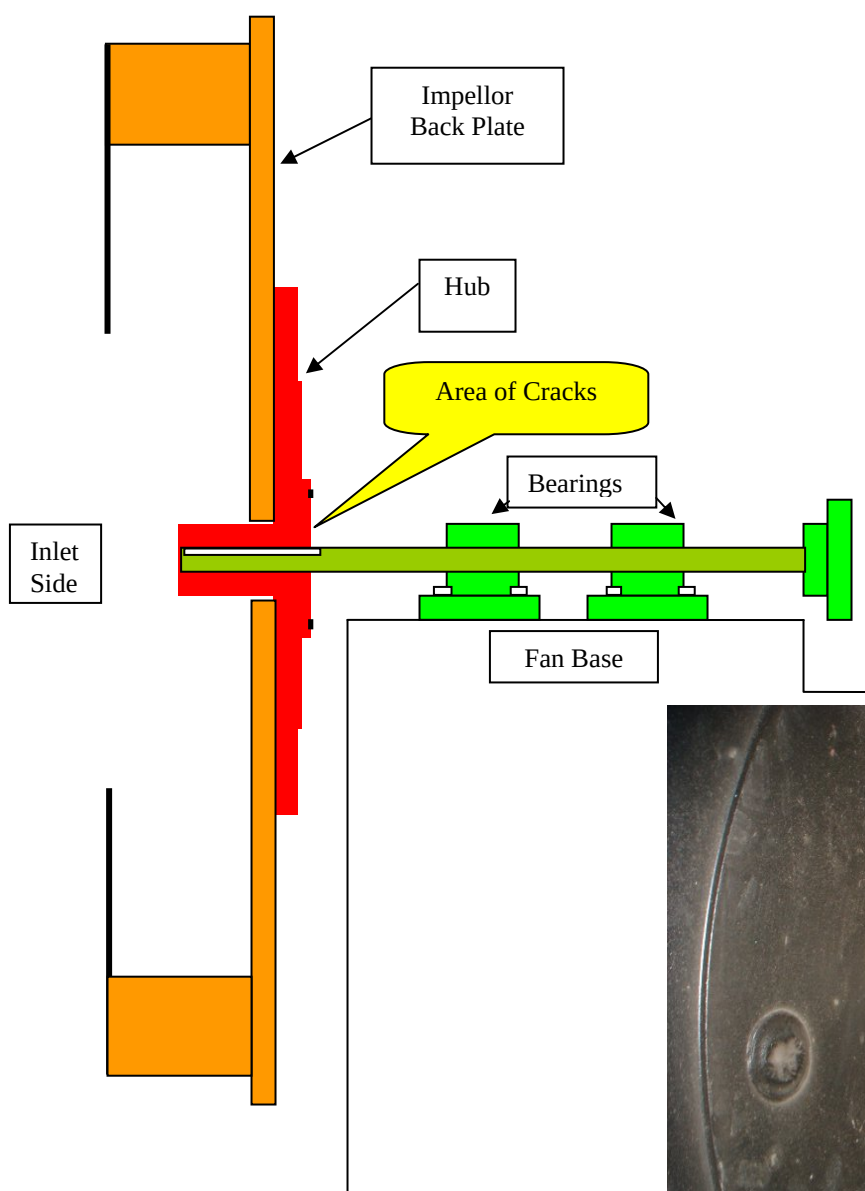
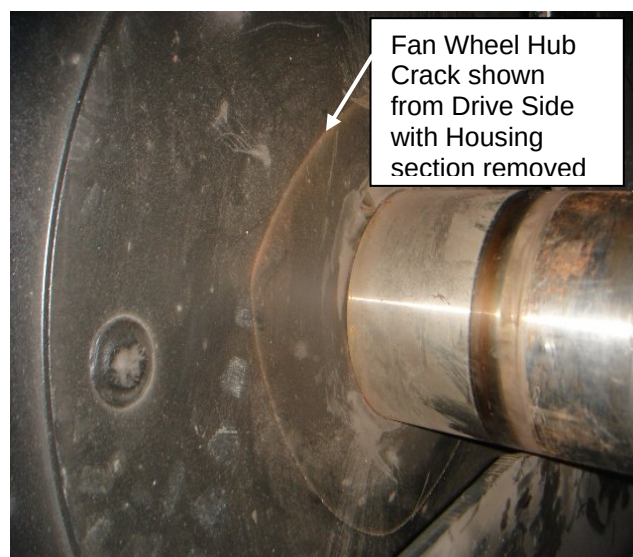
1. Immediately inspect the four quench fan wheels and hubs using visual means through the inspection hatch provided on the fan housing. The reported failures have been cracking of the cast hub and the fabricated impellor (see photos & sketch on page 2 of this document).

2. If cracks are identified with a visual inspection, a follow-up inspection using a dye penetrate test should be conducted. Removal of a housing section from the fan may be required to gain access for optimal viewing, particularly on the drive side of the hub.

3. If cracks are identified, operation of the suspect fan(s) should be immediately suspended. Depending on the location and/or severity of any cracks that are found, Chicago Blower recommends that repair or replacement of the hub be completed. The fan bearings should also be inspected and replaced as necessary.
