Subject: **INVERTER 19 FIRE INCIDENT REPORT**

| <b>Equipment:</b> | Inverters 19 and 20 |
| <b>Brand / Serial No.:</b> | INGECON SUN 920TL X360 (SN: 400152A17R20 and 400152A17R80) |
| <b>Location:</b> | Block 10 |

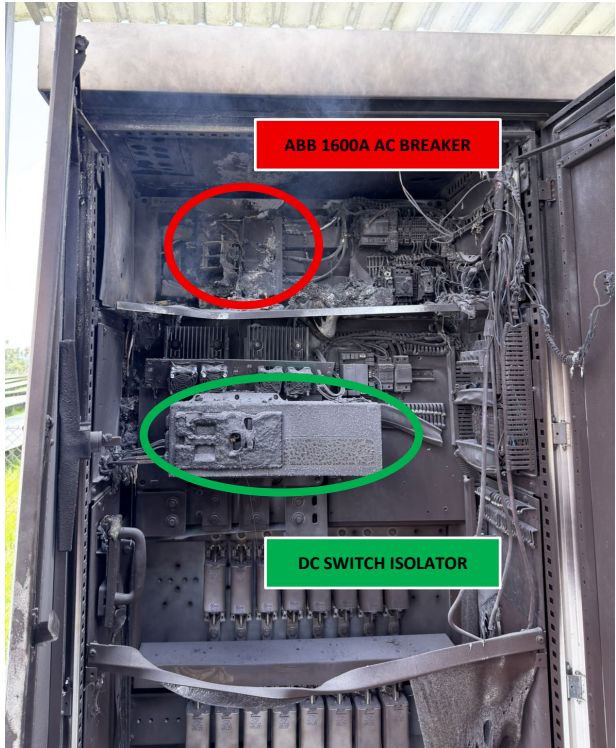
ABB 1600A AC BREAKER

DC SWITCH ISOLATOR

**INVERTER 19 CABINET 1** – Shown the situation of the major components on the cabinet 1.

7. All electronics devices and electrical components in the cabinet 1 are irreparable and the entire cabinet is unsafe for occupancy of new replacement parts.

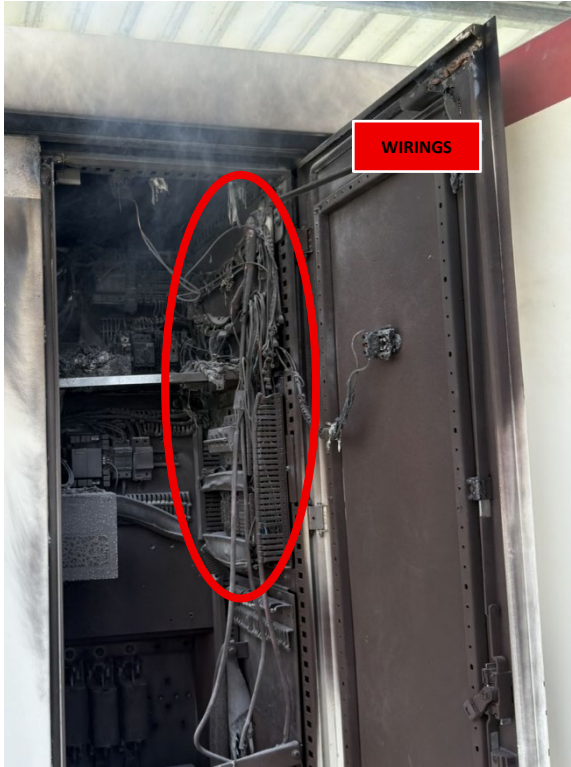
WIRINGS

**ELECTRONICS AND SIGNAL WIRINGS** – shown the damaged wirings on the right side of the cabinet.

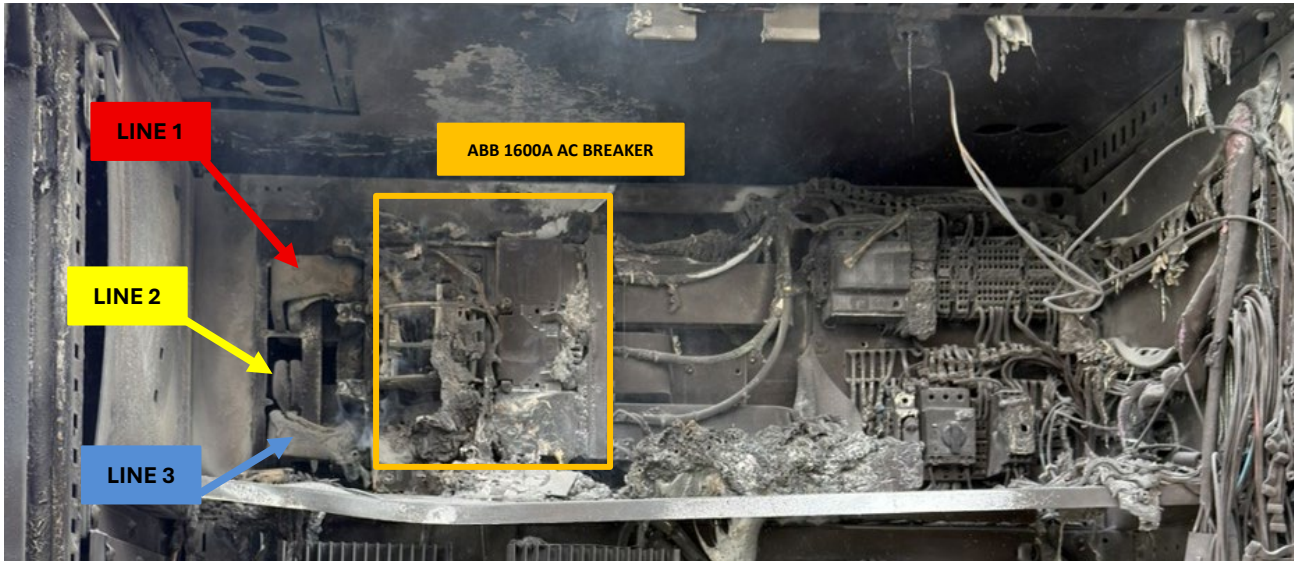
5. Engr. Clariden Montaño was able to identify clearly the highly suspected section where the fire started. The busbar of the L2 of the 3-phase lines connected to the input side of the AC Breaker rated 1600A was totally melted and the other two lines were severely damaged. This caused the entire surroundings of the AC-Breaker to get burned and melted. Below listed the severely affected major components on the catastrophic fire of the cabinet 1:

**AC BUSBARS 1600A** – shown the totally disconnection of the busbar of Line 2 due to melting; suspected as where the fire started.
