Turbine ID#: T123

Turbine Defect Summary (all blades)

Summary for Blade #T123-1

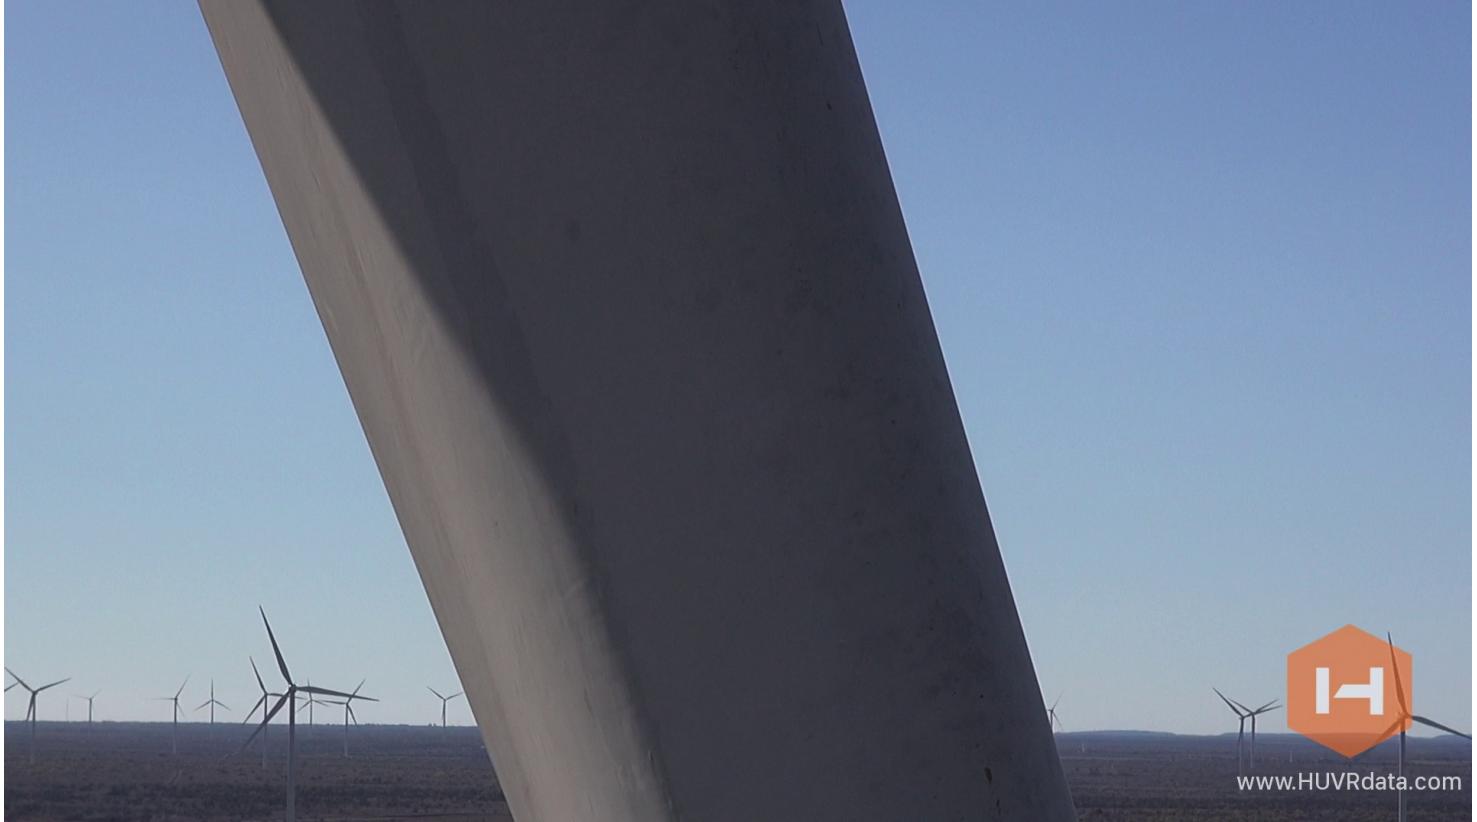
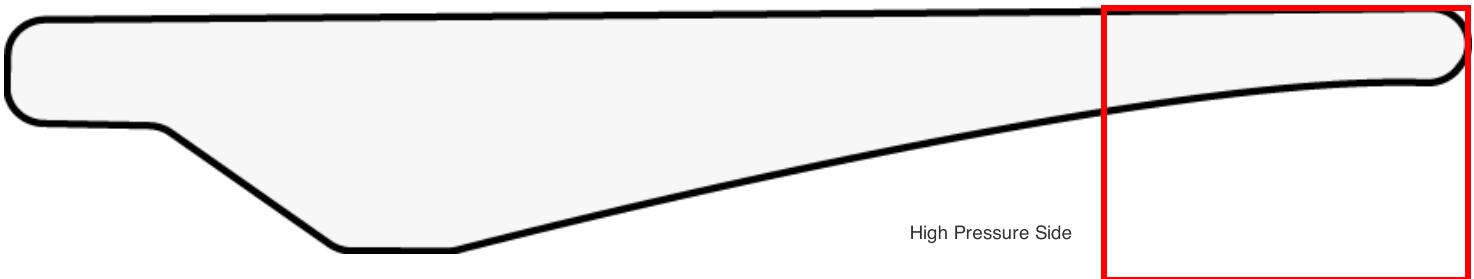
Blade #T123-1 Category 4-Delimitation Damage (moderate)

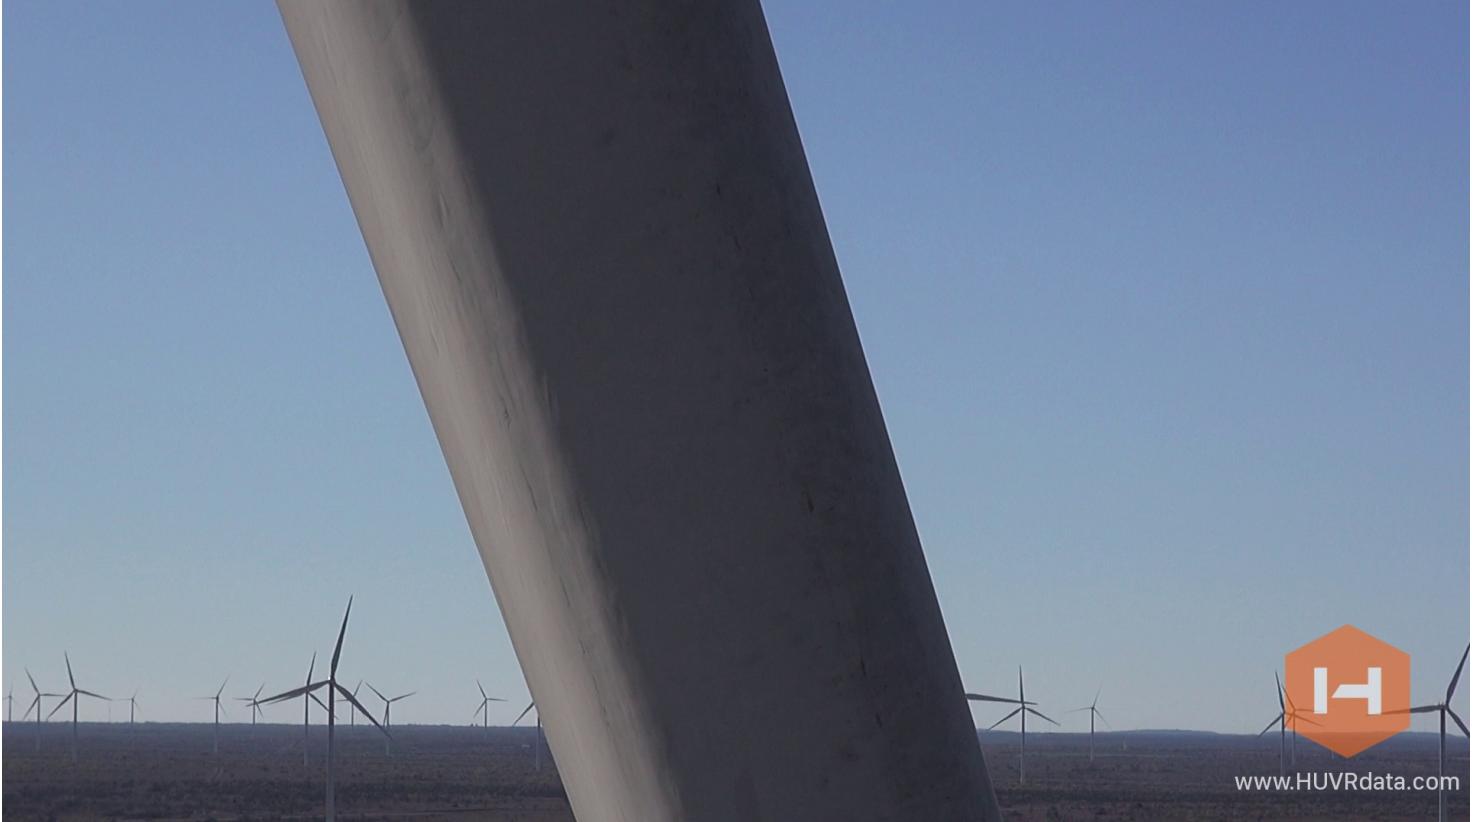
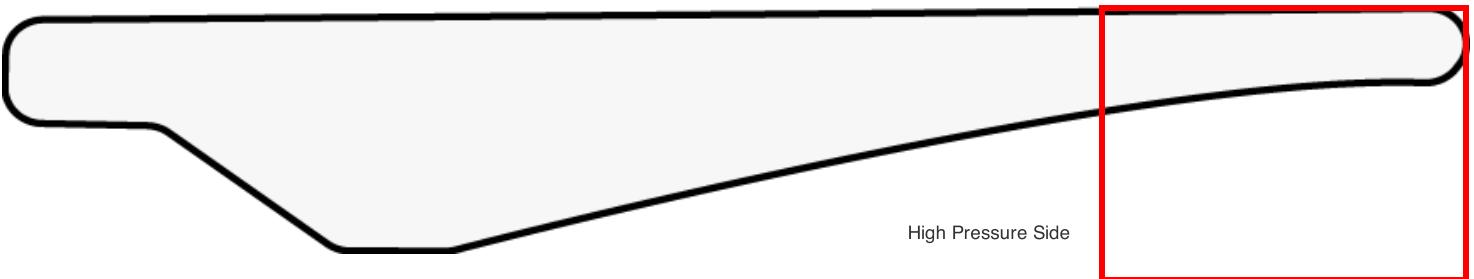
Blade #T123-1 Category 4-Delimitation Damage (moderate)

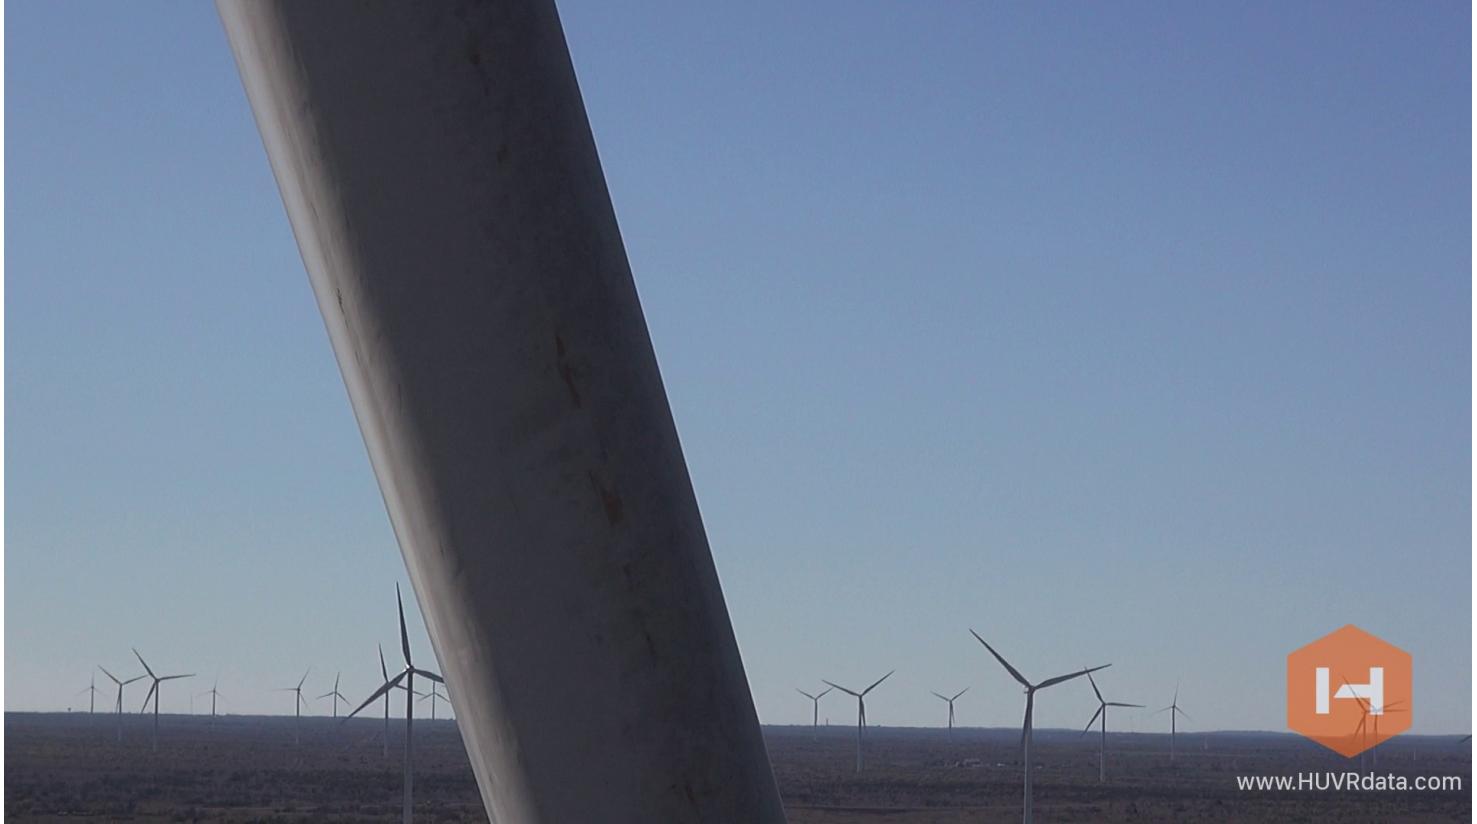
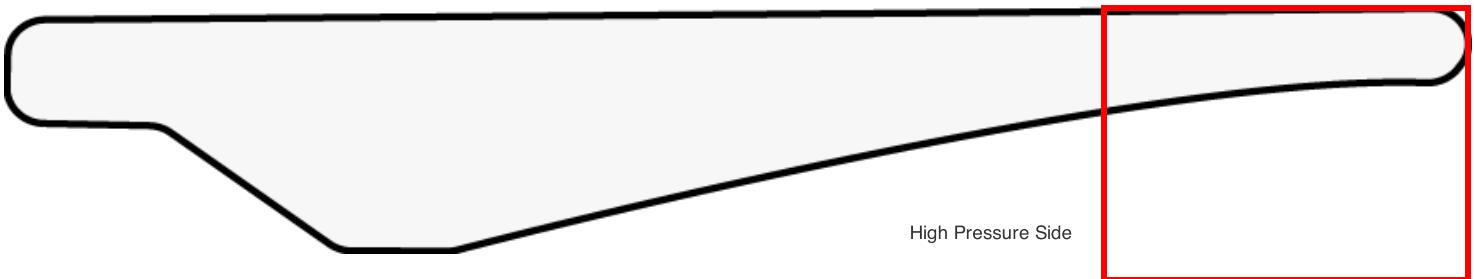
Blade #T123-1 Category 4-Delimitation Damage (moderate)

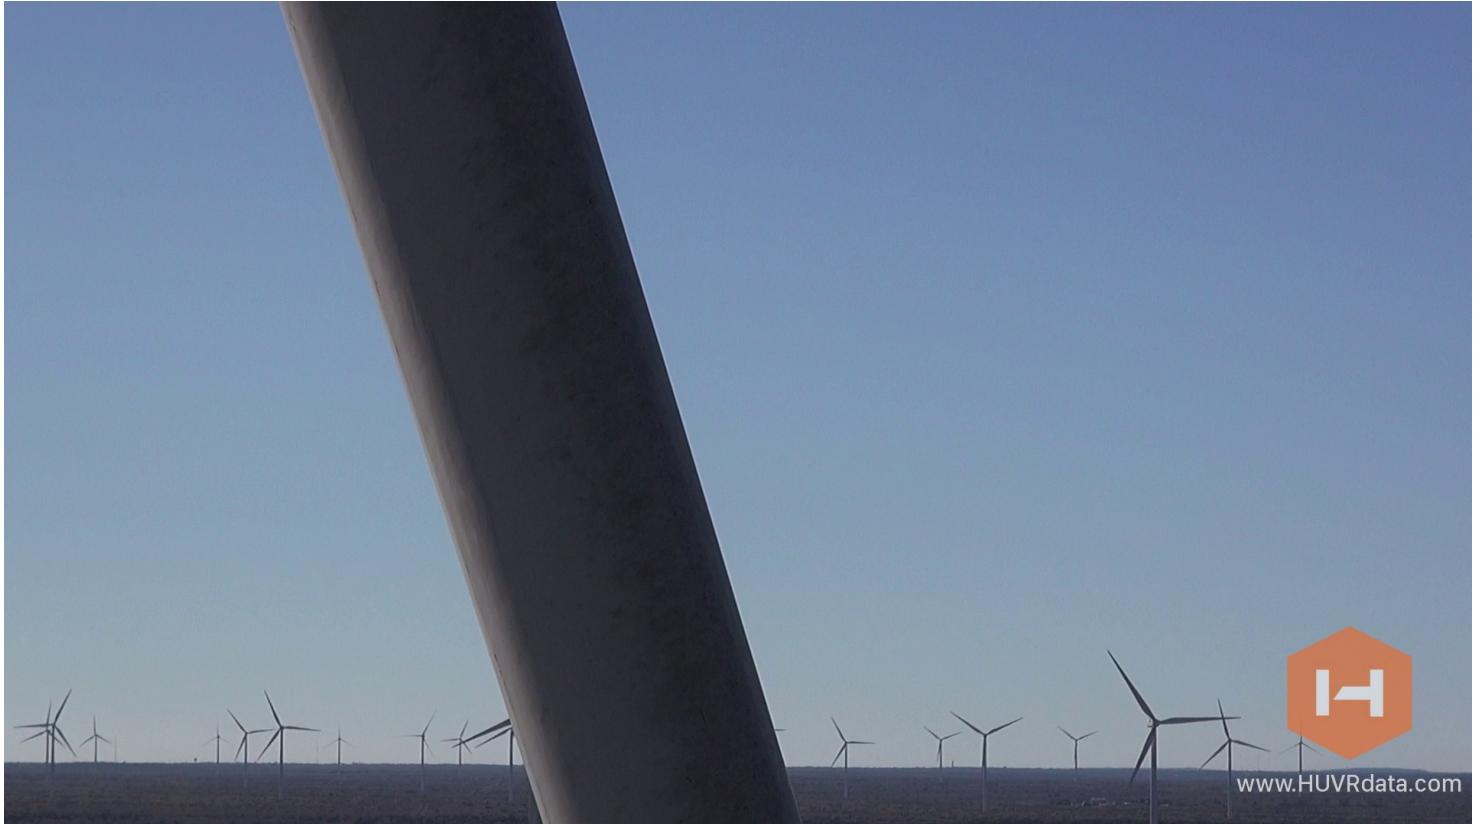
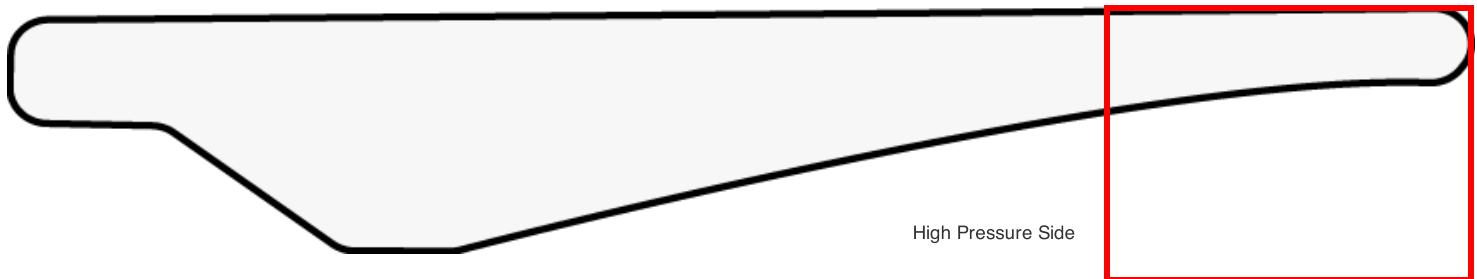
Blade #T123-1 Category 4-Delimitation Damage (moderate)

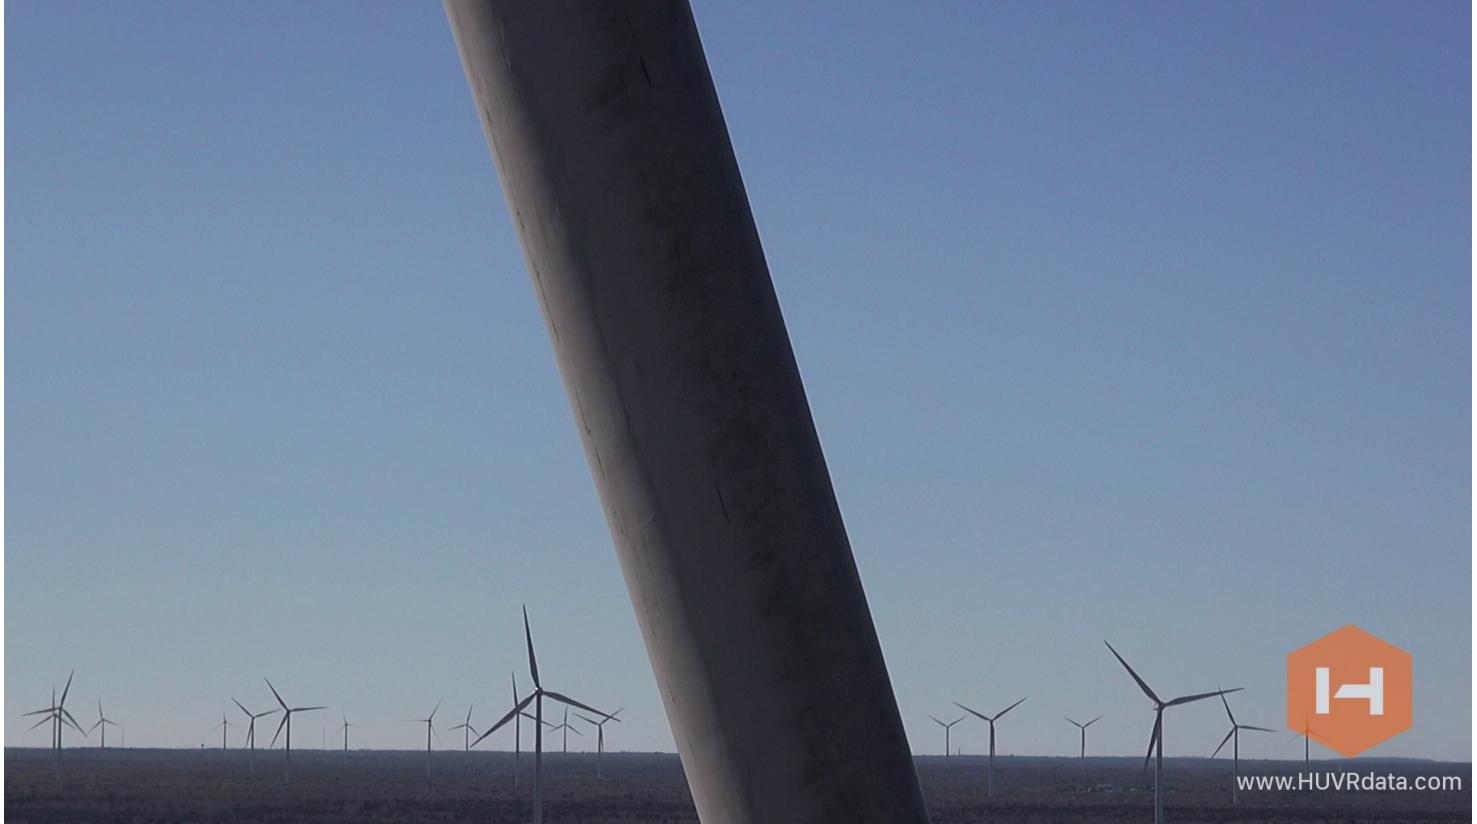
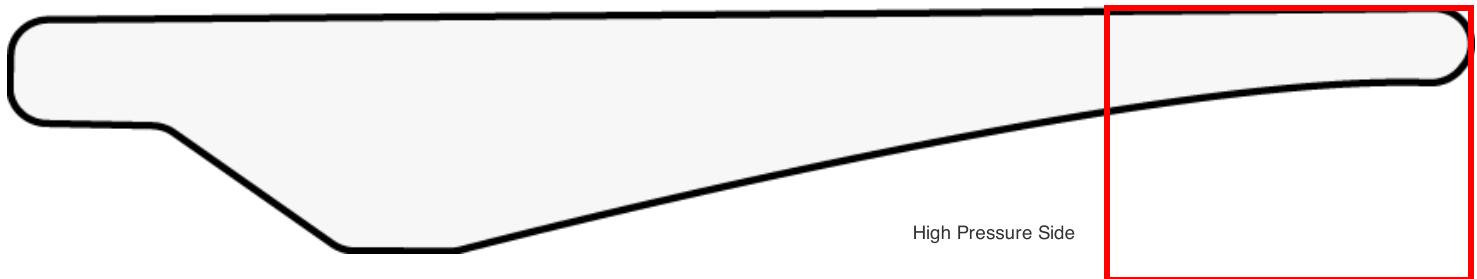
Blade #T123-1 Category 4-Delimitation Damage (moderate)

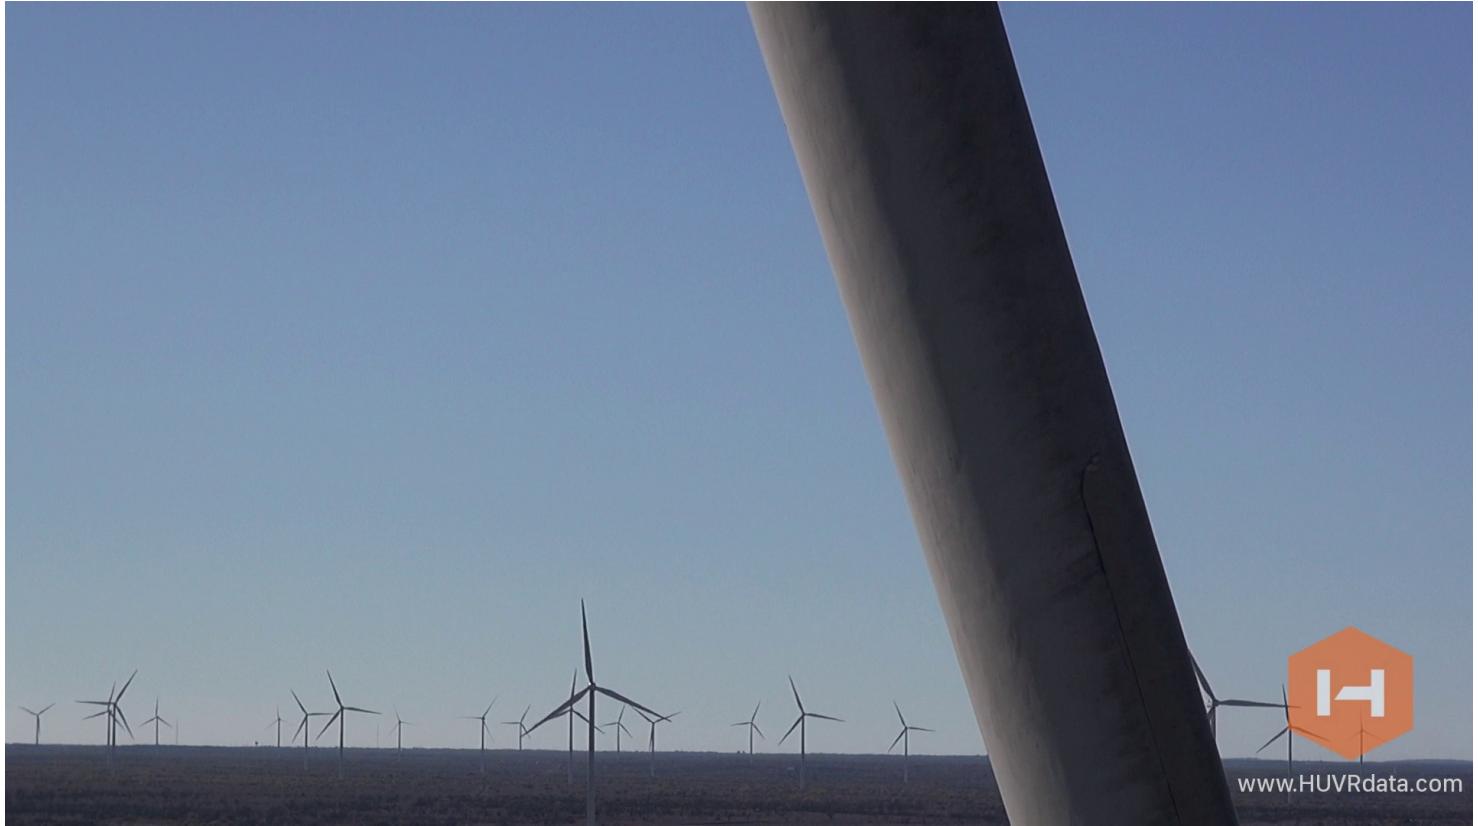
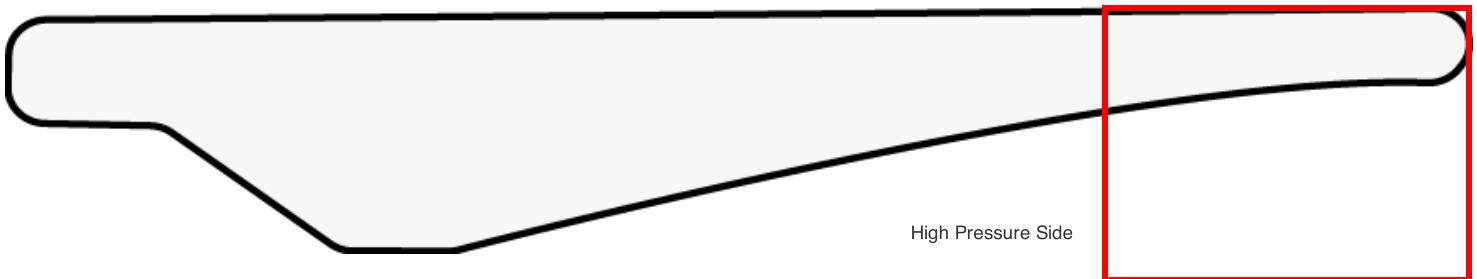
Blade #T123-1 Category 4-Delimitation Damage (moderate)

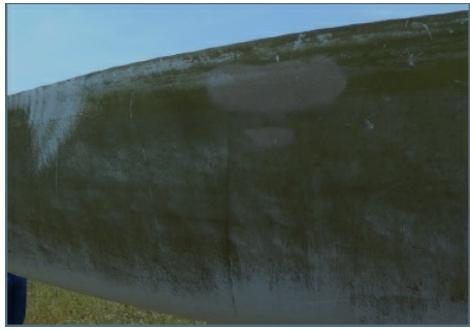
Contamination includes from dirt, mold, bugs, oil, or any other substance that attaches to the blade surface, resulting in decreased aerodynamic efficiency.

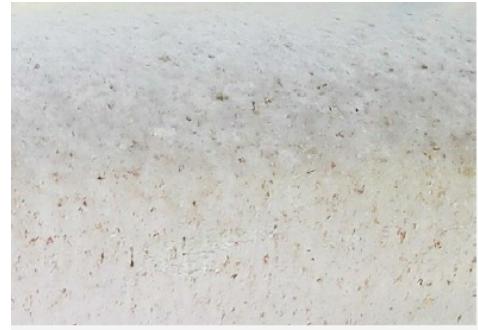
Insect Accumulation

Accumulation of bugs along the leading edge will result in performance losses over time. Rain showers will clean the leading edge and remove bug debris. Bug debris should be removed during regular scheduled blade cleaning exercises.

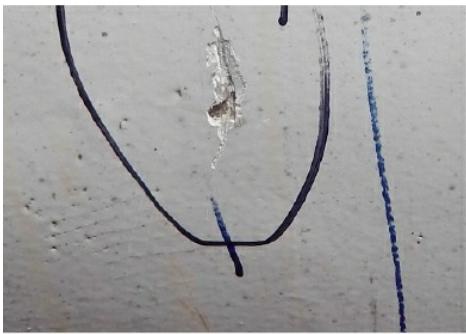
Paint Gouge

Paint gouges typically occur from transportation and handling but may also result from inclement weather. A paint gouge will appear with sharp edges and may expose underlying laminate.

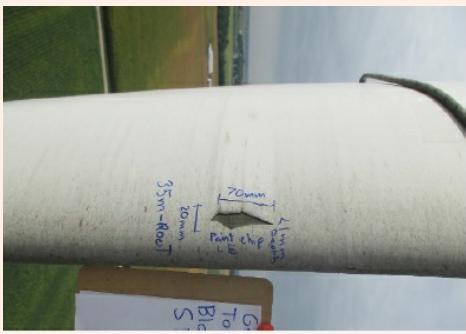
Paint Chip

Paint chips are commonly found near the leading edge and are usually attributed to impacts from ice or other objects. Paint chips are identified by their jagged appearance and exposed laminate.

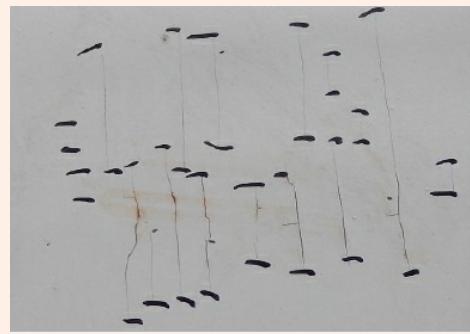
Paint Crack

Paint cracks may be singular or identified in groupings. Paint cracks can run spanwise or chordwise and are generally confined to the paint and filler layers only.

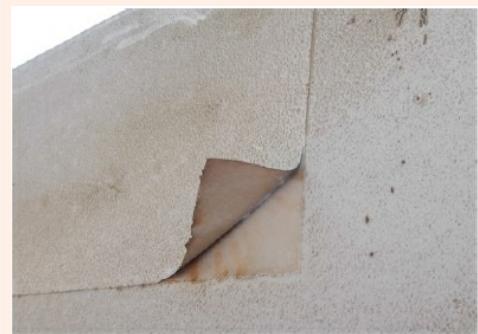
Peeling Paint

Peeling paint is usually caused by improper subsurface preparation during the manufacturing process or from a previous repair. Peeling paint may expose the underlying filler layer or in some cases bare laminate.

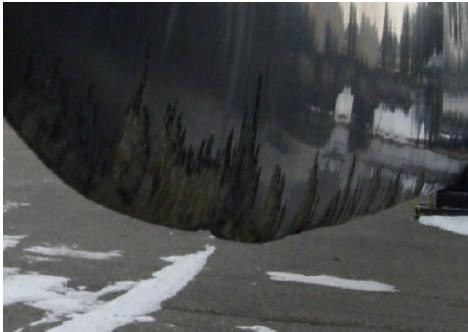
LE Erosion (Severe)

Severe leading edge erosion is identified by the presence of exposed laminate which may or may not be damaged. LE erosion of this magnitude effects power output and aerodynamic efficiency greatly.

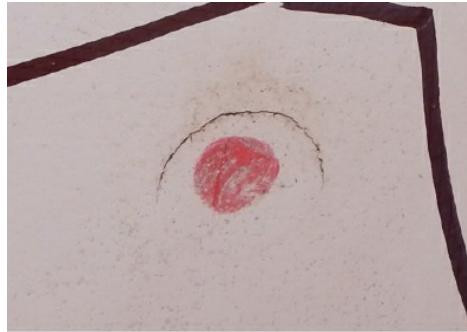
Cracked Balance Chamber

All rotor blades come from the factory balanced within a set. Balance chambers located outboard of mid-span may develop cracks, allowing moisture to seep into the chamber and result in costly repairs.

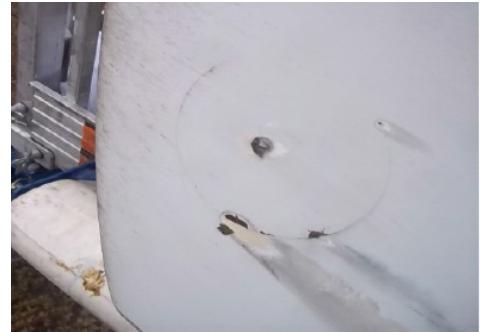
Lightning Strike (Minor)

Minor lightning strikes generally hit the designated LPS receptor and do not create apparent laminate damage, however underlying laminate damage may be present. Minor strikes generally have minor charring.

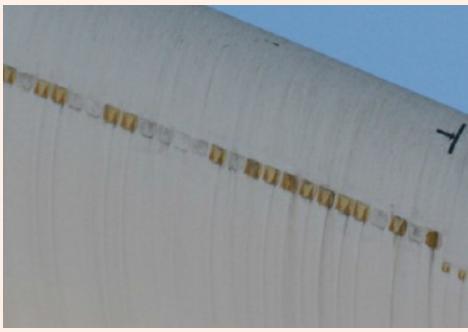
Missing/Damaged Blade Accessory

During turbine operation, blade accessories may be subject to impacts or instances where the accessory becomes broken, damaged, or missing. Missing blade accessories may impact blade performance.

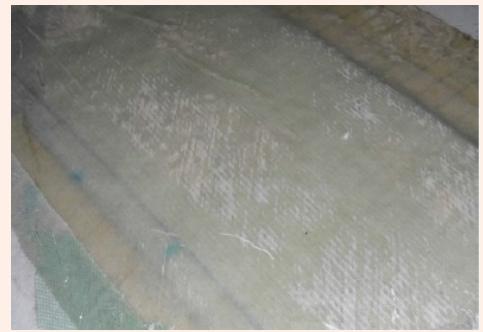
Fiber Rich Laminate

Fiber rich laminate has a white appearance and is an indication of laminate that was not fully wetted during manufacturing or repair. Fiber rich laminate differs from delaminate in that there is no separation between layers.

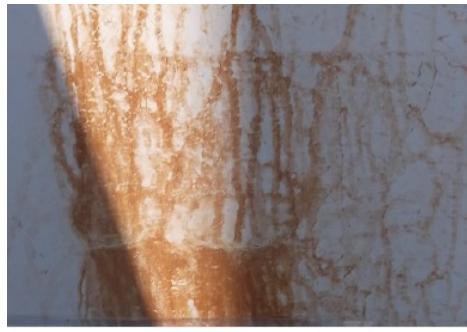
Laminate Contamination

Laminate contamination occurs when a substance is allowed to absorb into the laminate. The most common substances are water and/or oil. Laminate contamination will degrade laminate over time and cause an imbalance.

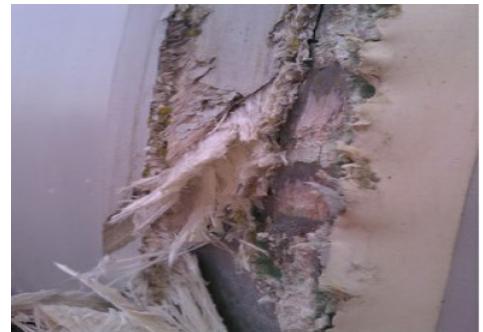
Root Ring Damage

Some rotor blades have a root ring at the root that covers the hardware used to mount the blade to the pitch bearing. The root ring must completely seal the internal hardware from the environment to prevent damage.

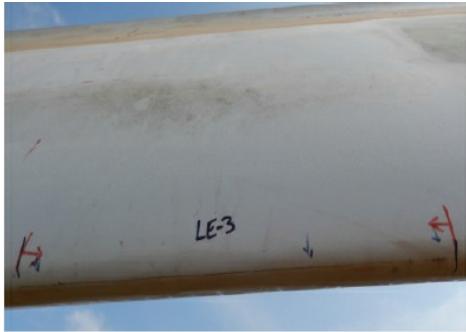
LE Split ($\leq 1000\text{mm}$)

Leading edge splits are identified by a crack or separation of shells along the leading edge. The leading edge may open during operation, allowing the split to propagate. Level 4 LE splits must be 1000mm in length or less.

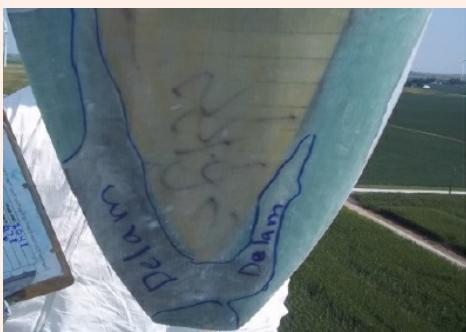
Delamination (Moderate)

Moderate delamination may be identified internally or externally. External delamination are generally caused by lightning strikes or impact and appear white in color. Use of tap testing may confirm the presence of delamination.

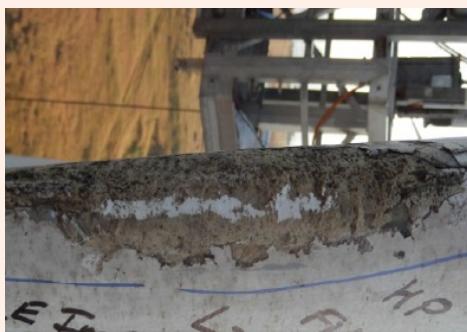
Crushed Laminate (Moderate)

Crushed laminate generally occurs from impact during operation. Crushed laminate is identified by inward orientated damage and random delaminated fiberglass layers with a white appearance.

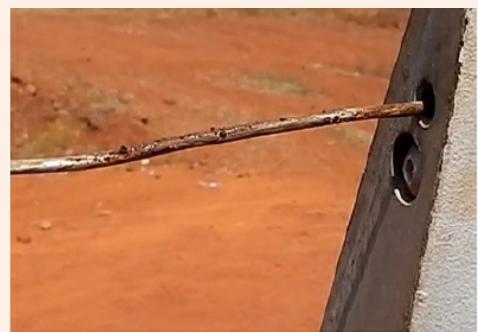
Clogged Drain Tip

A clogged drain tip occurs when debris from the blade interior is forced to the tip and becomes clogged over time. This allows condensation to accumulate resulting in imbalance and severe damage if a lightning strike occurs.

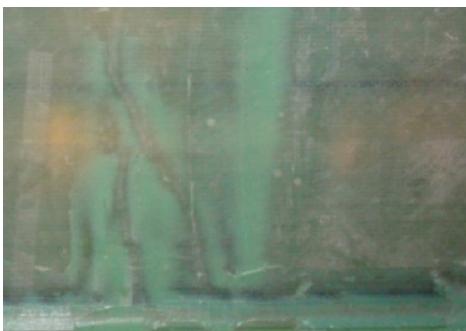
Chordwise Laminate Winkle

Chordwise laminate wrinkles are generally observed internally. A wave-like appearance in the laminate will indicate a chordwise wrinkle. Chordwise wrinkles should be repaired due to the risk of catastrophic failure.

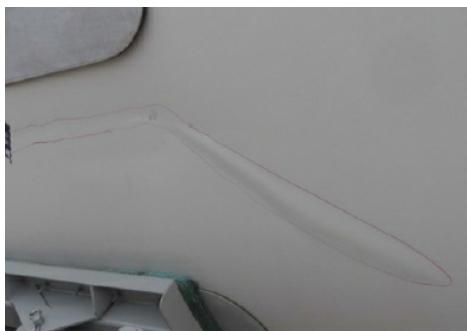
Buckle (Moderate)

A moderate buckle has the appearance of a bubbled laminate. The buckle can be located anywhere along the blade shells but generally near the center of the shells. Buckles have the tendency to propagate rapidly.

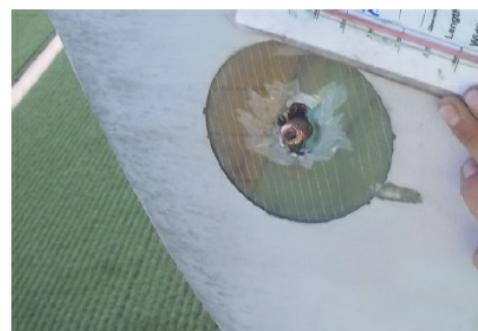
Missing/Damaged Hardware

Missing or damaged hardware on a rotor blade may consist of LPS components, mounting hardware, or hardware used to secure the lightning protection system. The most common missing or damage blade hardware is the LPS receptor.

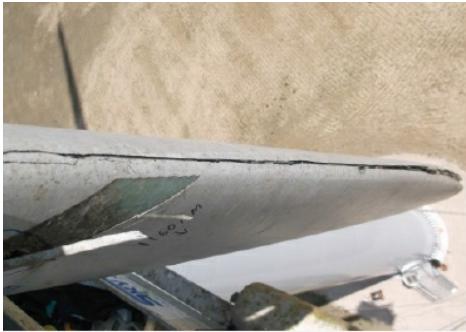
LE Split ($\geq 1000\text{mm}$)

Leading edge splits are identified by a crack or separation of shells along the leading edge. The leading edge may open during operation, allowing the split to propagate. Level 5 LE splits may propagate rapidly to the point of complete failure.

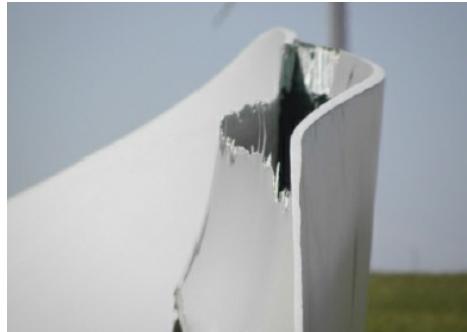
TE Split ($\geq 1000\text{mm}$)

Trailing edge splits are identified by a crack or separation of shells along the trailing edge. The trailing edge may open during operation, allowing the split to propagate. Level 5 TE splits may propagate rapidly to the point of complete failure.

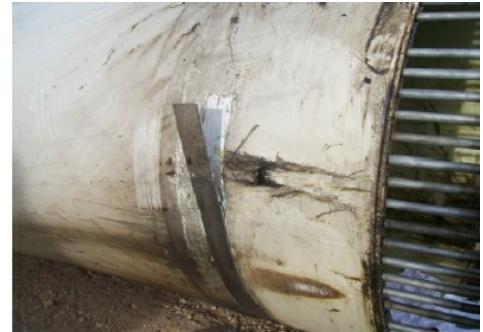
Lightning Strike (Severe)

Severe lightning strikes are evident by charring, obvious delamination, or extreme laminate damage. Severe lightning strikes may be an indication of a malfunctioning LPS system. Verify LPS integrity by use of continuity verification.

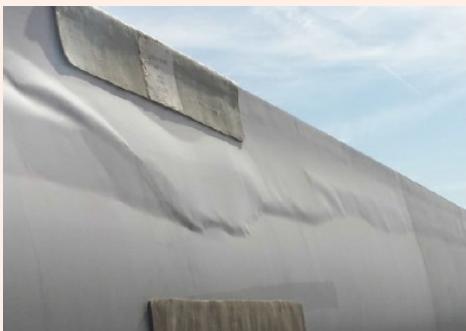
Delamination (Severe)

Severe delamination may be identified internally or externally. Severe delamination will have a bubble appearance or white laminate if exposed. Severe delamination has the tendency to propagate rapidly.

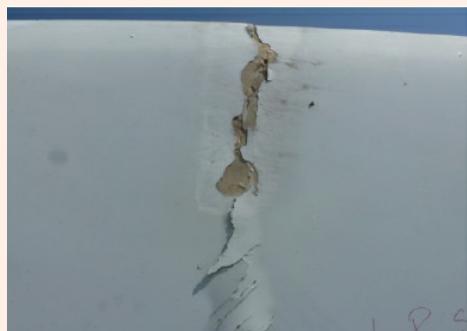
Laminate Crack

Laminate cracks are identified by a break in the fiberglass with possible adjacent delamination. Laminate cracks located near maximum chord will propagate extremely rapidly to the point of failure.

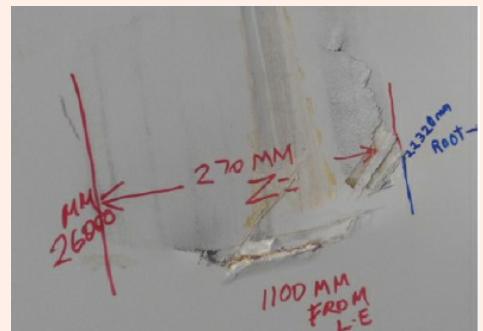
Laminate Puncture

Laminate punctures generally occur during handling and transport but may occur from impact during operation. Laminate punctures identified by inward orientated damage or damage known to have been caused by an impact.

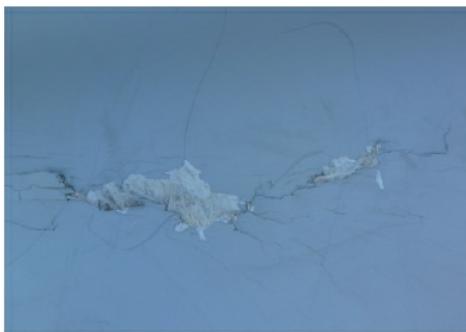
Dry Laminate

Dry laminate is considered a manufacturing or repair defect. Dry laminate appears white and will have a soft texture. Generally, the paint or gelcoat over dry laminate will bubble due to heat expansion difference.

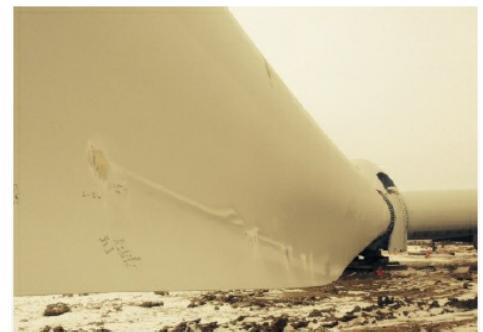
Buckle (Severe)

A severe buckle has the appearance of a bubbled laminate and may be several meters in length. Buckles are generally located near the center of the shells. Buckles have the tendency to propagate rapidly.
