ICAM Investigation Report

Rail

Tuesday 14th October 2008

Brief Description of Incident:

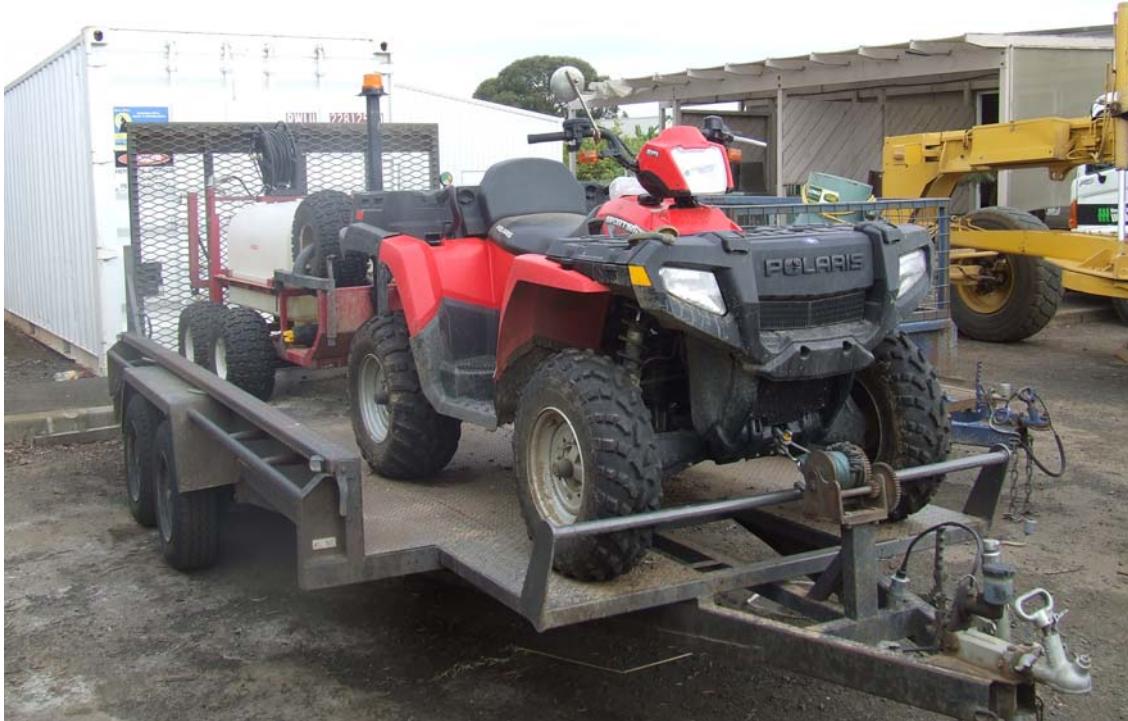
Items of plant being towed

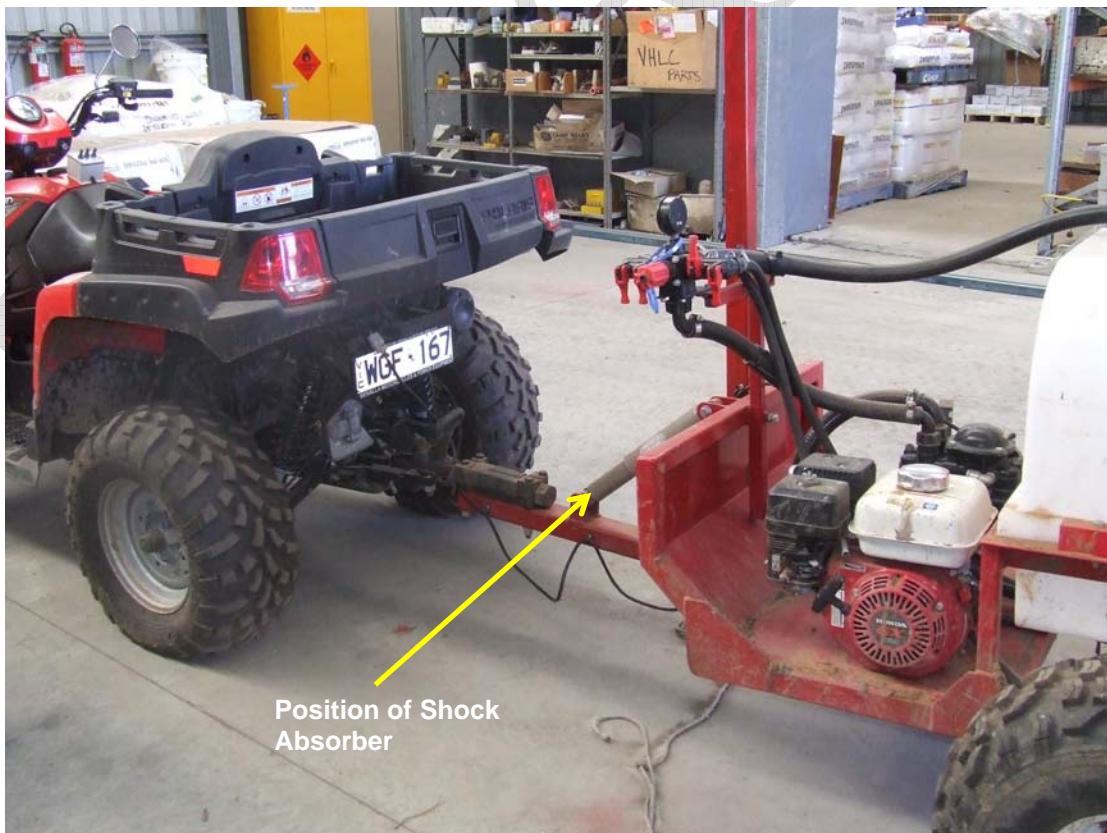
Towing arrangement for quad bike & buggy

- An additional 440kg (400litres) of weight in the buggy due to lack of local knowledge of where the next available water supply was.
 - Deflated tyres on the buggy placed all weight of buggy on to drawbar (750kg). Tyres had been deflated for days due to repeated and frequent punctures.

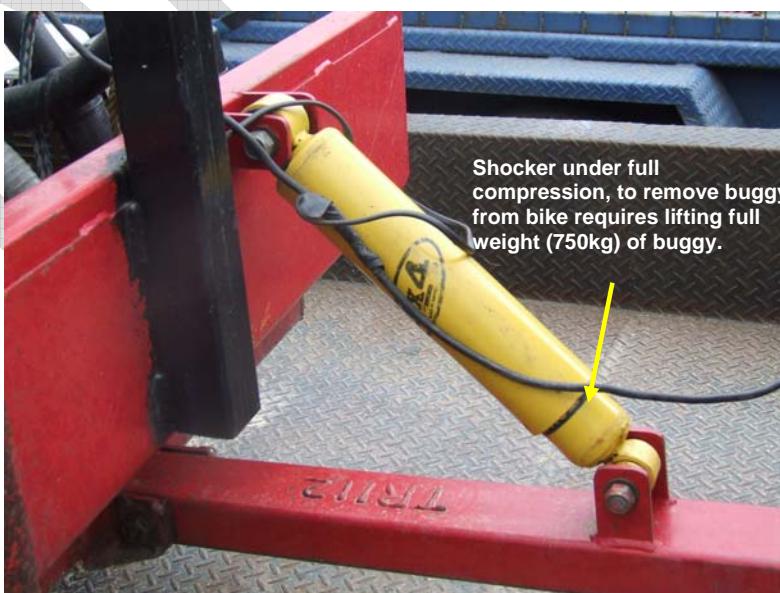
Example of modified Shock Absorber

- Replacement of standard shock absorber, because of repeated/frequent failures, with an after market shock absorber. This negated the advantage the original shocker gave for removing spray buggy from bike.

3. A pre-start checklist for Quad bike & Spray buggy be drawn up.	Supervisor	1
4. A systematic review of all operations involving spraying equipment to include solutions to repeated failures of tyres, shock absorbers. This review to be done in conjunction with Plant Department.	Manager Plant Department, Supervisor, employees.	1
