FY 2024

Pavement Management Summary

Prepared for:
City of Medford
Department of
Public Works

Prepared by:
Stantec

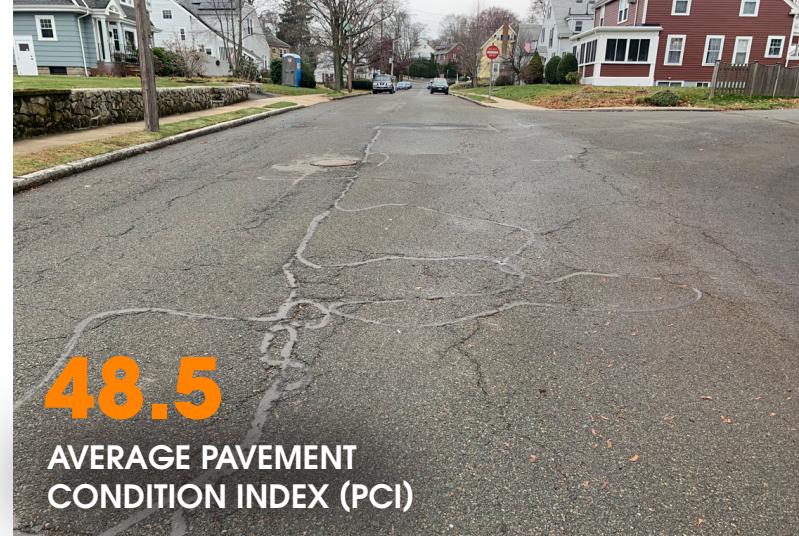
Current PCI Distribution in Miles By Treatment Band

The backlog is defined as the cost of repairing all the roads within one year and bringing the average PCI to a near perfect 100. Backlog is a "snapshot" or relative measure of outstanding repair work. The backlog not only represents how far behind Medford's roadway network is in terms of its present physical condition, but it's cost value also serves as a benchmark to measure the impact of various funding scenarios. The current backlog offers a basis for comparison to future and/or past year's backlog(s). Backlog dollars account for the pavement structure only; they do not include related repair cost for drainage, sidewalk, curbing, signals, or signs. Medford's backlog as of December 2023 is \$67,547,767. The figure to the right summarizes the backlog repair costs by PCI treatment bands since the original study in 2021.

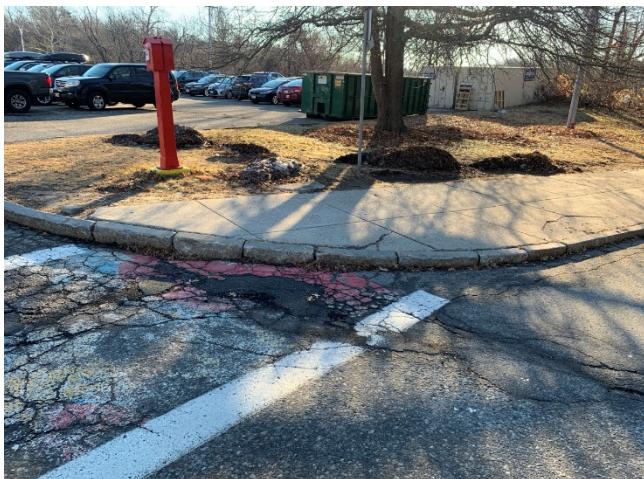
Of the 2,878 total ramp locations, 582 are “missing” ramps which hinder accessibility greatly. These include situations where driveways act as ramps, sidewalks end abruptly with no ramp, or crosswalks lead directly into a curb. Below is a picture of a missing ramp on Steve Miller Drive.

Missing Ramp at the end of Steve Miller Drive near the High School
