# Scaffold GA3

## Report of Results of Inspections of Scaffolds

| Site Address: | KILCARN WOOD 2 ,<br>Kilcarn, Navan, Co.<br>Meath, C15D2E7 , Ireland | Location /<br>Description of<br>Scaffold: | Water tank tower |
| Date & Time of<br>Inspection: | 2025-12-18 14:54:54 | | |

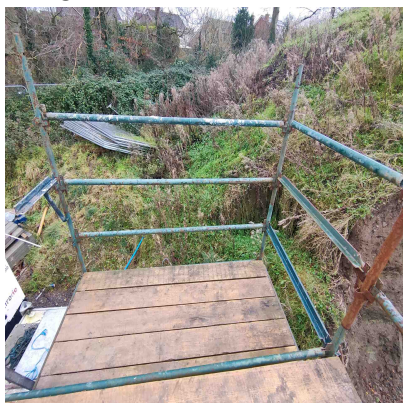
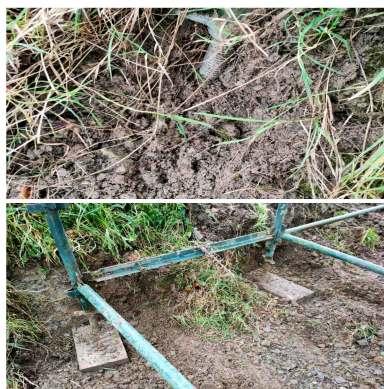
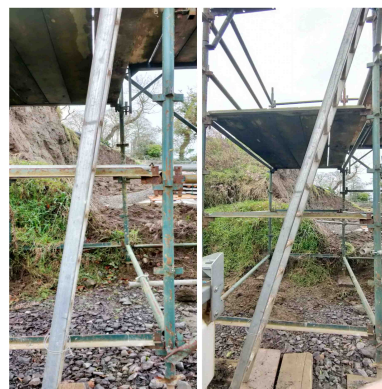
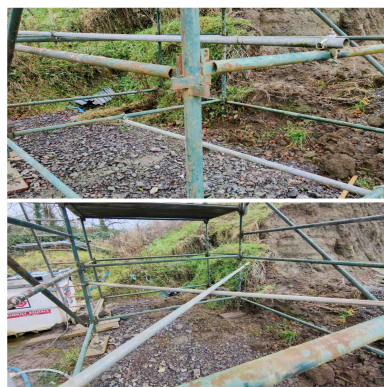
## Images

| Item Inspected | Condition (Include any defected found) | Corrections taken / required |
|---|---|---|
| Base plates & Base Jacks | There was no soil pad under 2 standards. Cause of that the level of scaffold was incorrect. | Soil pads has been placed under jacks in right position. The level of scaffold is correct. |
| Pian bracing | Plan braces were installed incorrect | Plan braces were installed according to the rules |

| Item Inspected | Condition (Include any defected found) | Corrections taken / required |
|---|---|---|
| Access / egress | The ladder was installed in incorrect position | The angle of ladder has been changed according to the rules - 75° |

| Item Inspected | Condition (Include any defected found) | Corrections taken / required |
|---|---|---|
| Ledgers | Good | 6 more ledgers were installed for stability of platform |
| Guard rails | Good | Handrail was installed next to ladder acces |
