# Aggarwal Kamikazes

### GPR CONCRETE SCANNING · CORE CLEARANCE REPORT

PROJECT  
**AKCC-2026-0431**

| Site | Cedar Crossing podium, 8800 Cambie, Vancouver BC | Equipment | GSSI StructureScan Mini XT (1.6 GHz) |

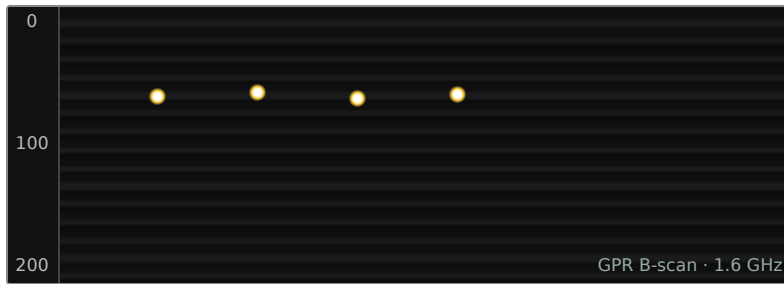
### Grid A • P1 Bay 1 mid-span

| CORE | SIZE | LEVEL | VERDICT | CLEARANCE & RECOMMENDATION |
|---|---|---|---|---|
| A | 4" | P1 | SAFE | 65 mm clear of all targets. Cleared to drill as marked. |

SAFE

**Observation.** Clear cone at the proposed centre — no targets within 65 mm in any direction. Uniform top mat at ~45 mm cover. Safe to drill as marked.

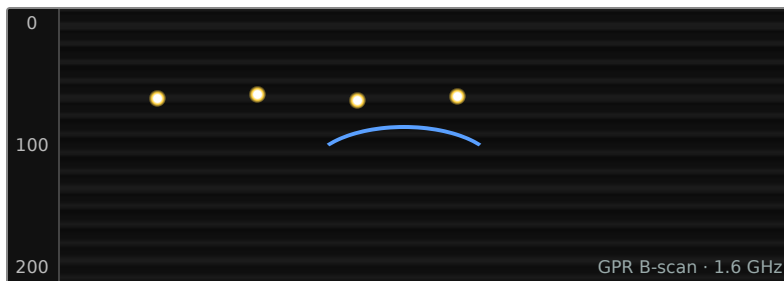
### Grid B • P1 Bay 2 column line

| CORE | SIZE | LEVEL | VERDICT | CLEARANCE & RECOMMENDATION |
|---|---|---|---|---|
| B | 6" | P1 | CAUTION | PT tendon crosses within 30 mm — relocate 80 mm S and re-scan before drilling. |

CAUTION

**Observation.** A post-tension tendon crosses on a diagonal within 30 mm of the proposed centre. Relocate the core 80 mm south, clear of the tendon envelope, and re-scan before drilling.

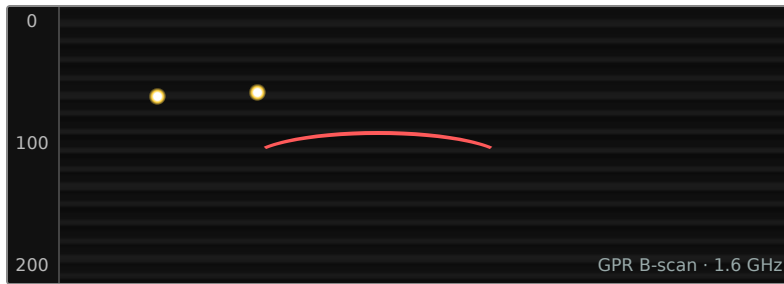
### Grid C • P1 Bay 2 wall line

| CORE | SIZE | LEVEL | VERDICT | CLEARANCE & RECOMMENDATION |
|---|---|---|---|---|
| C | 4" | P1 | NO-GO | Directly over an energised conduit run. Do not drill; EOR redesign required. |

**NO-GO**

**Observation.** Energised electrical conduit detected directly beneath the proposed centre at ~110 mm. No-go — do not drill; refer to the EOR for a redesigned core position.

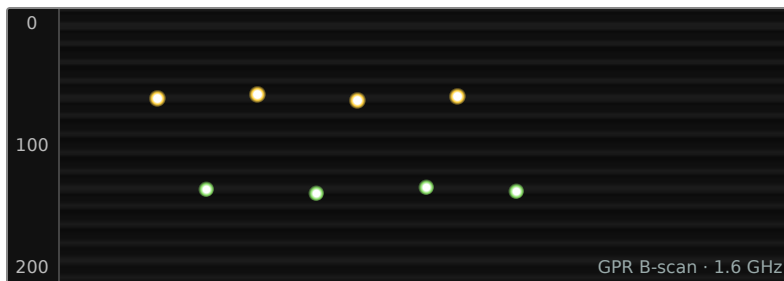
### Grid E • L2 Bay 4 mid-span

| CORE | SIZE | LEVEL | VERDICT | CLEARANCE & RECOMMENDATION |
|---|---|---|---|---|
| E | 4" | L2 | CAUTION | Two-way mat congestion — best gap is 18 mm. Tight but workable; centre precisely on the mark. |

**CAUTION**

**Observation.** Heavy two-way reinforcement — top and second mats both present. The best clear gap at the mark is 18 mm. Workable for a 4" core if centred precisely; flag the tight tolerance to the operator.

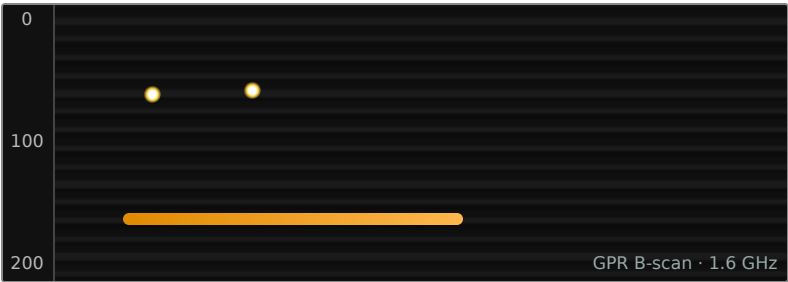
Grid F · L2 mechanical room

| CORE | SIZE | LEVEL | VERDICT | CLEARANCE & RECOMMENDATION |
|---|---|---|---|---|
| F | 5" | L2 | SAFE | Hydronic radiant tubing mapped and avoided; 55 mm clear. Cleared as marked. |

SAFE

**Observation.** Radiant floor-heating tubing mapped along the south of the grid and avoided. Proposed centre is 55 mm clear of both rebar and tubing. Cleared to drill as marked.

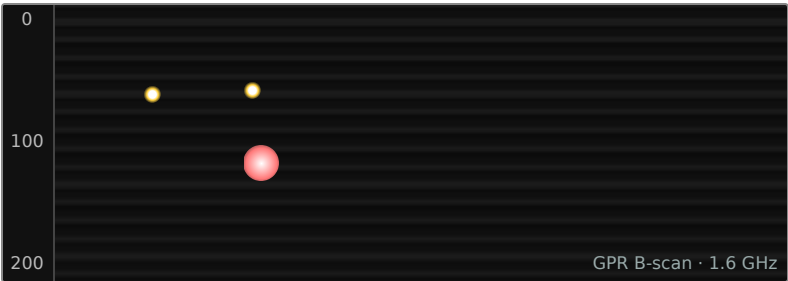
Grid G · L2 Bay 5 wall line

| CORE | SIZE | LEVEL | VERDICT | CLEARANCE & RECOMMENDATION |
|---|---|---|---|---|
| G | 4" | L2 | NO-GO | Unidentified metallic object at ~90 mm directly below. No-go pending intrusive verification. |

NO-GO

**Observation.** A strong, isolated metallic reflection sits at ~90 mm directly below the proposed centre — not consistent with rebar spacing. No-go until its nature is confirmed by intrusive verification (e.g. small inspection hole).

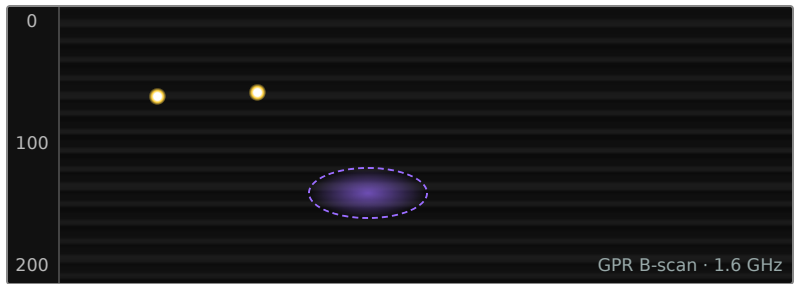
Grid H · L2 slab edge

| CORE | SIZE | LEVEL | VERDICT | CLEARANCE & RECOMMENDATION |
|---|---|---|---|---|
| H | 6" | L2 | CAUTION | Within 300 mm of slab edge; possible void beneath. Reduced confidence — proceed slowly, verify on site. |

CAUTION

**Observation.** Core sits ~300 mm from a slab edge with a low-amplitude zone suggesting a void or delamination beneath. Confidence reduced. Proceed slowly with a pilot; stop and reassess if the bit breaks through.
