Metallographic Examination of White etching Cracks in Bearing Steels

Matthew Petersen

August 26, 2016

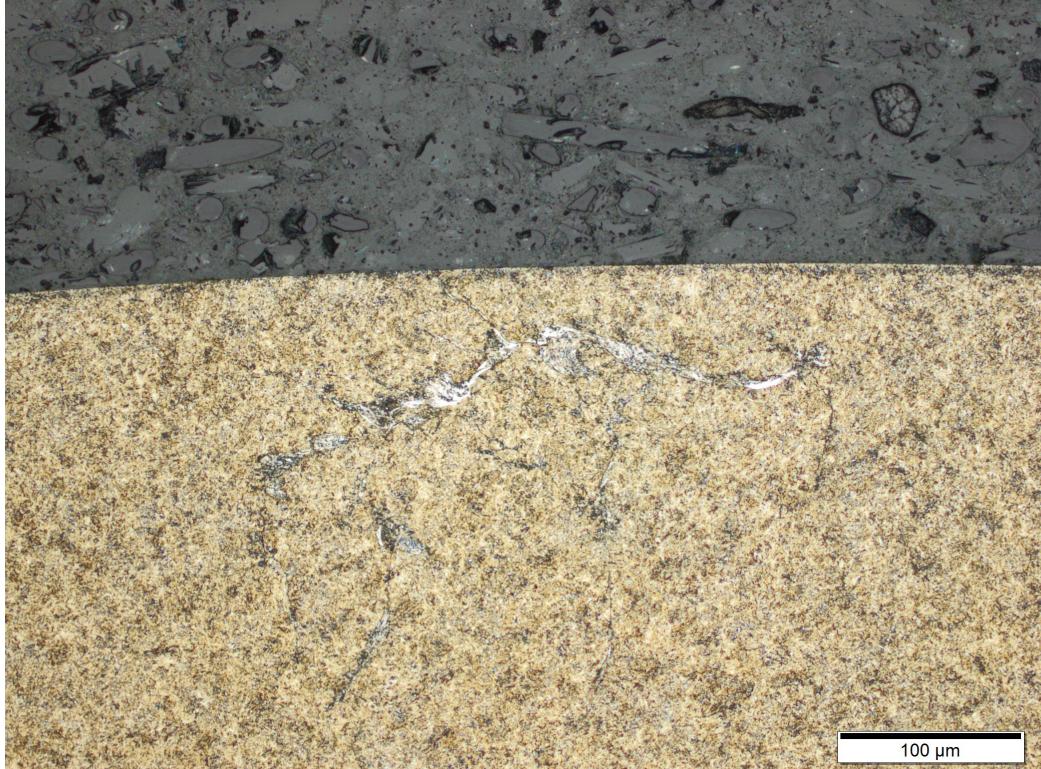
Figure 2: White etching crack

White etching cracks are characterized by a white appearance when etched with nital, indicative of grain refinement at the nanoscale[5] (see figure 2). This white etching area consists of nano-ferrite grains, and possesses a hardness 30-50% higher than the bulk material around it[6]. The cracks are associated with spalls and pits on the bearing surface; see figure 3. However, the surface features associated with WEC differ from those associated with RCF and conventional material decay[6]. The mechanism of WEC formation

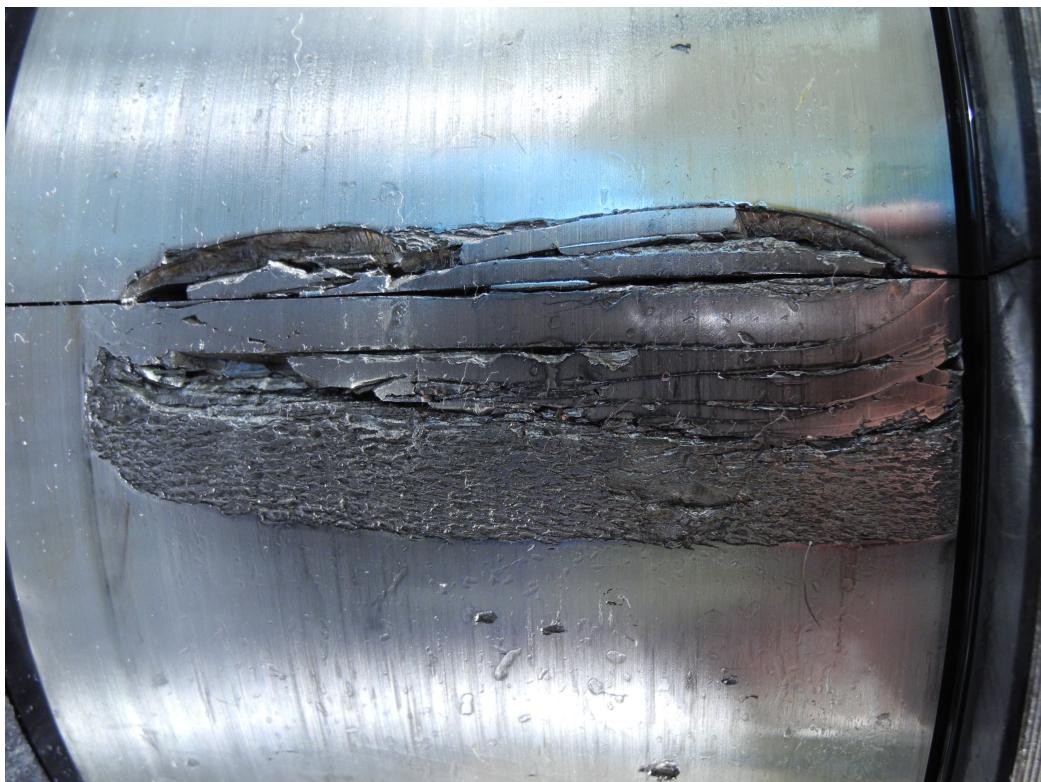
Figure 3: Failed wind turbine gearbox bearing (inner raceway, high speed shaft)

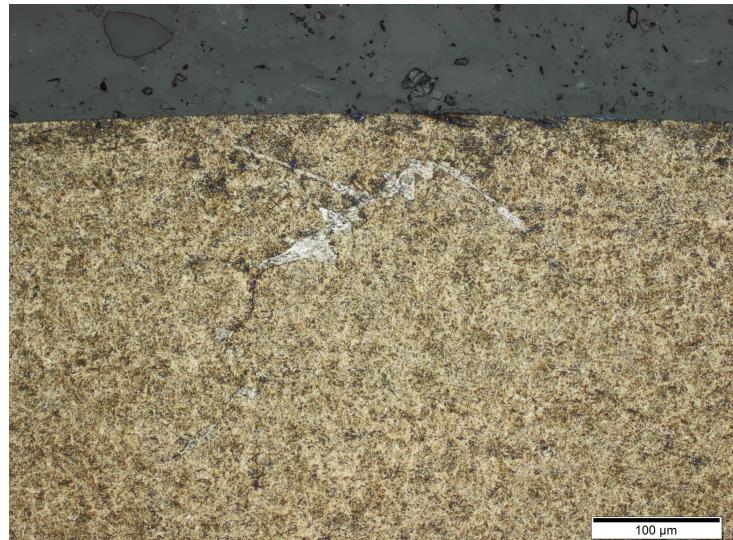
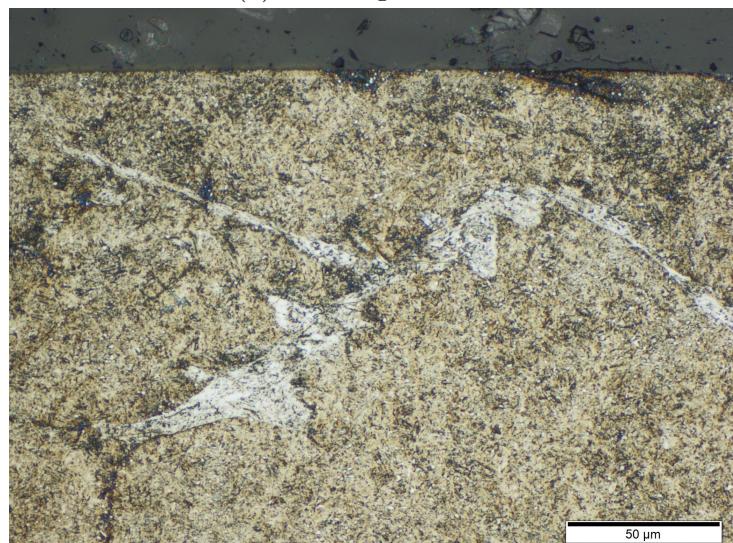
The sectioning methods described above yielded many high quality images of WEC, both in test rollers and in WTGB specimens. The cracks themselves had many characteristics in common. Both sets of cracks, roller and WTGB, exhibited similar branching structures, and were located at similar depths, as can be seen in figures 5 and 6. The subsurface nature of the cracks is a key feature, marking out the crack as being initiated by something other than surface damage. In addition, in both classes of sample, cracks were often found without nucleating inclusions. This is notable because it points to a source of cracking other than stress concentration in at least some cases.

One difference between tests, appearing in both WTGB and roller samples, was the thickness of the white etching area (WEA) around the cracks. As figure 6 shows, some cracks exhibited a thin WEA extending a short distance, no more than a few microns, from the crack itself. Others, as in figure 5, had a thicker, more extensive layer, with greater irregularity in WEA breadth. This did not appear to occur more commonly in either roller or WTGB samples when compared to the other, and so may reflect some other effect upon WEC formation that is yet to be determined.

Figure 5: WEC in roller 160715, 30°location

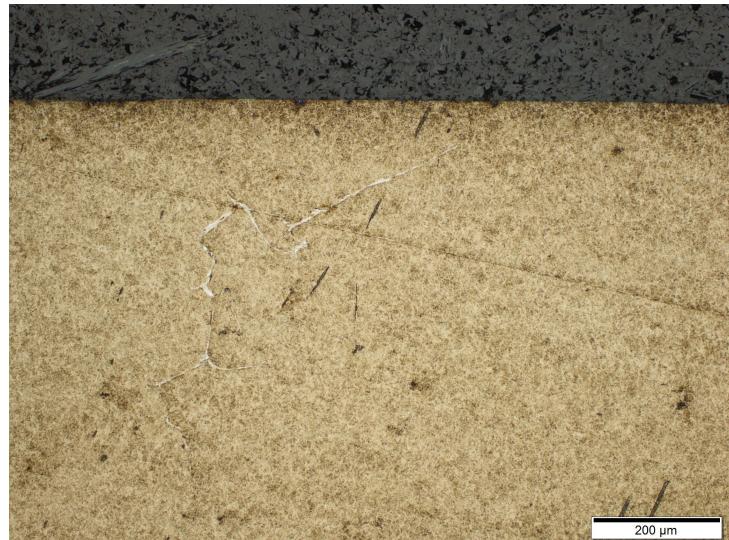
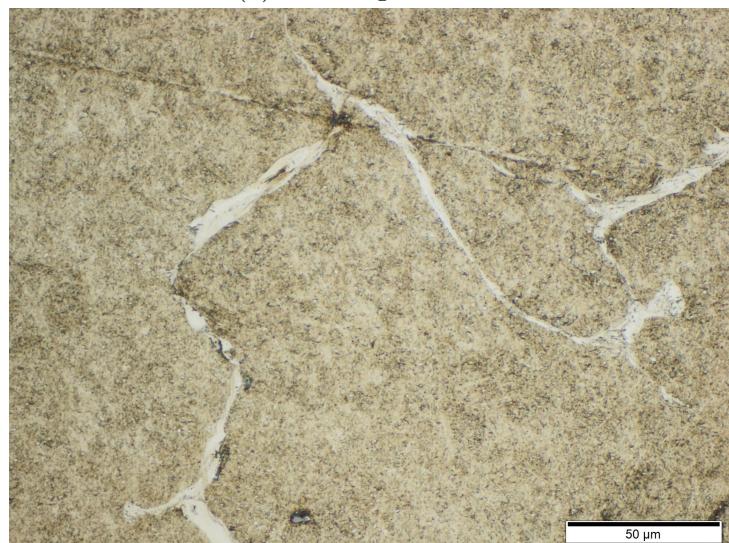
Figure 6: WEC in wind turbine sample

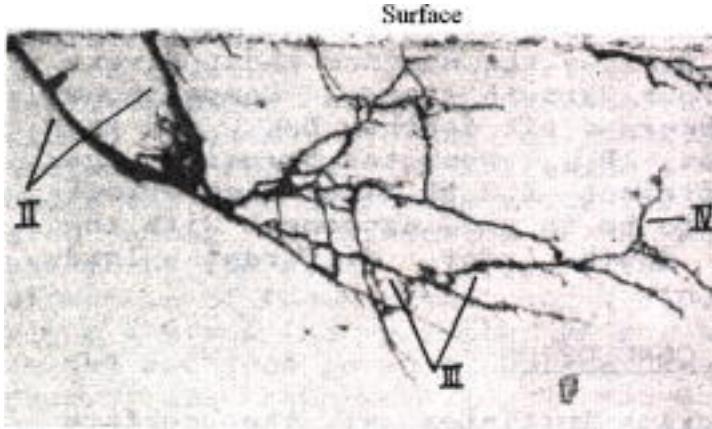
Figure 7: Crack from rolling contact fatigue; figure after [7]

The testing is also useful in comparing the cracks formed as WEC to those formed as the result of rolling contact fatigue. Crack networks formed by RCF occasionally present as dense networks of cracks, with many branches reaching the surface. Often, the cracks also exhibit a directional tendency related to the over-rolling direction. In the case of WEC, cracks almost never formed dense networks as seen in figure 7, and when interacting with the surface, often only connected at one location, usually a spall or pit. This reinforces the clear distinction between RCF cracks and WEC.
