### REPAIRABLE REPORT

**RE: Road traffic Accident: Mr Jack Brownlee: 07/01/2025**

| Make | <b>PORSCHE</b> | Registration | <b>ST24YVA</b> |
| Model | <b>911 CARRERA GTS S-A</b> | Status | <b>Repair</b> |

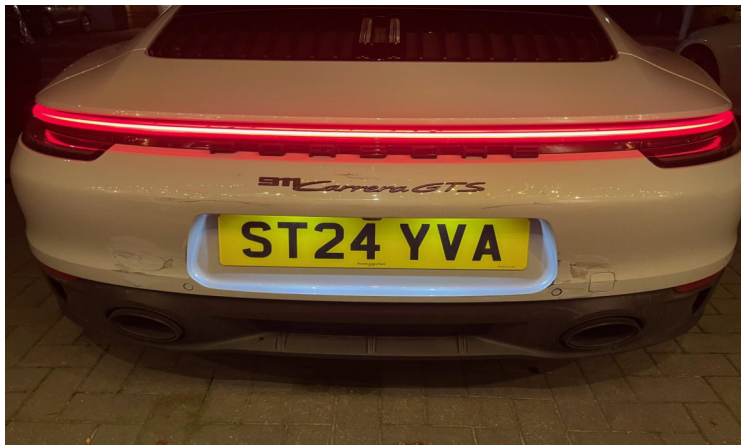
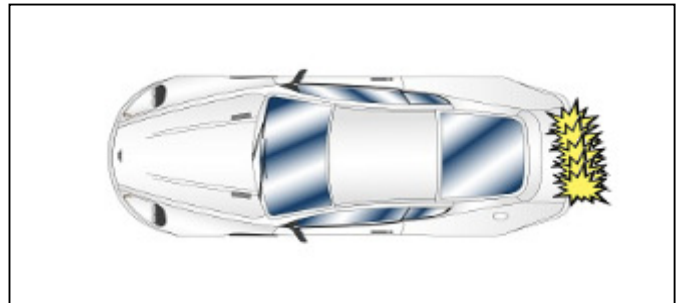
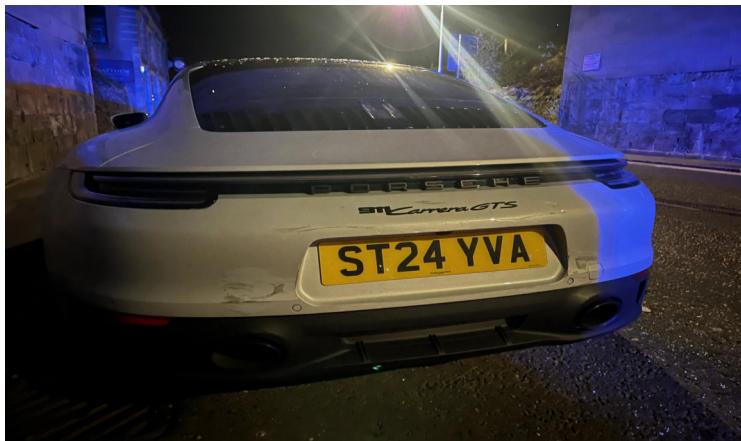
Impact Area

The vehicle has suffered moderate collision/impact damage to the rear.
