**Our Ref:** kb25006

**Date:** 20/06/2025

### TOTAL LOSS REPORT

**RE: Road traffic Accident: Mr Steven Millar: 13/06/2025**

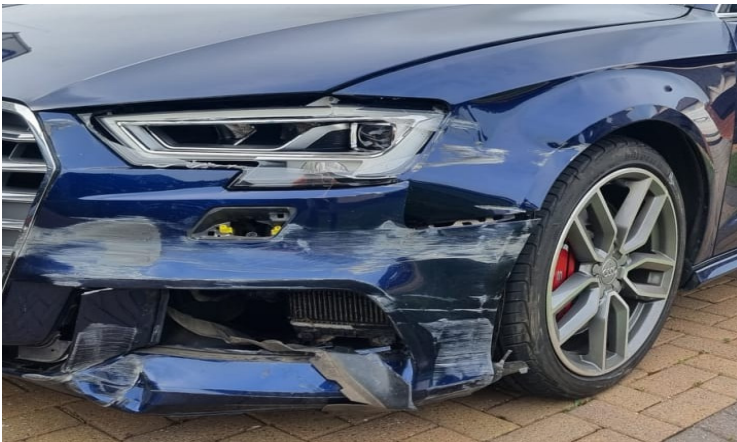
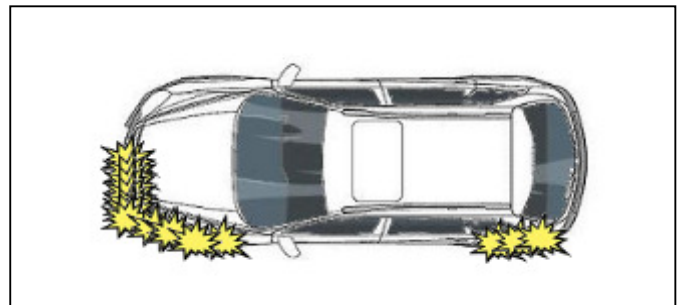
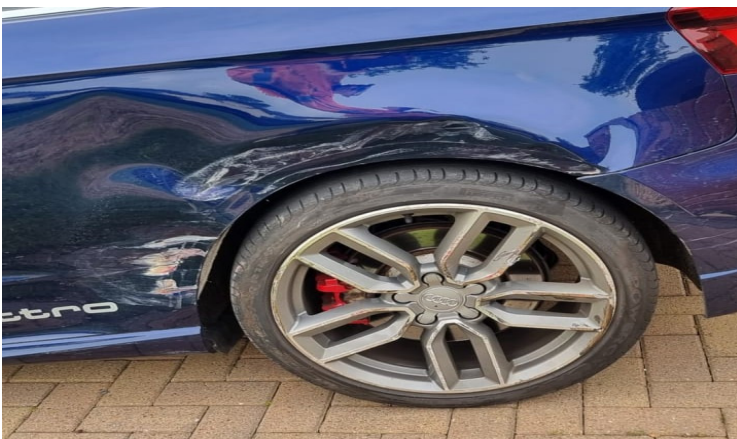
Impact Area

The vehicle has suffered moderate collision/impact damage to the front, and moderate to heavy collision/impact to the left hand side.

20/06/2025 - Please note the vehicle is unroadworthy due to the extent of panel distortion sustained to the nearside
