## To the Court REPAIRABLE REPORT

| Vehicle: <b>NISSAN JUKE TEKNA + DIG-T</b> | | Colour: <b>WHITE</b> | Speedo: <b>20558</b> Miles | |
| Reg No: <b>NG22FVH</b> | Registered: <b>Jul 2022</b> | Type: <b>5 Door Hatchback</b> | Trans: <b>Manual</b> | |
| Damage: <b>Moderate Collision/Impact RH Rear Door</b> | Incident: <b>02/05/2026</b> | | | |

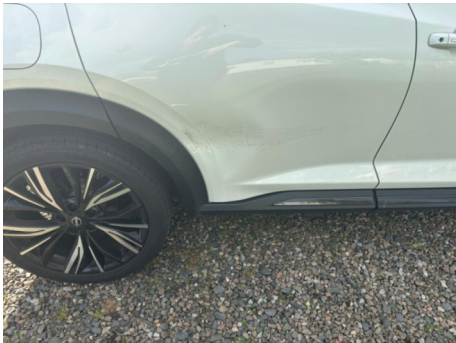
3\_CLVDamage-V1.jpg

The vehicle has suffered moderate collision/impact damage to the right hand rear door.

**New parts required:-** R/R Door, R/R Door Seal, R/R Door Clamp Kit, R/R Door Front Strip, Panel Sundries, Car Care Kit, Glass Lifting Tape, Sundry Parts
