## To the Court REPAIRABLE REPORT

| Vehicle: <b>CUPRA FORMENTOR VZ2 TSI 4DRIVE S</b> | Colour: <b>BLACK</b> | Speedo: <b>8583</b> | Miles |
| Reg No: <b>GO13UCS</b> | Registered: <b>Jun 2025</b> | Type: <b>5 Door Hatchback</b> | Trans: <b>Semi-Auto</b> |
| Damage: <b>Light to Moderate Collision/Impact Rear</b> | Incident: <b>01/05/2026</b> | L/H/F Tyre <b>Not Kno</b> | L/H/R Tyre <b>Not Kno</b> |

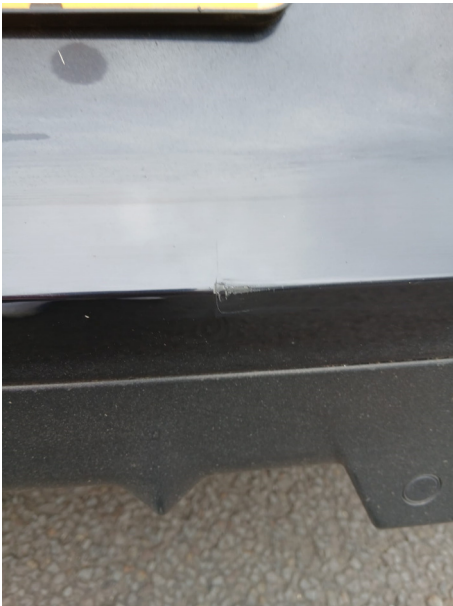
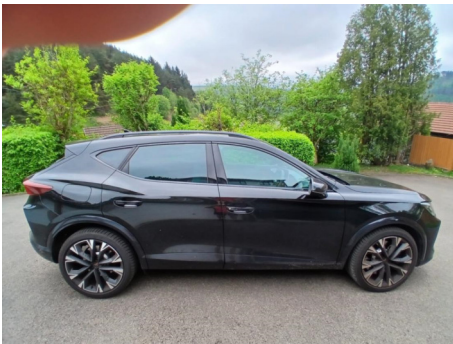
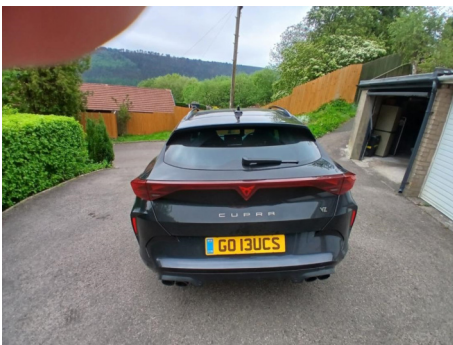
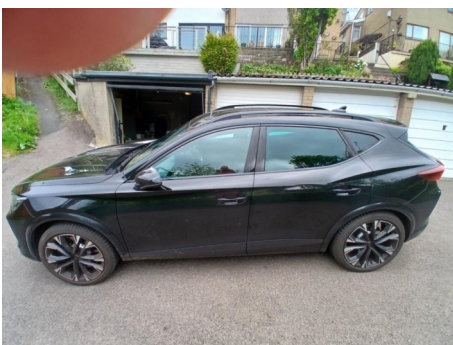
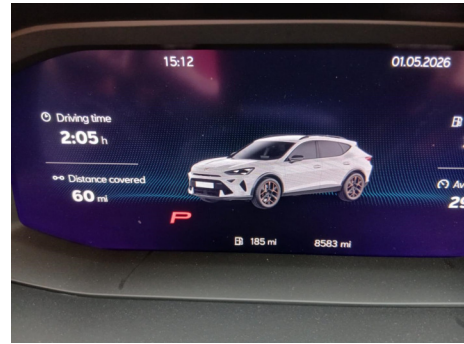
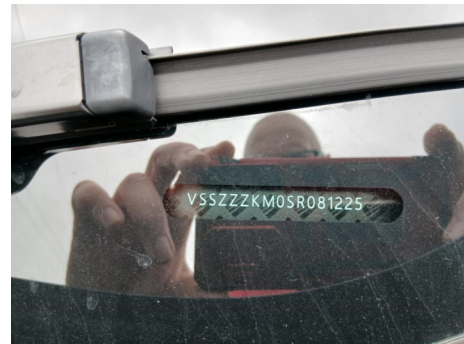
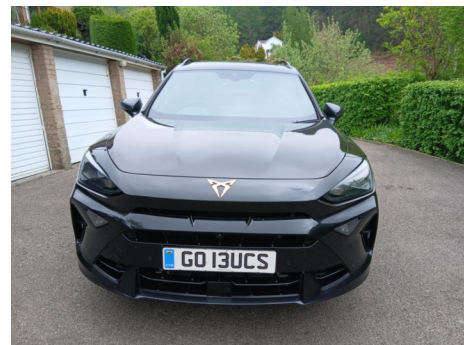
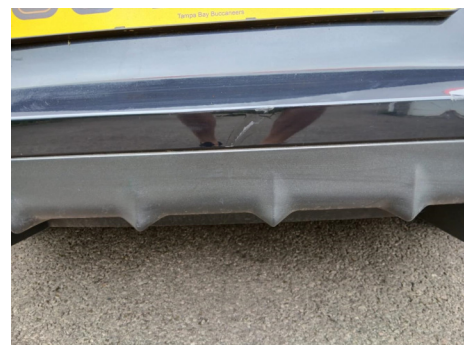
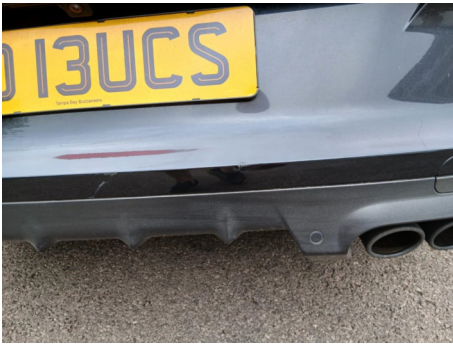
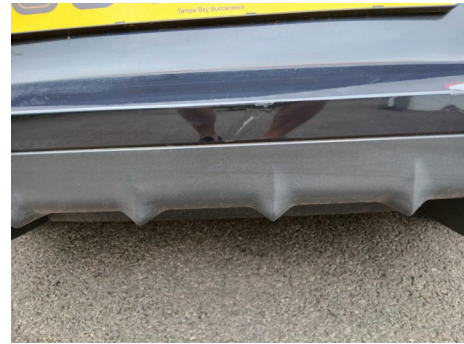
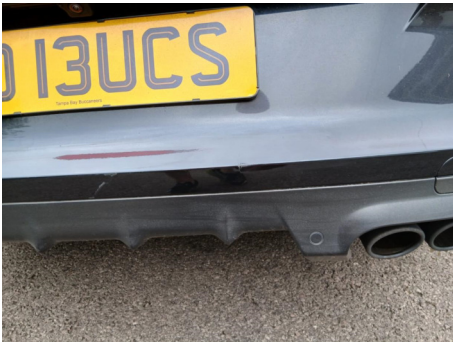
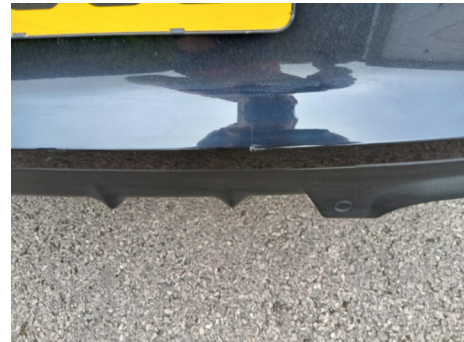
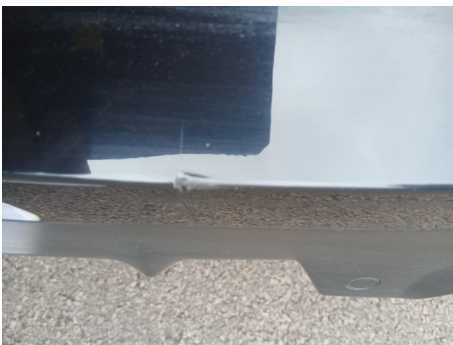
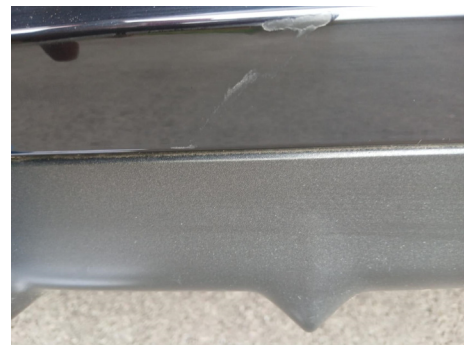
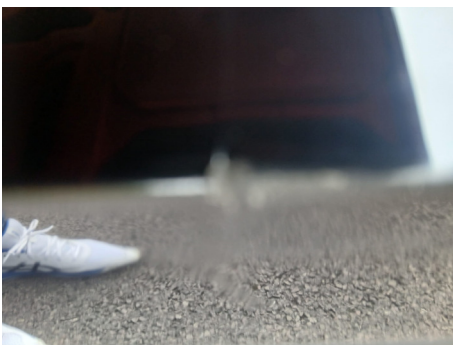
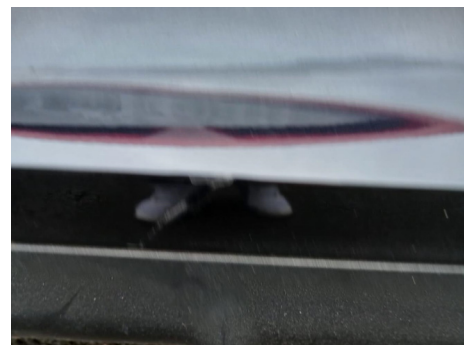
The vehicle has suffered light to moderate collision/impact damage to the rear.

The engineer has inspected this vehicle from images supplied by the principal only, the repair costs have been based on the images received and therefore may not be accurate if further damage is found, condition details and service records have not been checked in relation to the pre-accident value.

**New parts required:-**Rr Bump Lwr Spoiler, Rear Bumper Diffuser, L/R Out Sensor Brkt, R/R Out Sensor Brkt, L/R Inn Sensor Brkt, R/R Inn Sensor Brkt, Car Care Kit, Sundry Parts

**Repairable parts:-**Rear Bumper Spoiler, Rear Bumper Diffuser

**Repaint only parts:-**Two Coat Metallic, Rr Bump Lwr Spoiler New Part Paint K1r, De Nib & Polish. Per Panel, Preparation For Pre-Painting
