## To the Court REPAIRABLE REPORT

| Vehicle: <b>HYUNDAI I30 SE NAV BLUE DRIVE CRDI</b> | Colour: <b>SILVER</b> | Speedo: <b>46892</b> | Miles |
| Reg No: <b>YP66VJL</b> | Registered: <b>Nov 2016</b> | Type: <b>5 Door Hatchback</b> | Trans: <b>Manual</b> |
| Damage: <b>Light to Moderate Collision/Impact RH Rear</b> | Incident: <b>04/05/2026</b> | L/H/F Tyre <b>Not Kno</b> | L/H/R Tyre <b>Not Kno</b> |

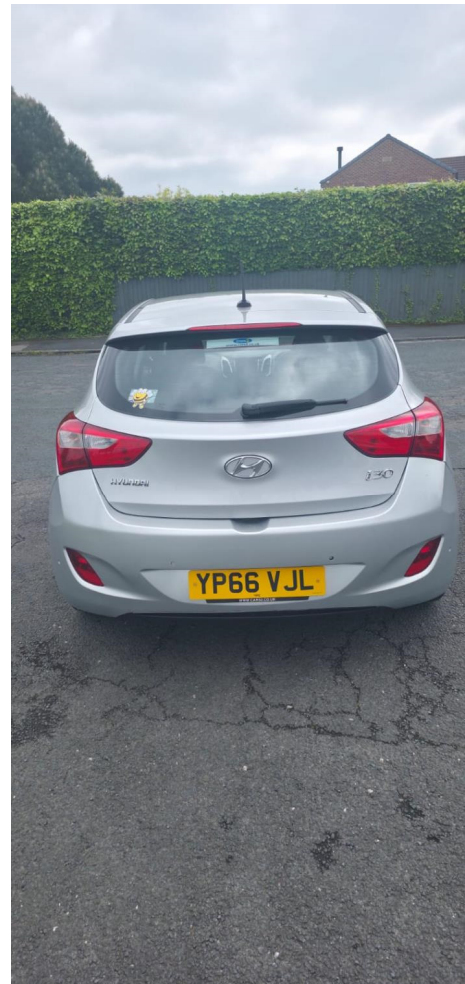
3 ClientVehicleRearjpg-V1.jpg

The vehicle has suffered light to moderate collision/impact damage to the right hand rear.

**Repairable parts:-**Rear Bumper, R/R Side Panel

**Repaint only parts:-**Rear Bumper Repair Paint Plastic, R/R Side Panel Repair Painting <50%, De Nib & Polish. Per Panel, Preparation For Pre-Painting
