## To the Court REPAIRABLE REPORT

| Vehicle: <b>MINI COOPER S EXCLUSIVE</b> | Colour: <b>SILVER</b> | Speedo: <b>14841</b> | <b>Miles</b> |
| Reg No: <b>BK22FSN</b> | Registered: <b>May 2022</b> | Type: <b>3 Door Hatchback</b> | Trans: <b>Automatic</b> |
| Damage: <b>Light to Moderate Collision/Impact Front</b> | Incident: <b>01/05/2026</b> | | |

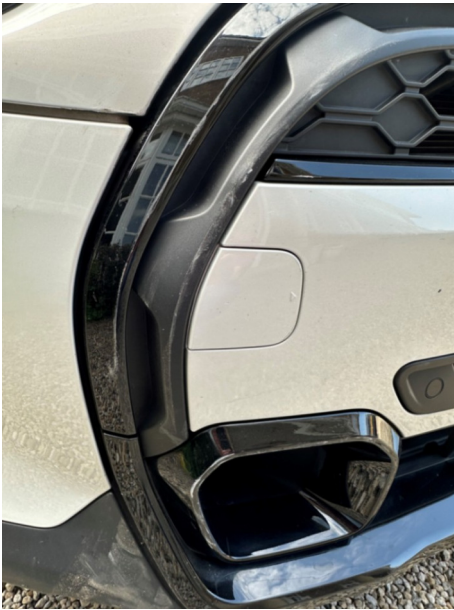
Clientvehicledamages2-V1.jpg

The vehicle has suffered light to moderate collision/impact damage to the front.

**New parts required:-**Front Bumper Cover, Frt Towing Eye Cover, L/F Impact Damper, R/F Impact Damper, R/F Lwr Bumper Cover, Grille Trim Frame, Upp Rad Grille Mldg, Sundry Parts
