## **Executive Summary of Meridian Kessler Infrastructure Priorities**

## **City-County Council District 2 Infrastructure Needs**

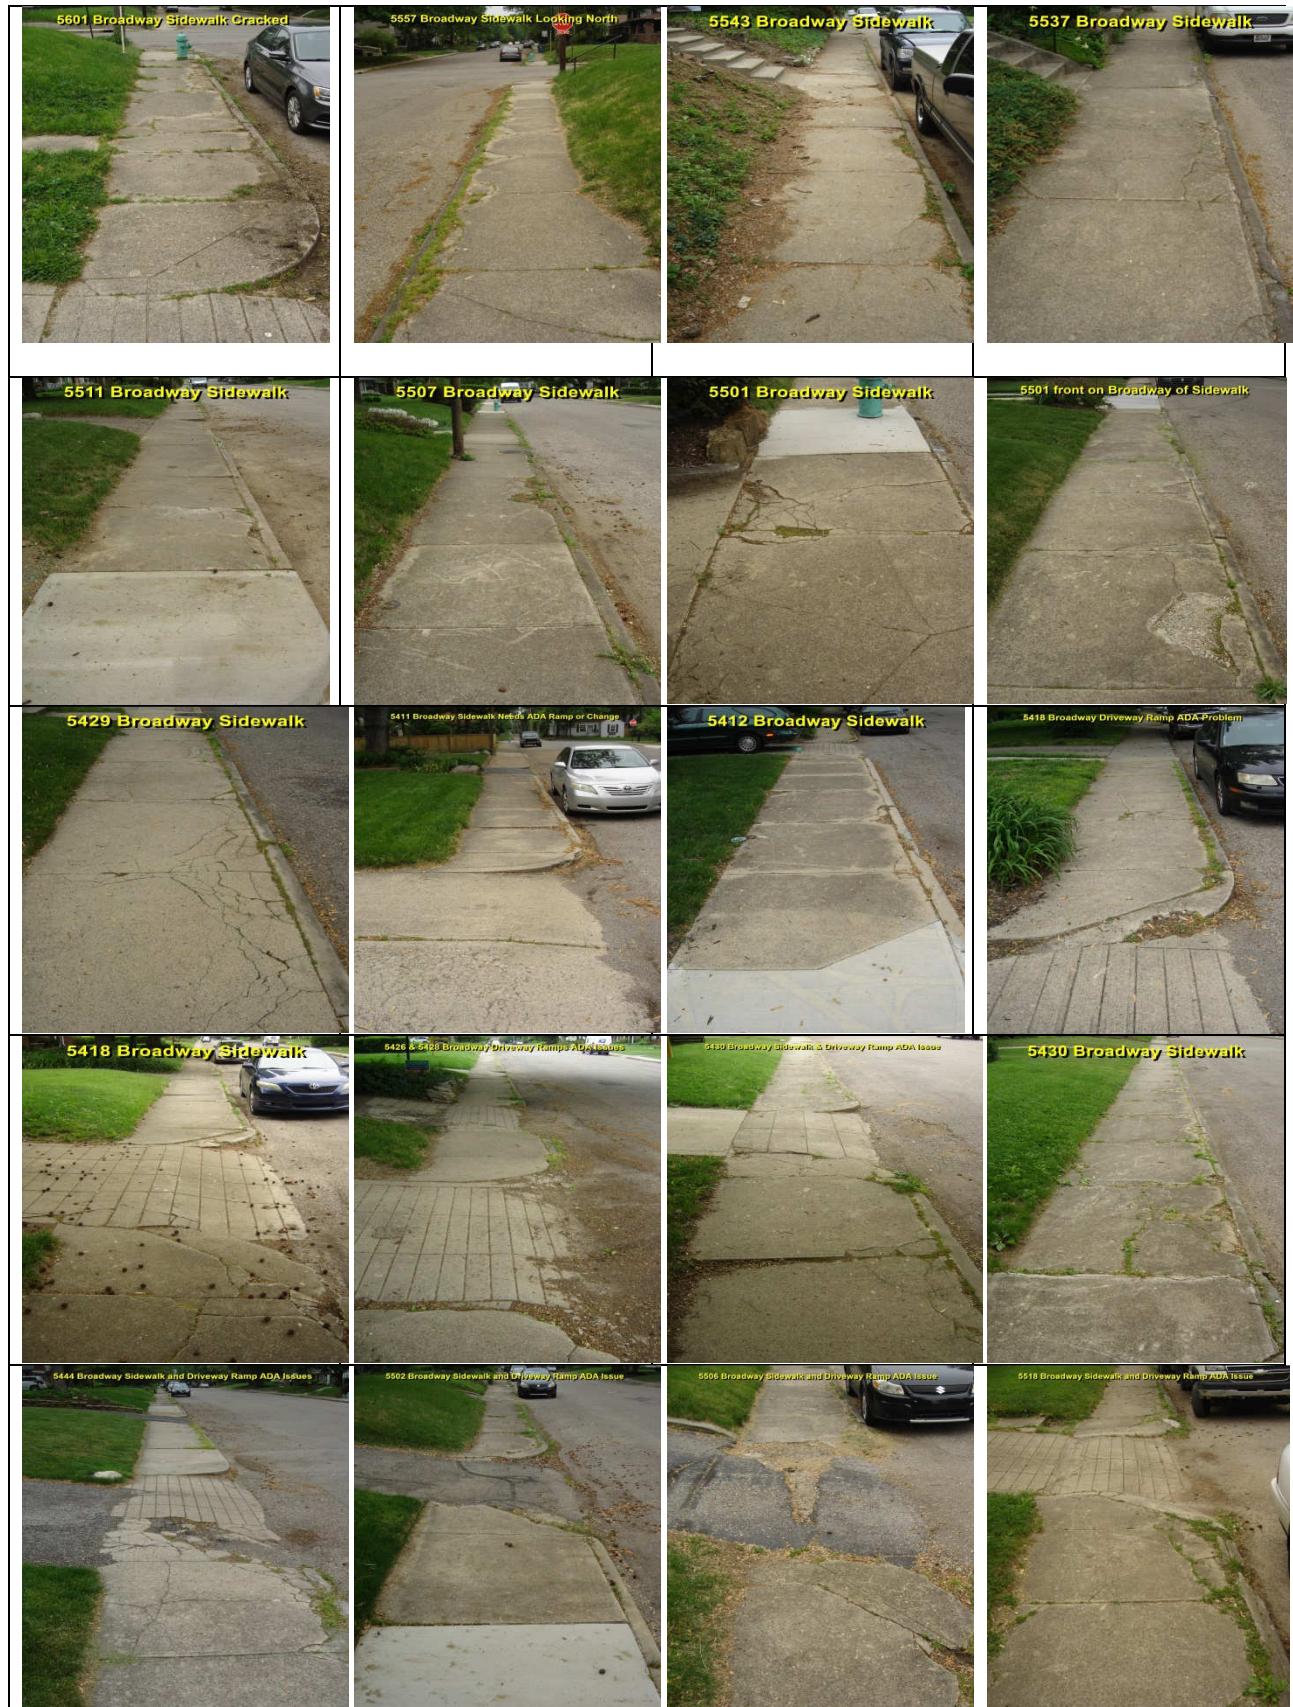
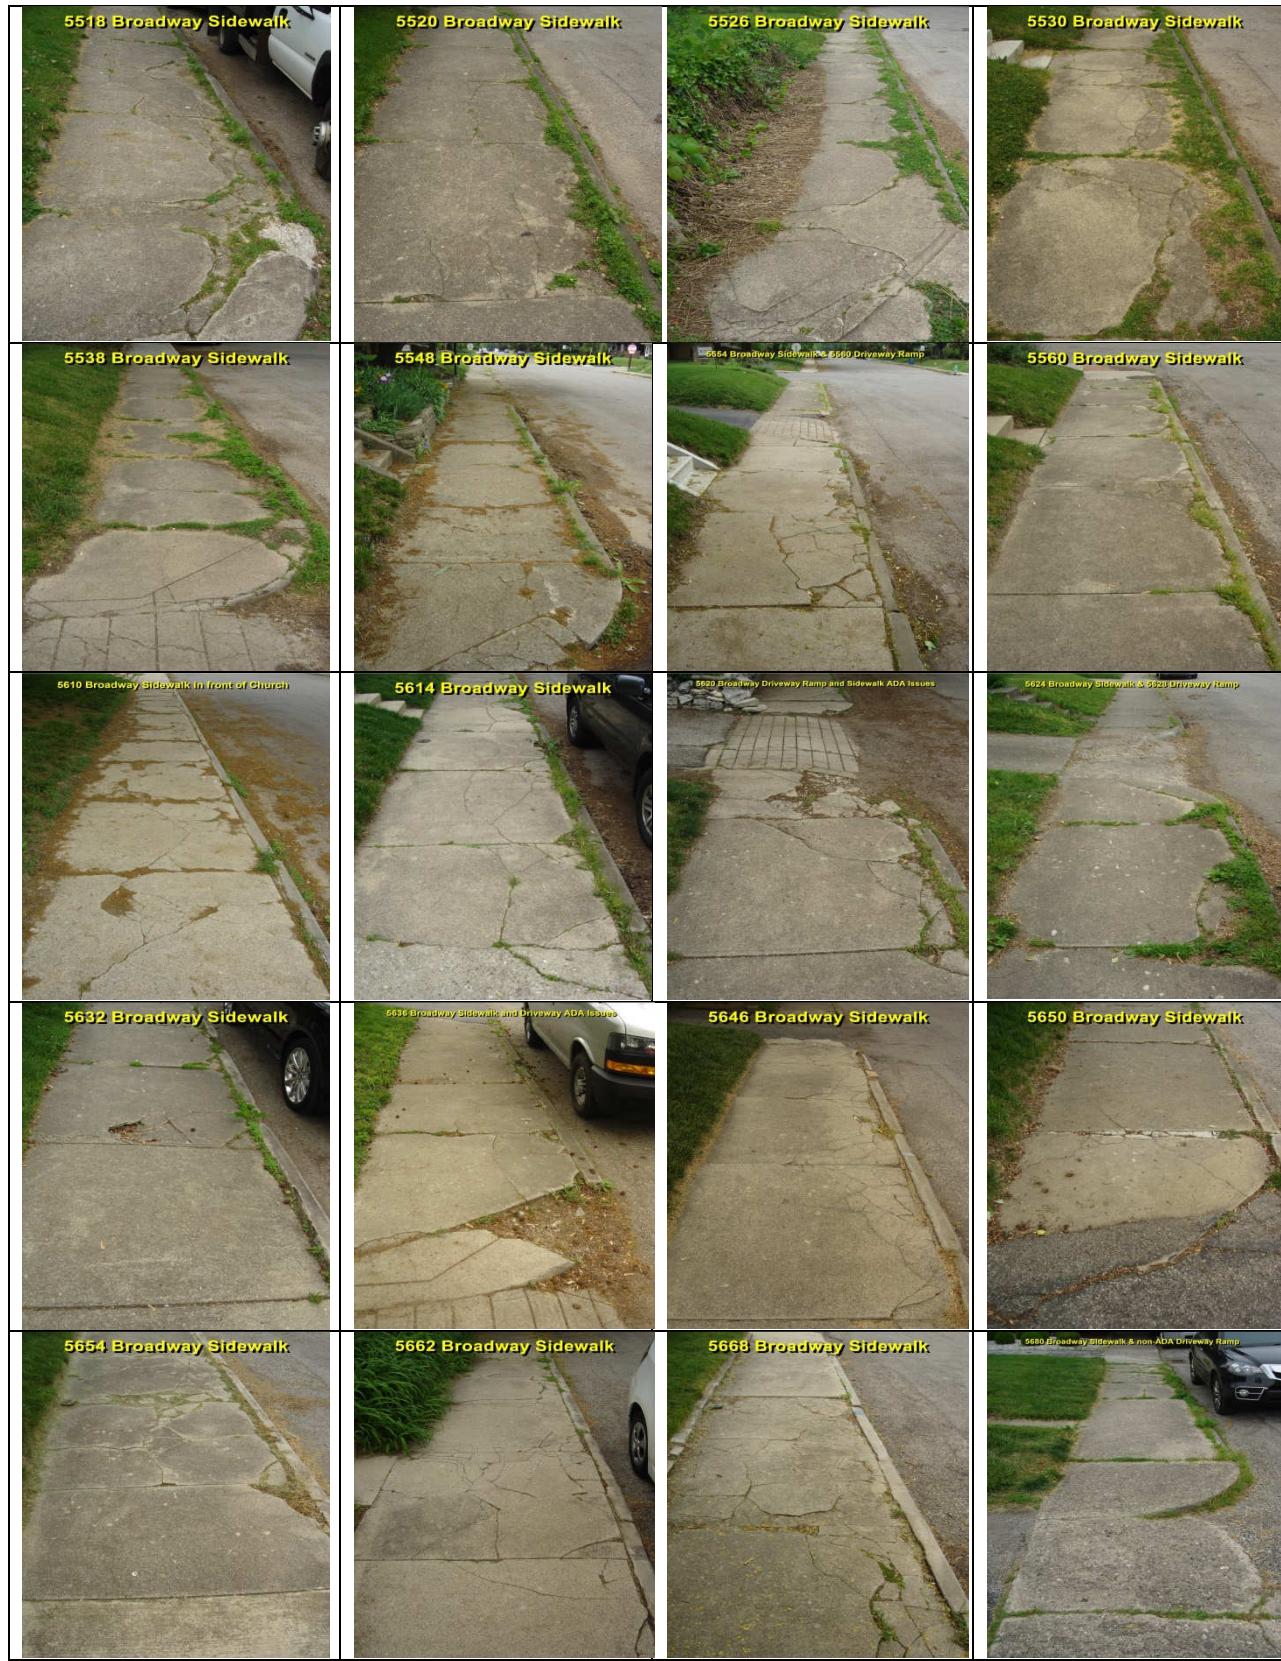
The set of photos, read from left to right and top to bottom, shows exactly what would be experienced as one walked on Broadway St southbound on the east side from 57<sup>th</sup> to 54<sup>th</sup> and then northbound on the west side from 54<sup>th</sup> to 57<sup>th</sup> Streets. The following is a semi-virtual tour of the sidewalks on this street. The number of photos illustrates the magnitude of the problem.

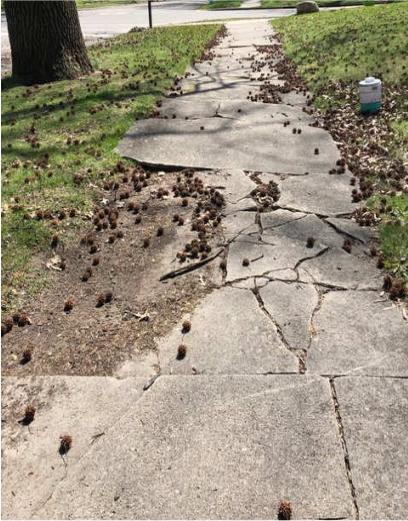
W	5410	Sidewalk badly broken up and deteriorating with many trip hazards. Using a stroller on this sidewalk is virtually impossible.

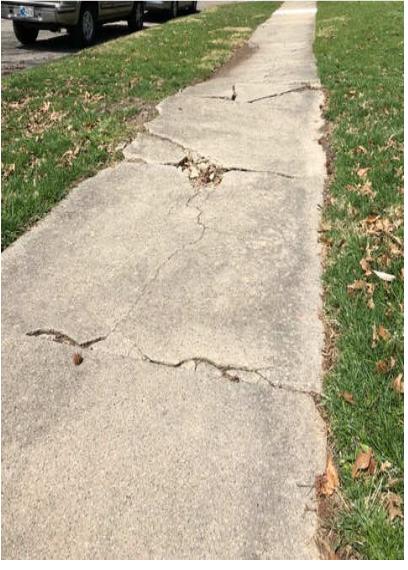
E	5401-5407	Sidewalk cracked and broken creating many trip hazards. Using a stroller on this sidewalk is difficult at best.

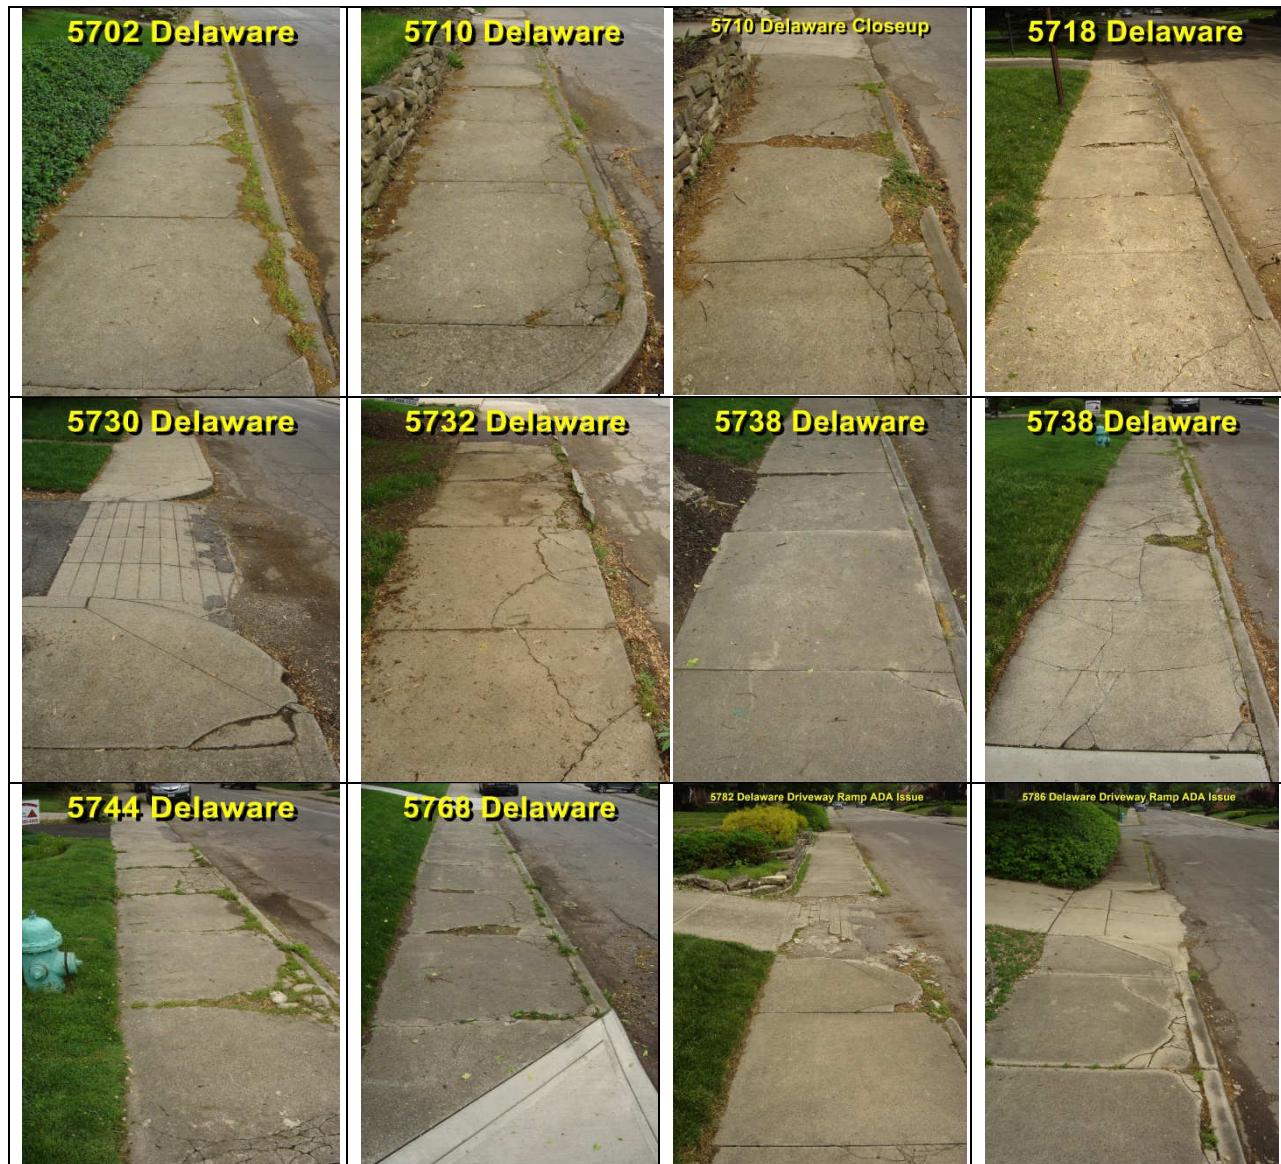
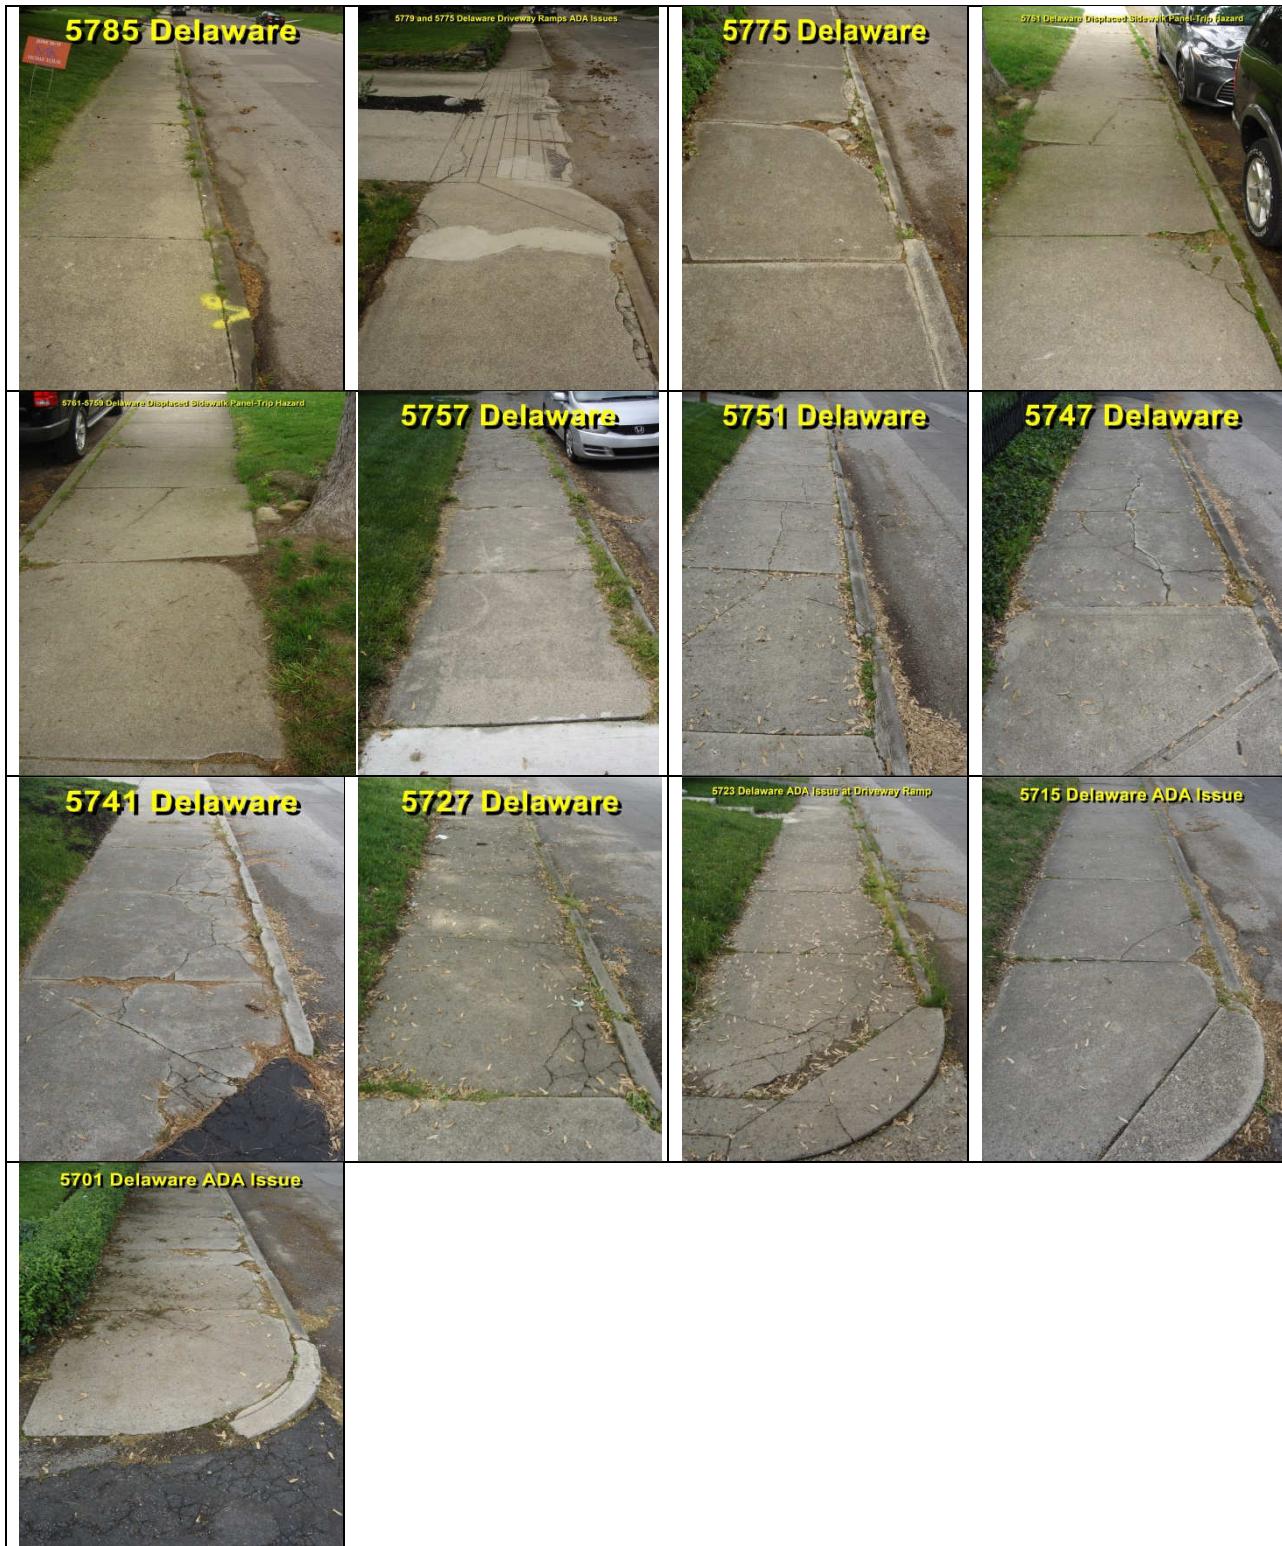
The sidewalks are trip hazards with many panels badly broken or heaved or both. The curbs are broken and badly deteriorated. There are many ADA-type access issues due to driveway cuts.

Following is a sequence of photos seen as if walking from 57<sup>th</sup> St north along the west side of Delaware St. to 58<sup>th</sup> St and then south along the east side of Delaware St. Photos should be viewed from left to right, top to bottom for the proper sequence. It is a semi-virtual tour.

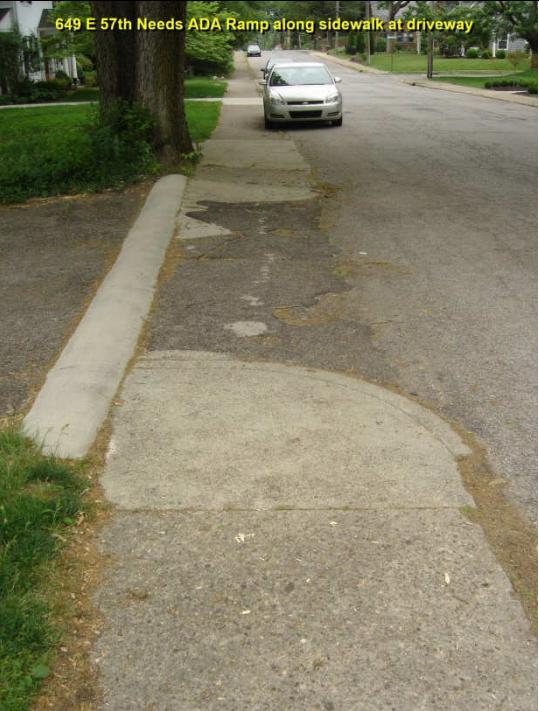
S	649	Driveway cut at street is not ADA compliant. Curb is to prevent street run-off from entering garage which is lower than street level.

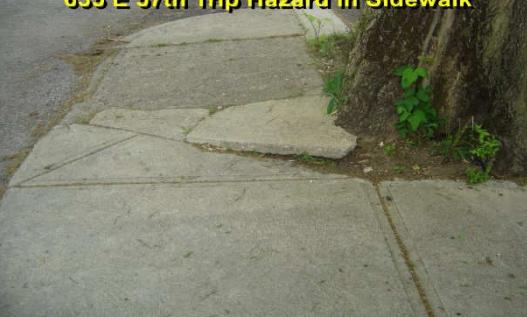
<p><b>635 E 57th Trip Hazard in Sidewalk</b></p>	S	635	Sidewalk has been cracked by tree roots and now presents a trip hazard on a Safe Route to School

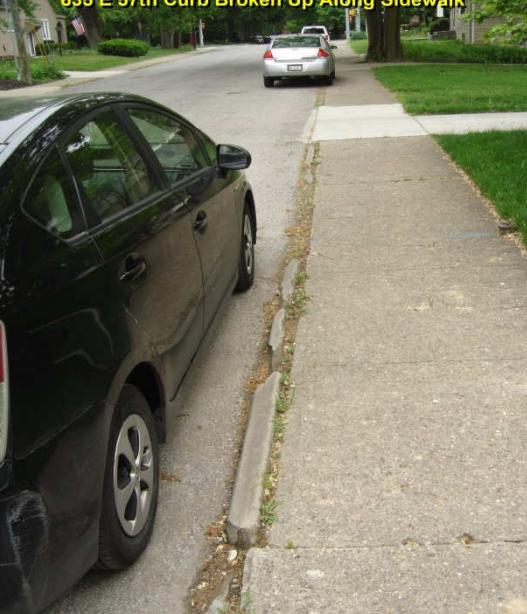
<p><b>635 E 57th Curb Broken Up Along Sidewalk</b></p>	S	635	View looking east along sidewalk showing broken curb and settled sidewalk both of which constitute a trip hazard

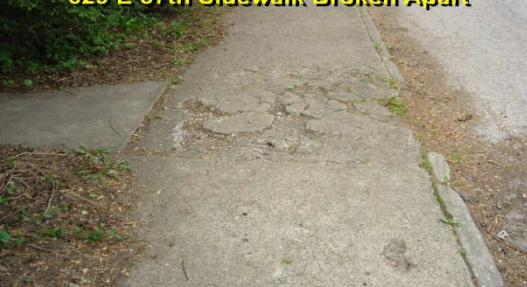
<p><b>635 E 57th No ADA Ramp at Alley</b></p>	S	635	Alley entrance is curbed and does not comply with ADA requirements thus limiting use by those with disabilities, pushing a stroller, or using a walker

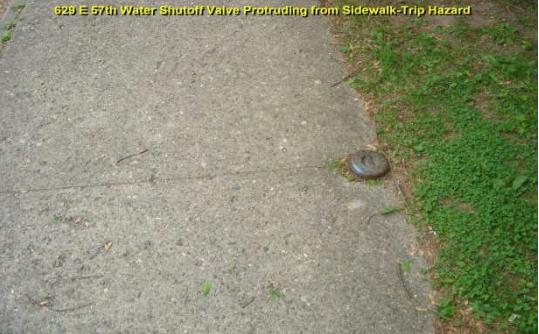
629 E 57th Water Shutoff Valve Protruding from Sidewalk-Trip Hazard	S	629	Water shutoff valve protrudes above sidewalk surface creating a trip hazard

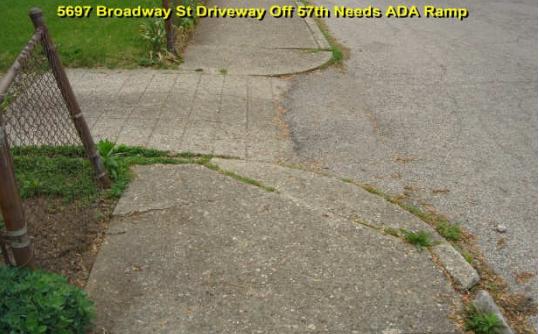
5697 Broadway St Driveway Off 57th Needs ADA Ramp	S	57 <sup>th</sup> St Side of 5697 Broadway St	Driveway cut is not ADA compliant and sidewalk and curbs are cracked and deteriorated

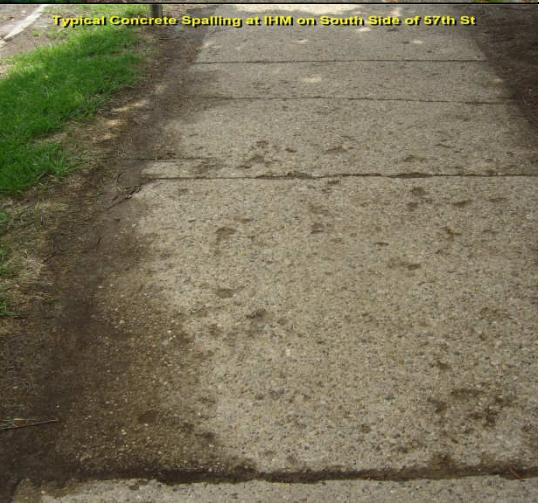
Typical Concrete Spalling at IHM on South Side of 57th St	S	57 <sup>th</sup> St Side of IHM School Sidewalk	Typical example of spalling of concrete surface along this section of sidewalk particularly at the east end of this section of the Central Ave to Washington Blvd block

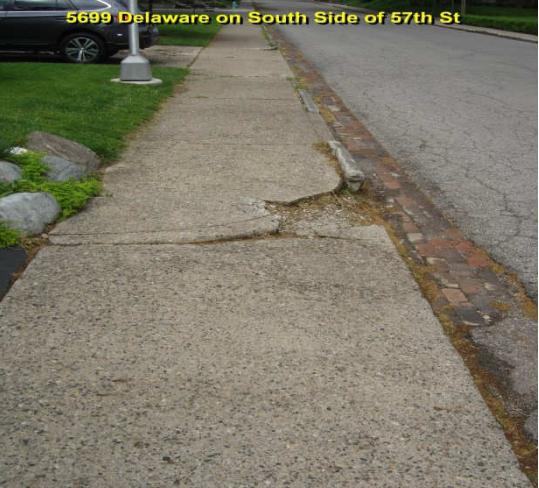
5699 Delaware on South Side of 57th St	S	57 <sup>th</sup> St Side of 5699 Delaware St	Badly broken and damaged sidewalk and curb sections with obvious trip hazards on main route to IHM

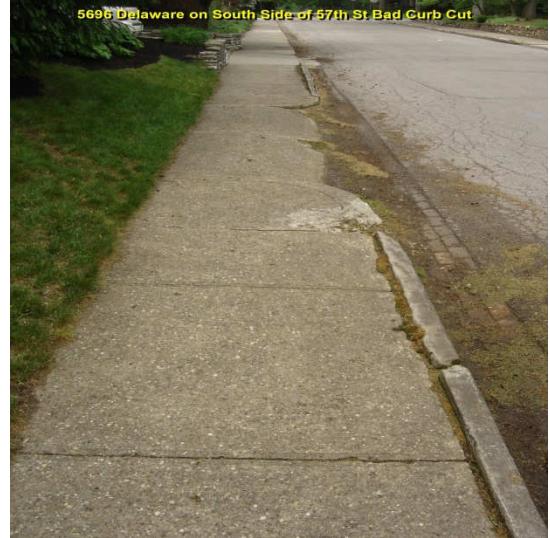
<p><b>5696 Delaware on South Side of 57th St Bad Curb Cut</b></p>	S	57 <sup>th</sup> St Side of 5696 Delaware St	Unused curb cut creating and ADA issue as well as broken sidewalk and curbs all contributing to trip hazards

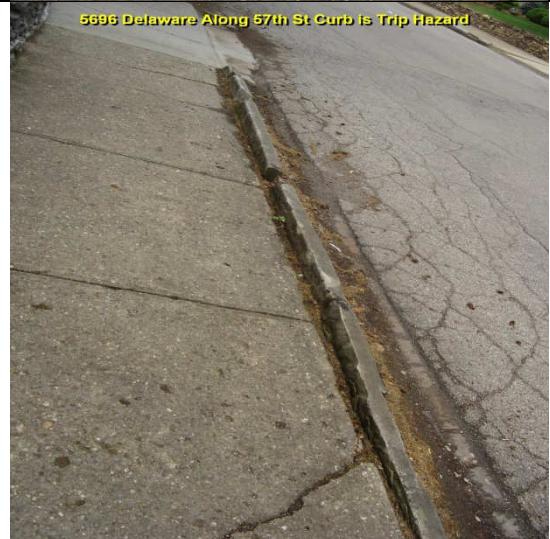
<p><b>5696 Delaware Along 57th St Curb is Trip Hazard</b></p>	S	57 <sup>th</sup> St Side of 5696 Delaware St	Sunken sidewalk has created major trip hazard along the curb.

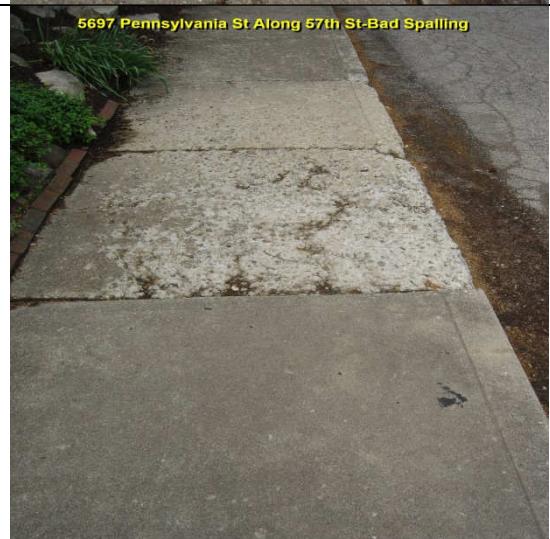
<p><b>5697 Pennsylvania St Along 57th St-Bad Spalling</b></p>	S	57 <sup>th</sup> St Side of 5697 Pennsylvania St	Badly spalled section of sidewalk which impedes wheeled strollers, wheel chairs, and walkers

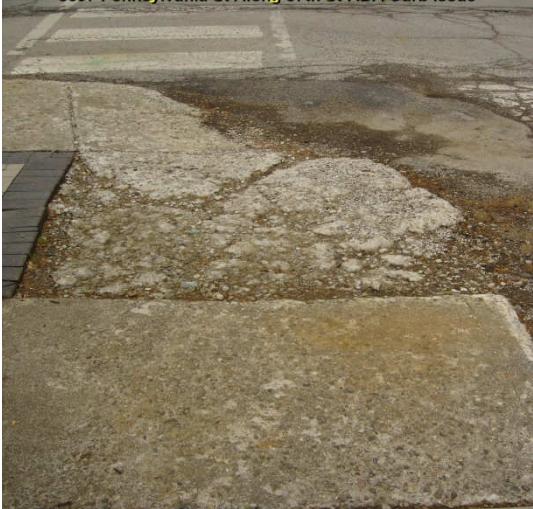
<p>S   57<sup>th</sup> St Intersection with Pennsylvania at 5697</p>	<p>Corner curb is gone and sidewalk is very badly deteriorated. This is a totally unacceptable ADA situation and a true safety hazard.</p>

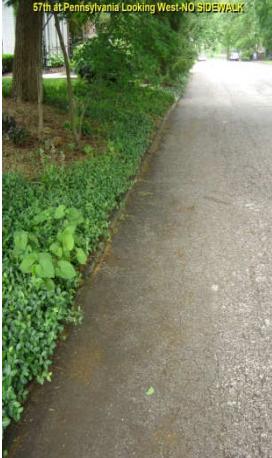
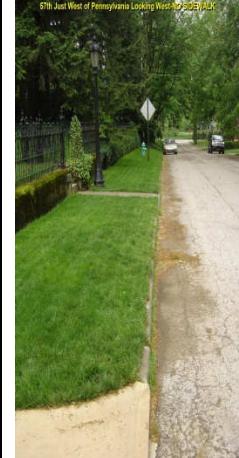
<p>S   Looking west from Pennsylvania Ave towards Meridian St.</p>	<p>No sidewalks along south side at all. Picture at left is at the corner of 57<sup>th</sup> and Pennsylvania; picture at right is from ~75' towards Meridian South side sidewalk right of way is problematic without loss of trees in left picture and sidewalk at street curb or actually in the street proper causing a narrowing of traffic lane.</p>

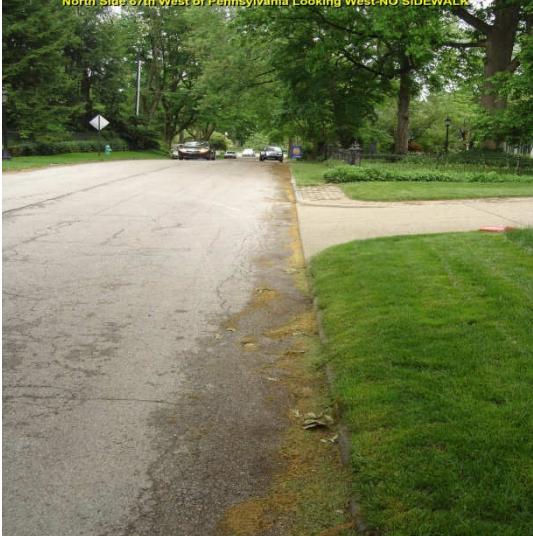
N	Looking west from Pennsylvania Ave towards Meridian St	No sidewalk for children or pedestrians. This is the clearer side except for one tree near Meridian which could have sidewalk circle around it with resident's concurrence to save the mature tree.

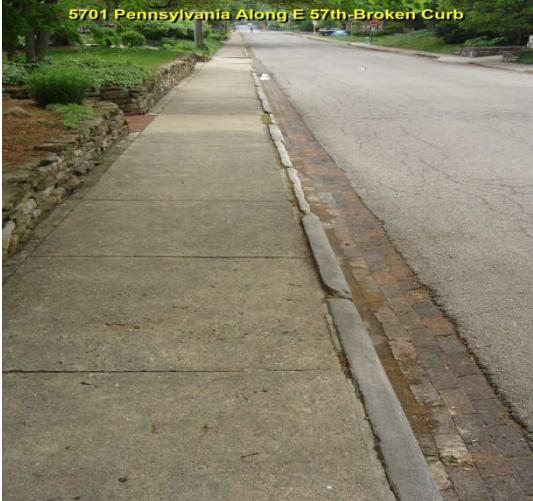
N	Along 57 <sup>th</sup> St at 5701 Pennsylvania St	Typical broken curbs that have become trip hazards

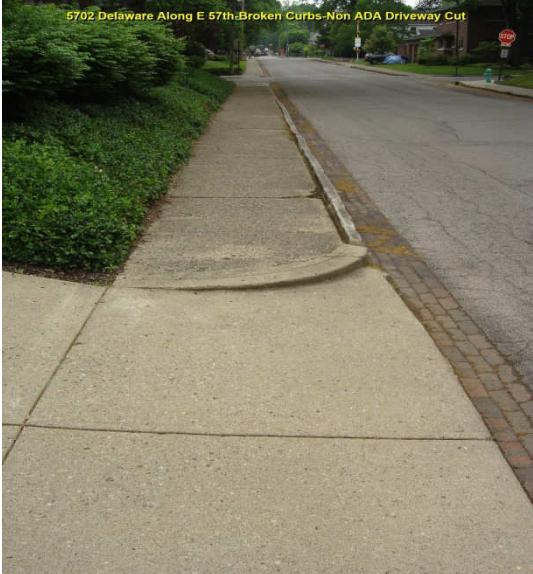
N	Along 57 <sup>th</sup> St at 5702 Delaware St	Typical sunken sidewalk and separated or broken curbs that have become trip hazards as well as driveway cut that is not ADA compliant

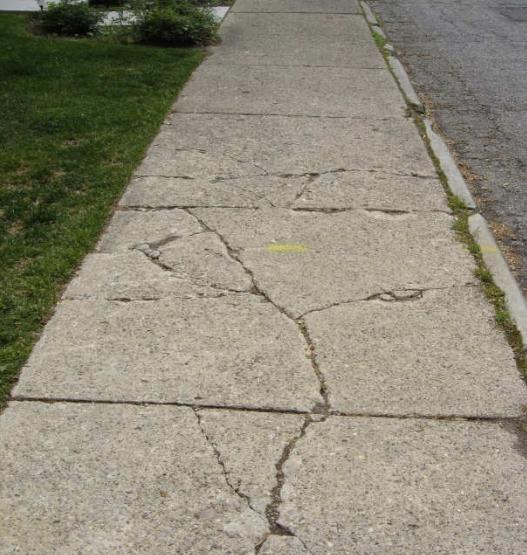
<p><b>522 E 57th Broken Sidewalk and Curb</b></p>	N	522	Broken sidewalk and separation of curb from sidewalk is a tripping hazard

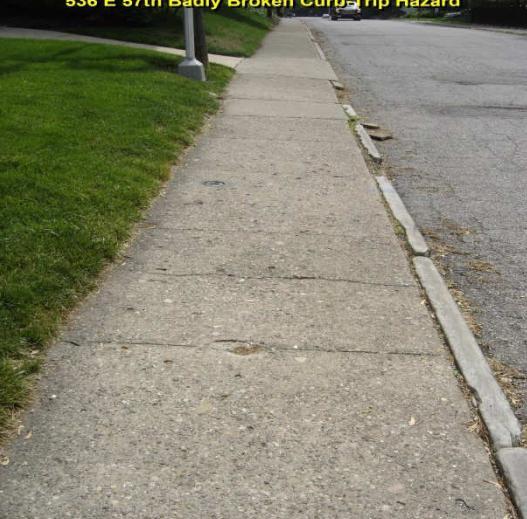
<p><b>536 E 57th Badly Broken Curb-Trip Hazard</b></p>	N	536	Broken curb and separation from sidewalk has created a tripping hazard

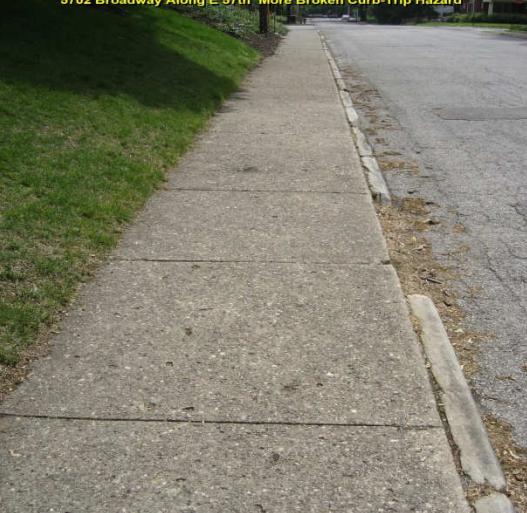
<p><b>5702 Broadway Along E 57th More Broken Curb-Trip Hazard</b></p>	N	57 <sup>th</sup> St side of 5702 Broadway St	Broken curb and separation from sidewalk has created a tripping hazard

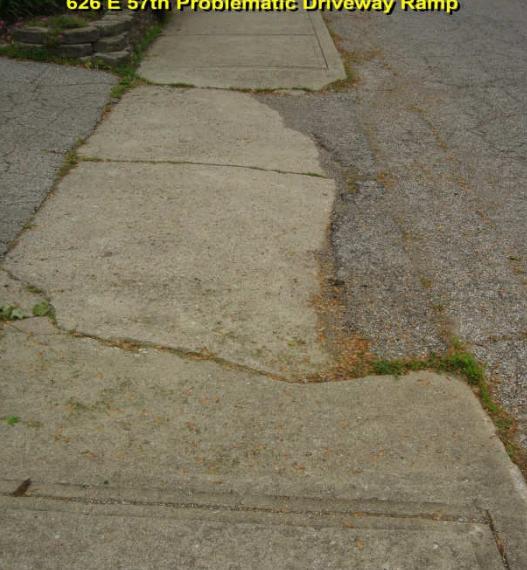
<p><b>626 E 57th Problematic Driveway Ramp</b></p>	N	626	Driveway ramp is not ADA compliant due to curbs and slope.

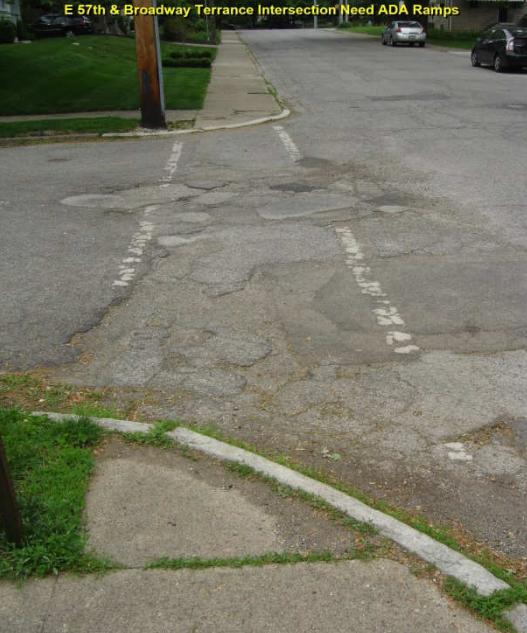
<p><b>E 57th &amp; Broadway Terrace Intersection Need ADA Ramps</b></p>	N	Intersection of E 57 <sup>th</sup> St and Broadway Terrace Looking East	Sidewalk panel has sunk and curbs are not ADA compliant on both sides of Broadway Terrace.

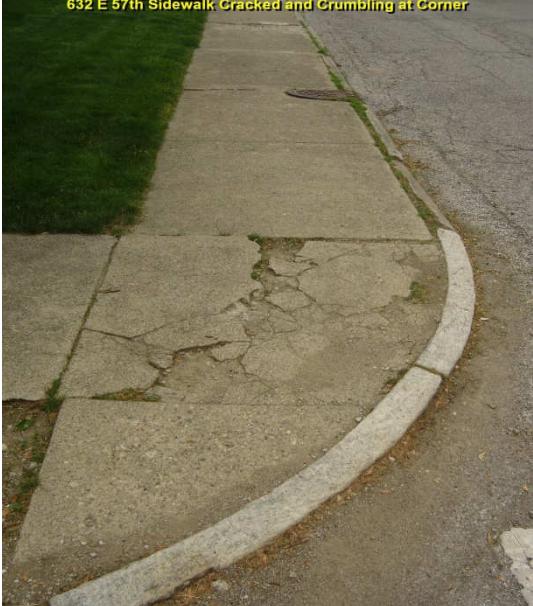
<p><b>632 E 57th Sidewalk Cracked and Crumbling at Corner</b></p>	N	632	Cracked sidewalk at intersection along east side of Broadway Terrance. Curb is not ADA compliant

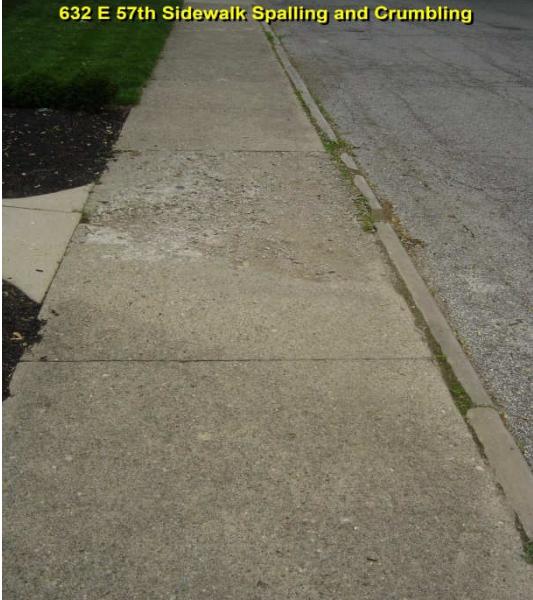
<p><b>632 E 57th Sidewalk Spalling and Crumbling</b></p>	N	632	Spalling and crumbling sidewalk surface typical of many locations along 57 <sup>th</sup> St

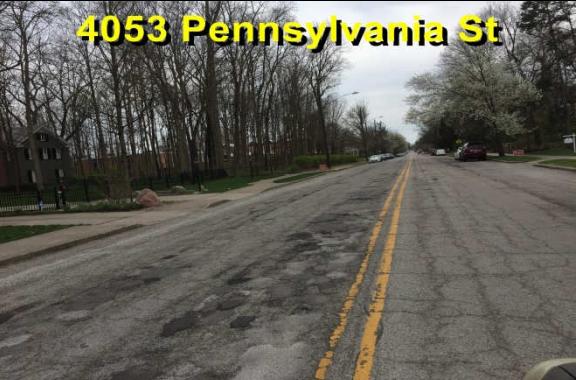
<b>4053 Pennsylvania St</b>	4053 Pennsylvania	Photo shows repeatedly patched pavement along with cracking and the unremitting deterioration of the asphalt

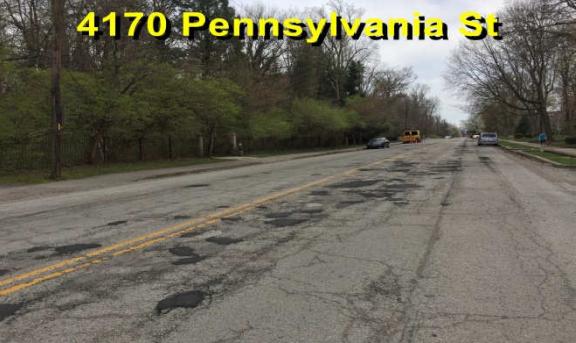
<b>4170 Pennsylvania St</b>	4170 Pennsylvania	Further illustration of repeated pavement patching along with cracking and the unremitting deterioration of the asphalt on both sides of the street

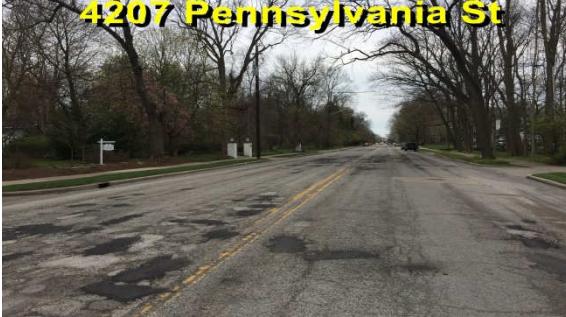
<p><b>4207 Pennsylvania St</b></p>	<p>4207 Pennsylvania</p>	<p>Another illustration of repeated pavement patching along with cracking and the unremitting deterioration of the asphalt on both sides of the street</p>

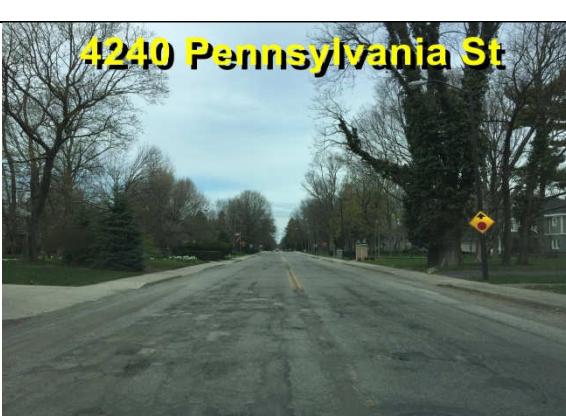
<p><b>4240 Pennsylvania St</b></p>	<p>4240 Pennsylvania</p>	<p>Another illustration of repeated pavement patching along with cracking and the unremitting deterioration of the asphalt on both sides of the street. From 43<sup>rd</sup> Street north pavement to 49<sup>th</sup> is tolerable.</p>

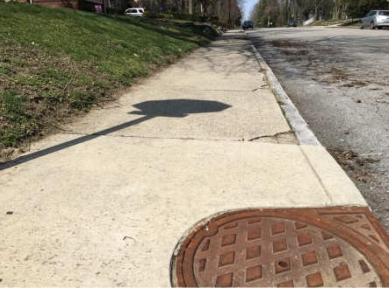
W	4404	Starting at the south corner of Park at 44th, visible cracking/unevenness

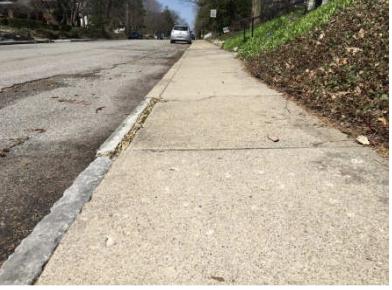
E	4401	Minor cracking and curb deterioration

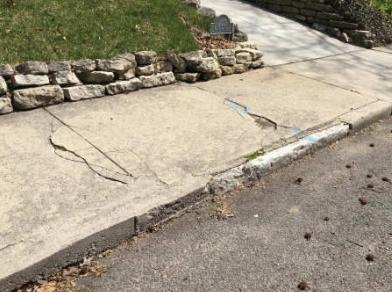
E	4411	Sidewalk cracks causing unevenness; crumbling curb

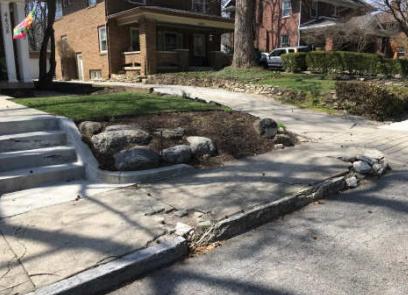
W	4408-4412	Major sidewalk/curb crumbling

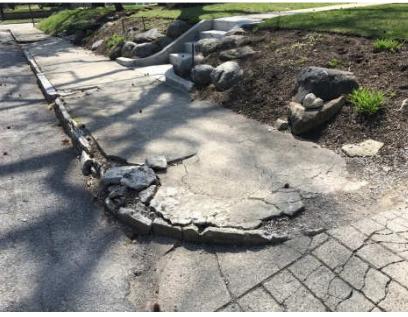
W	4412	Major sidewalk/curb deterioration, with displaced pavement (same as above from angle facing south)

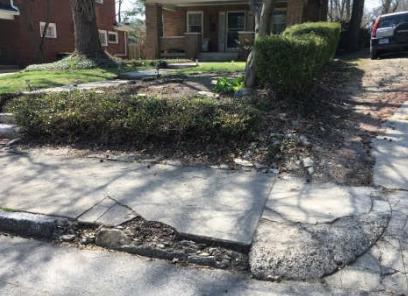
W	4412	Further curb deterioration and sidewalk cracking at 4412

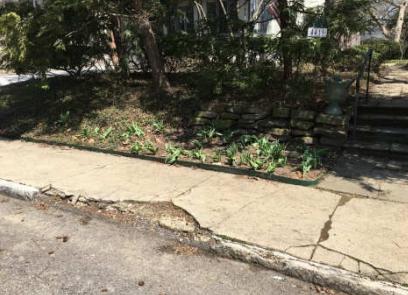
E	4419	Sidewalk faults and curb deterioration

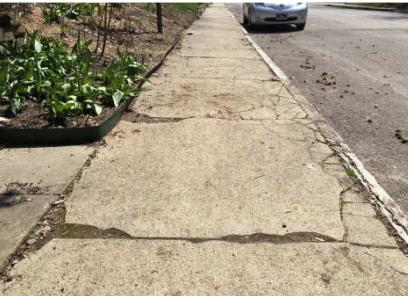
E	4419	Closer picture (facing south) of cracks

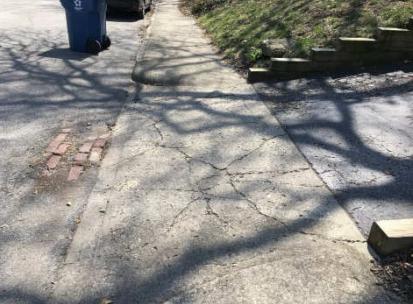
W	4440	As this picture shows, many of the existing driveway crossings in this block (there are many) are non-ADA steep curb slopes.

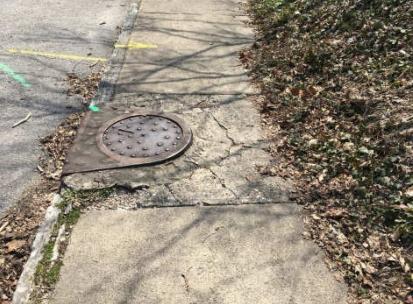
W	4450	Sidewalk cracking and surface deterioration around sewer drain

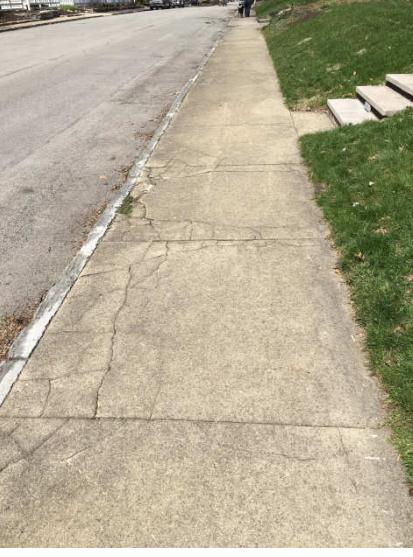
E	4451	Sidewalk cracks such as these are endemic

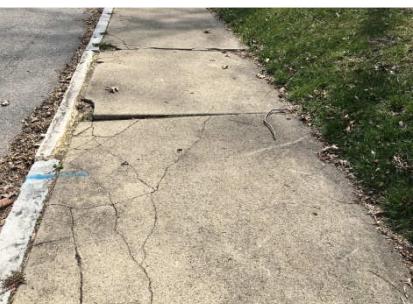
W	4450	Vertical sidewalk displacement causes a trip hazard

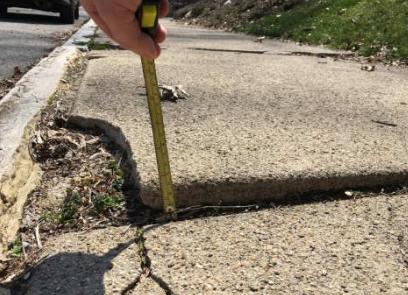
W	4450	This sidewalk displacement (same as above) is 1.5 to 2 inches. Trip hazard.

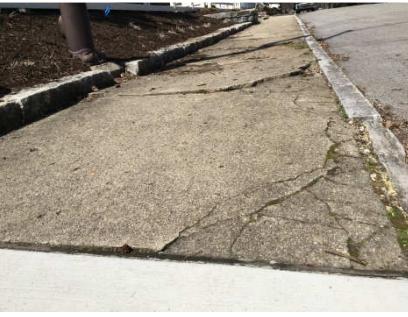
W	4456	Many sidewalk faults with vertical displacement coupled with significant panel deterioration

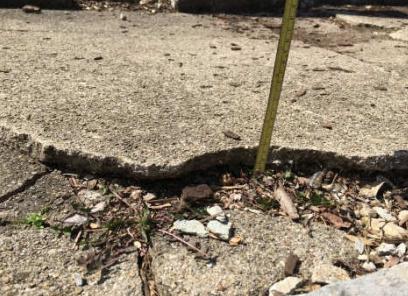
W	4456	This sidewalk displacement (same as above) is 2 inches.

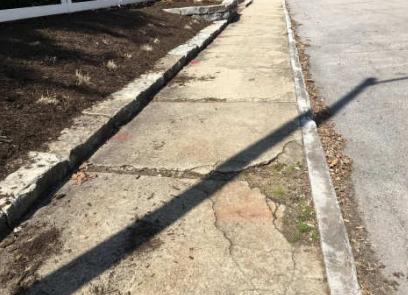
W	4456	Very wide sidewalk cracks

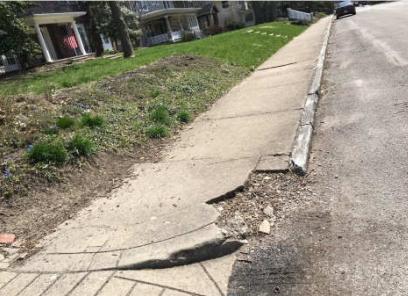
E	4455	Major curb/sidewalk deterioration

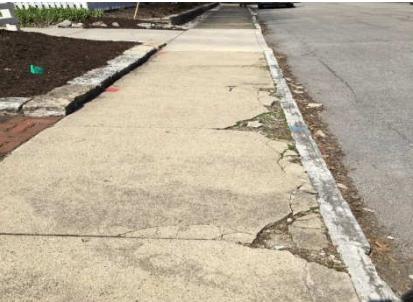
W	4456	Major sidewalk cracks

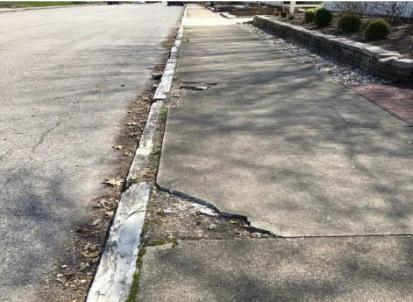
W	4460	Major sidewalk cracks

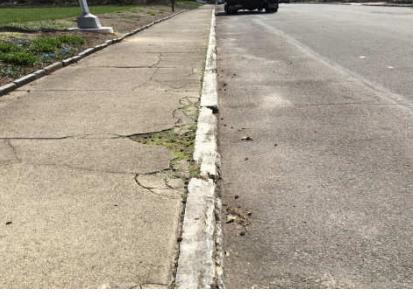
E	4455	Sidewalk cracking and vegetation

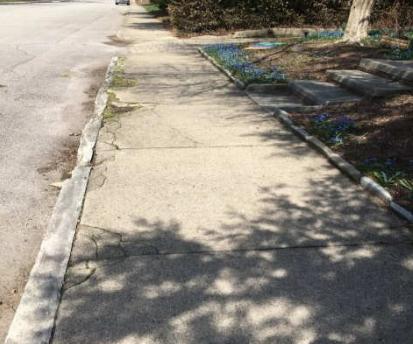
E	4455	Sidewalk cracking and vegetation (additional angle of above)

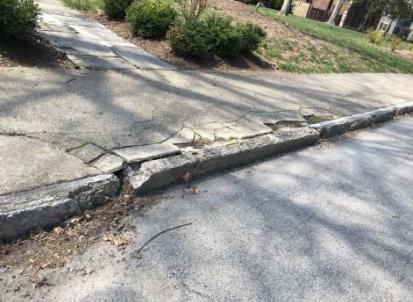
W	4510	Significant sidewalk/curb fracturing

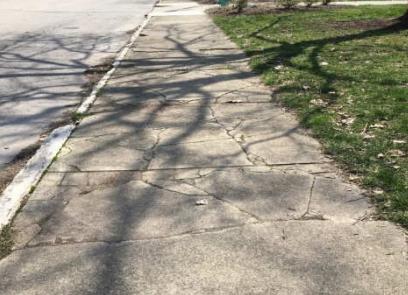
W	4510	Major sidewalk cracks and uneven pavement

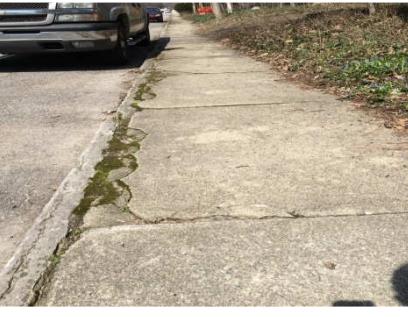
E	4525	Large sidewalk cracks with vegetation

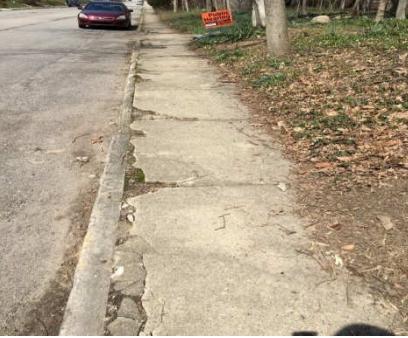
E	4525	Major sidewalk cracks and uneven pavement

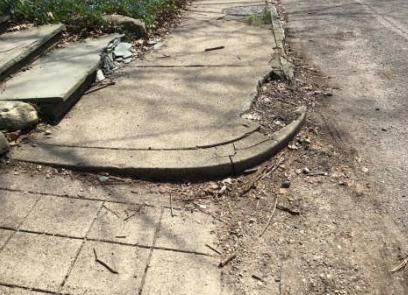
E	4535	Sidewalk/curb deterioration and inaccessible driveway crossing

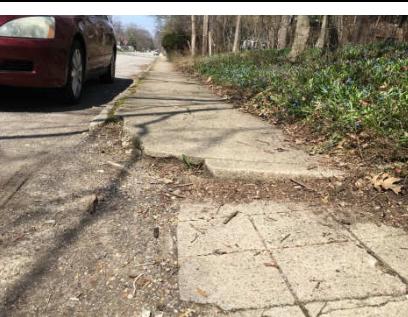
E	4535	Major sidewalk pavement loss which has led to inaccessible step in middle of sidewalk section

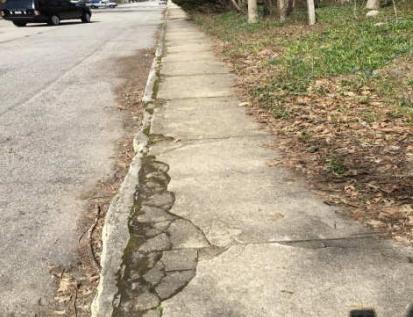
E	4535	Significant cracking

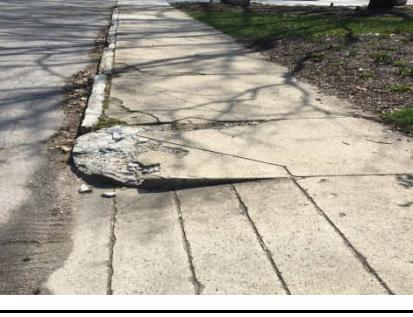
W	4530	Sidewalk cracking/crumbling

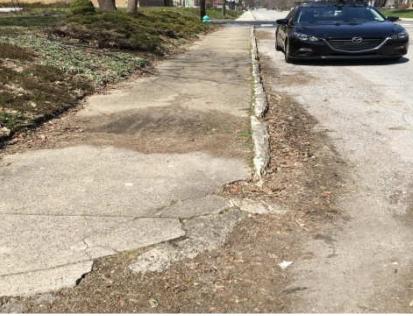
W	4530	Major curb crumbling and sidewalk cracks

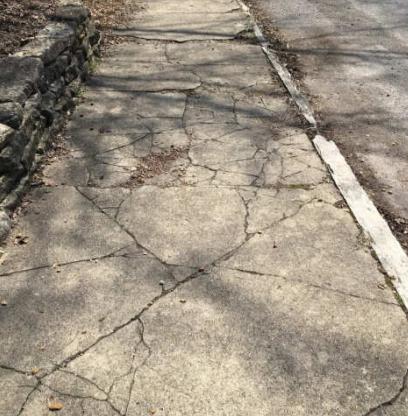
E	4565	Significant cracks

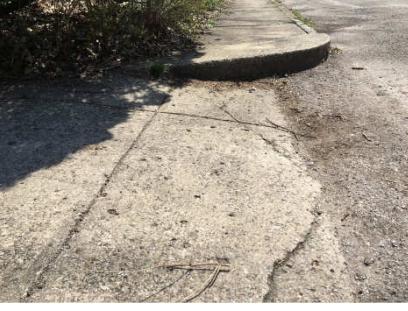
E	4553	Major cracks with displacement of sidewalk pavement

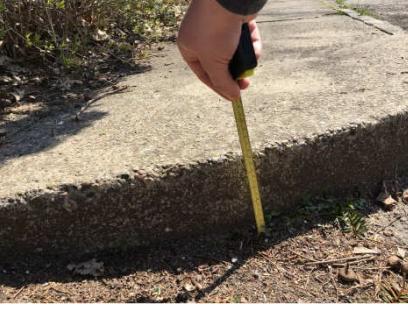
E	4551	This is probably the worst example of non-ADA driveway crossing curbs in the sidewalk

E	4551	Driveway crossing curb (from above) is up to 6 vertical inches and completely impassable to handicapped

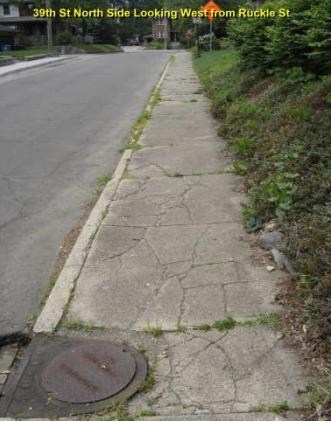
A photograph showing a sidewalk along the south edge of 3906 Ruckle St, looking west towards Ruckle St. The sidewalk is made of concrete pavers and shows significant cracking and separation from the curb.	N	39 <sup>th</sup> St Side along south edge of 3906 Ruckle St.	Sidewalk is badly cracks and breaking apart as is the curb with settling and heaving at various places along the entire stretch to Central Ave.

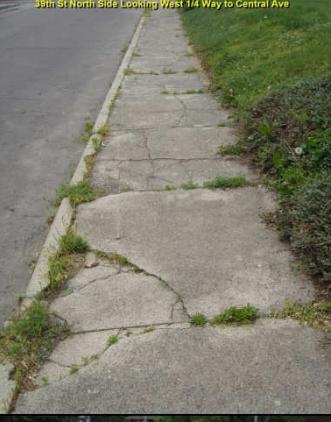
A photograph showing a sidewalk along the south edge of 3906 Ruckle St, looking west towards Central Ave. The sidewalk is made of concrete pavers and shows significant cracking and separation from the curb.	N	39 <sup>th</sup> St Side along south edge of 3906 Ruckle St	More detail showing treacherous walking surfaces as one walks towards Central Ave. This is a serious trip hazard and impairs the use by wheeled devices such as strollers and walkers.

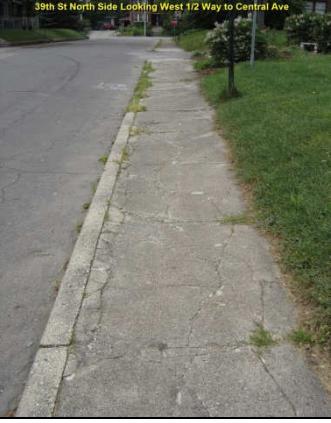
A photograph showing a sidewalk along the south edge of 3906 Ruckle St, looking west towards Central Ave. The sidewalk is made of concrete pavers and shows significant cracking and separation from the curb.	N	39 <sup>th</sup> St Side along south edge of 3906 Ruckle St	Sidewalk with grass growing through cracks which will ultimately result in heaving and more trip hazards.
