## **Executive Summary of Meridian Kessler Infrastructure Priorities**

## **City-County Council District 2 Infrastructure Needs**

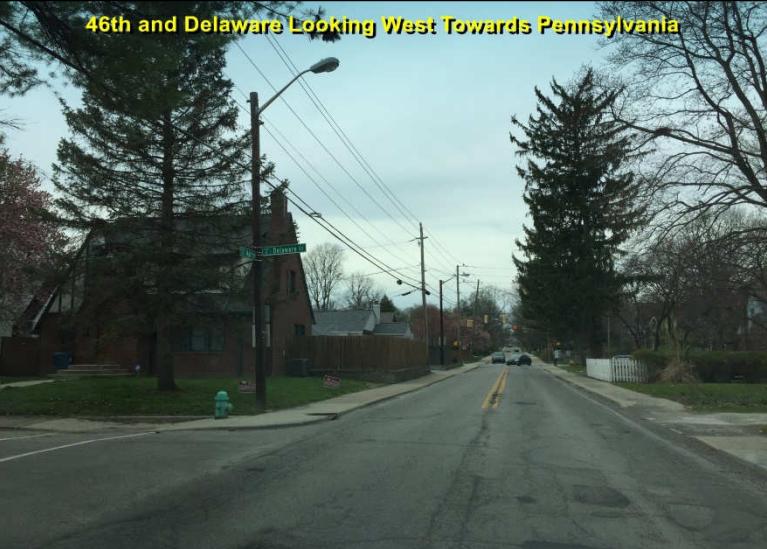
<b>46th and Delaware Looking West Towards Pennsylvania</b>	46 <sup>th</sup> and Delaware St	Roadway is developing potholes which propagate during the winter months

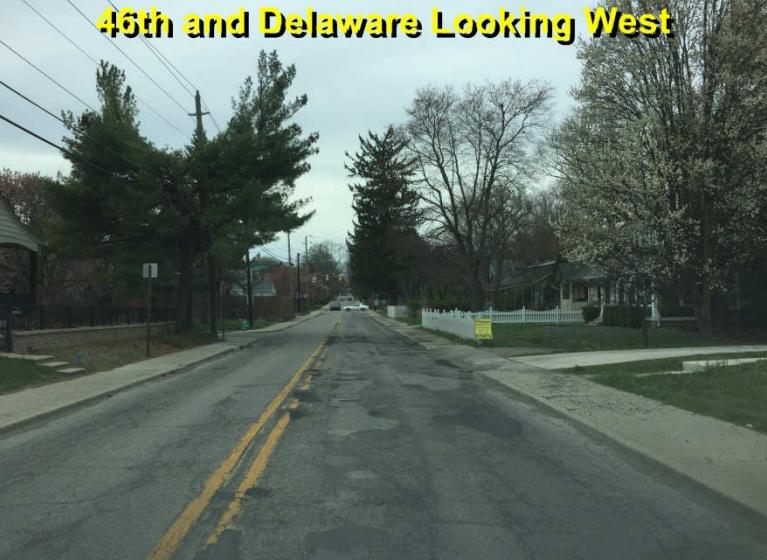
<b>46th and Delaware Looking West</b>	Just west of 46 <sup>th</sup> and Delaware	Evidence of deteriorating roadway due to heavy traffic

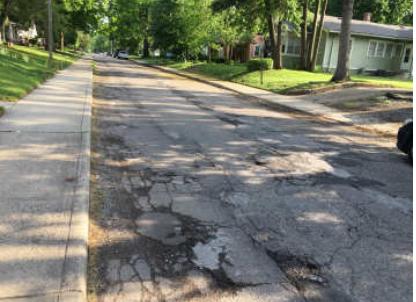
3949	Badly deteriorating street

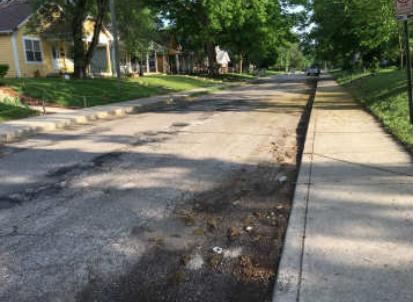
3950	Patched and unpatched potholes

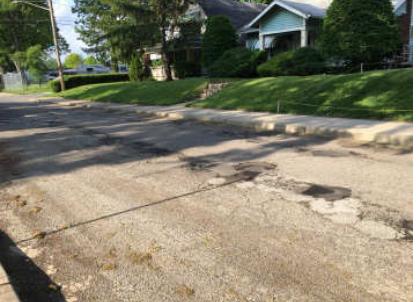
3949	Pavement crumbling

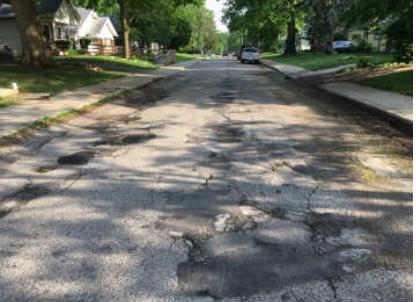
3947	Seriously deteriorating street (looking south)

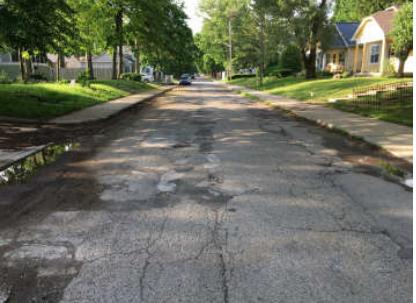
3947	Standing water due to potholes and decrepit pavement (looking north)

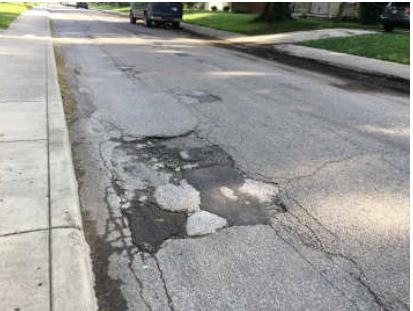
3941	Multiple patches on same recurring pothole

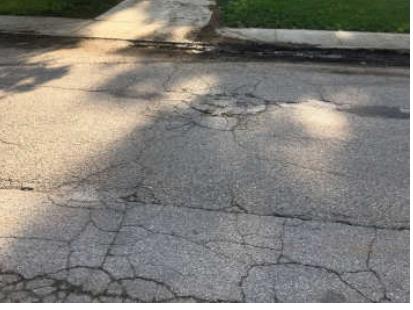
3934	Growing pavement cracks

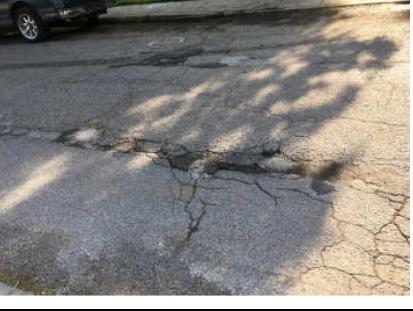
3923	Pavement deteriorating

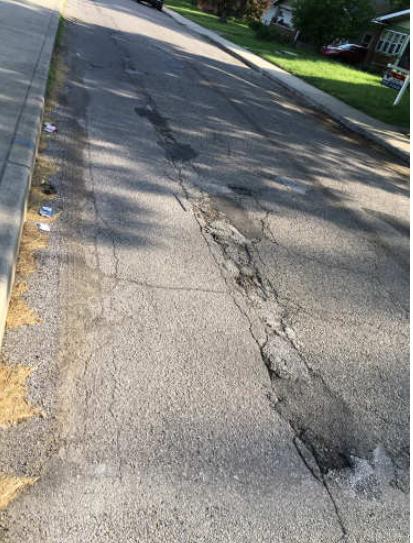
3923	Major pavement cracks

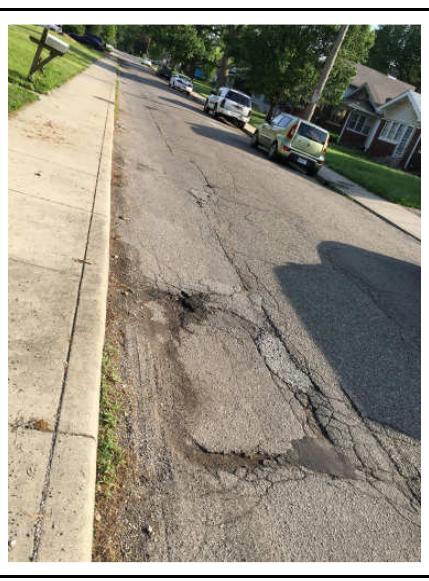
3860	Terrible street with excellent sidewalks

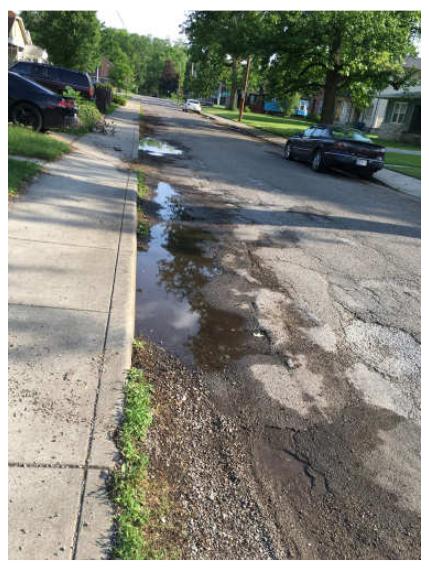
3843	Gravel illustrates severe deterioration of asphalt street

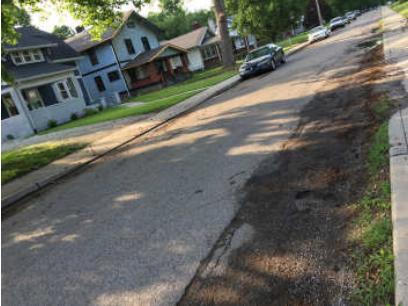
3843	Near total deterioration of roadway

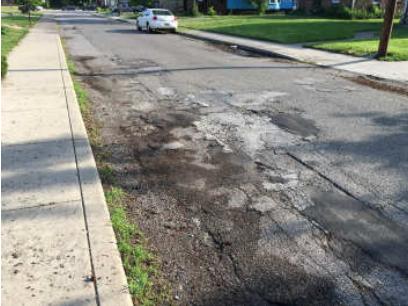
3839	Near total deterioration of roadway

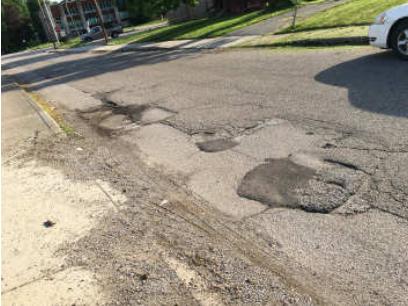
3831	Patching attempts but pavement breaking apart leaving aggregate

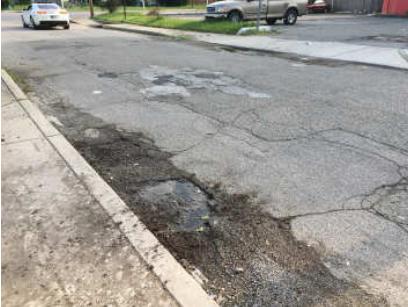
3818	Curb lane potholes are endemic

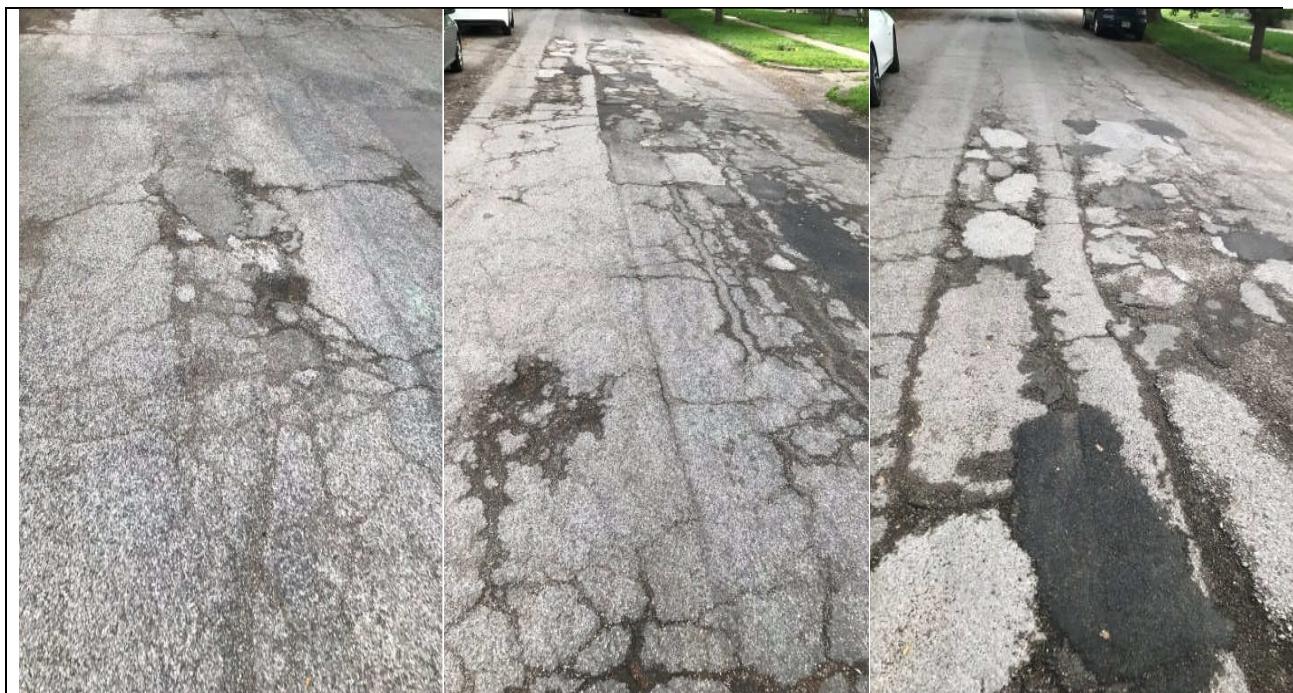
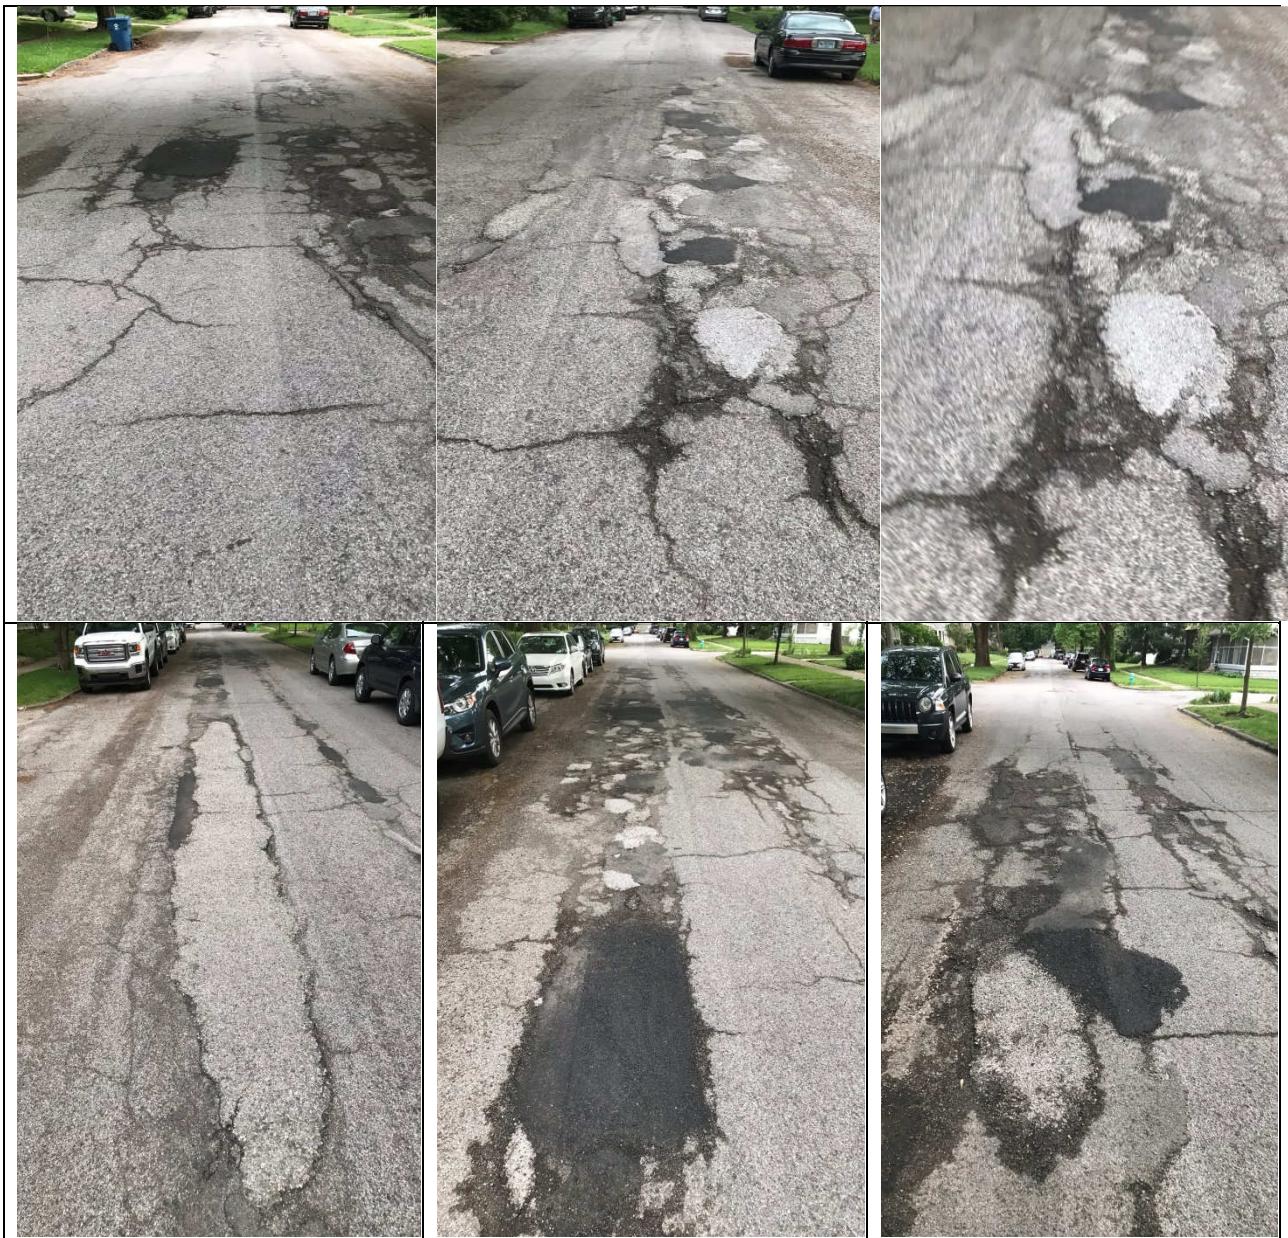
Sequential photos beginning at 56<sup>th</sup> Street and moving south to 54<sup>th</sup> Street are provided. As one can see, although recently patched, one can see the multiple patching that has taken place year after year. View from left to right, then top to bottom for the progression of photos. Photos were taken the week of May 14, 2018 after DPW had patched many of the potholes and cracks.

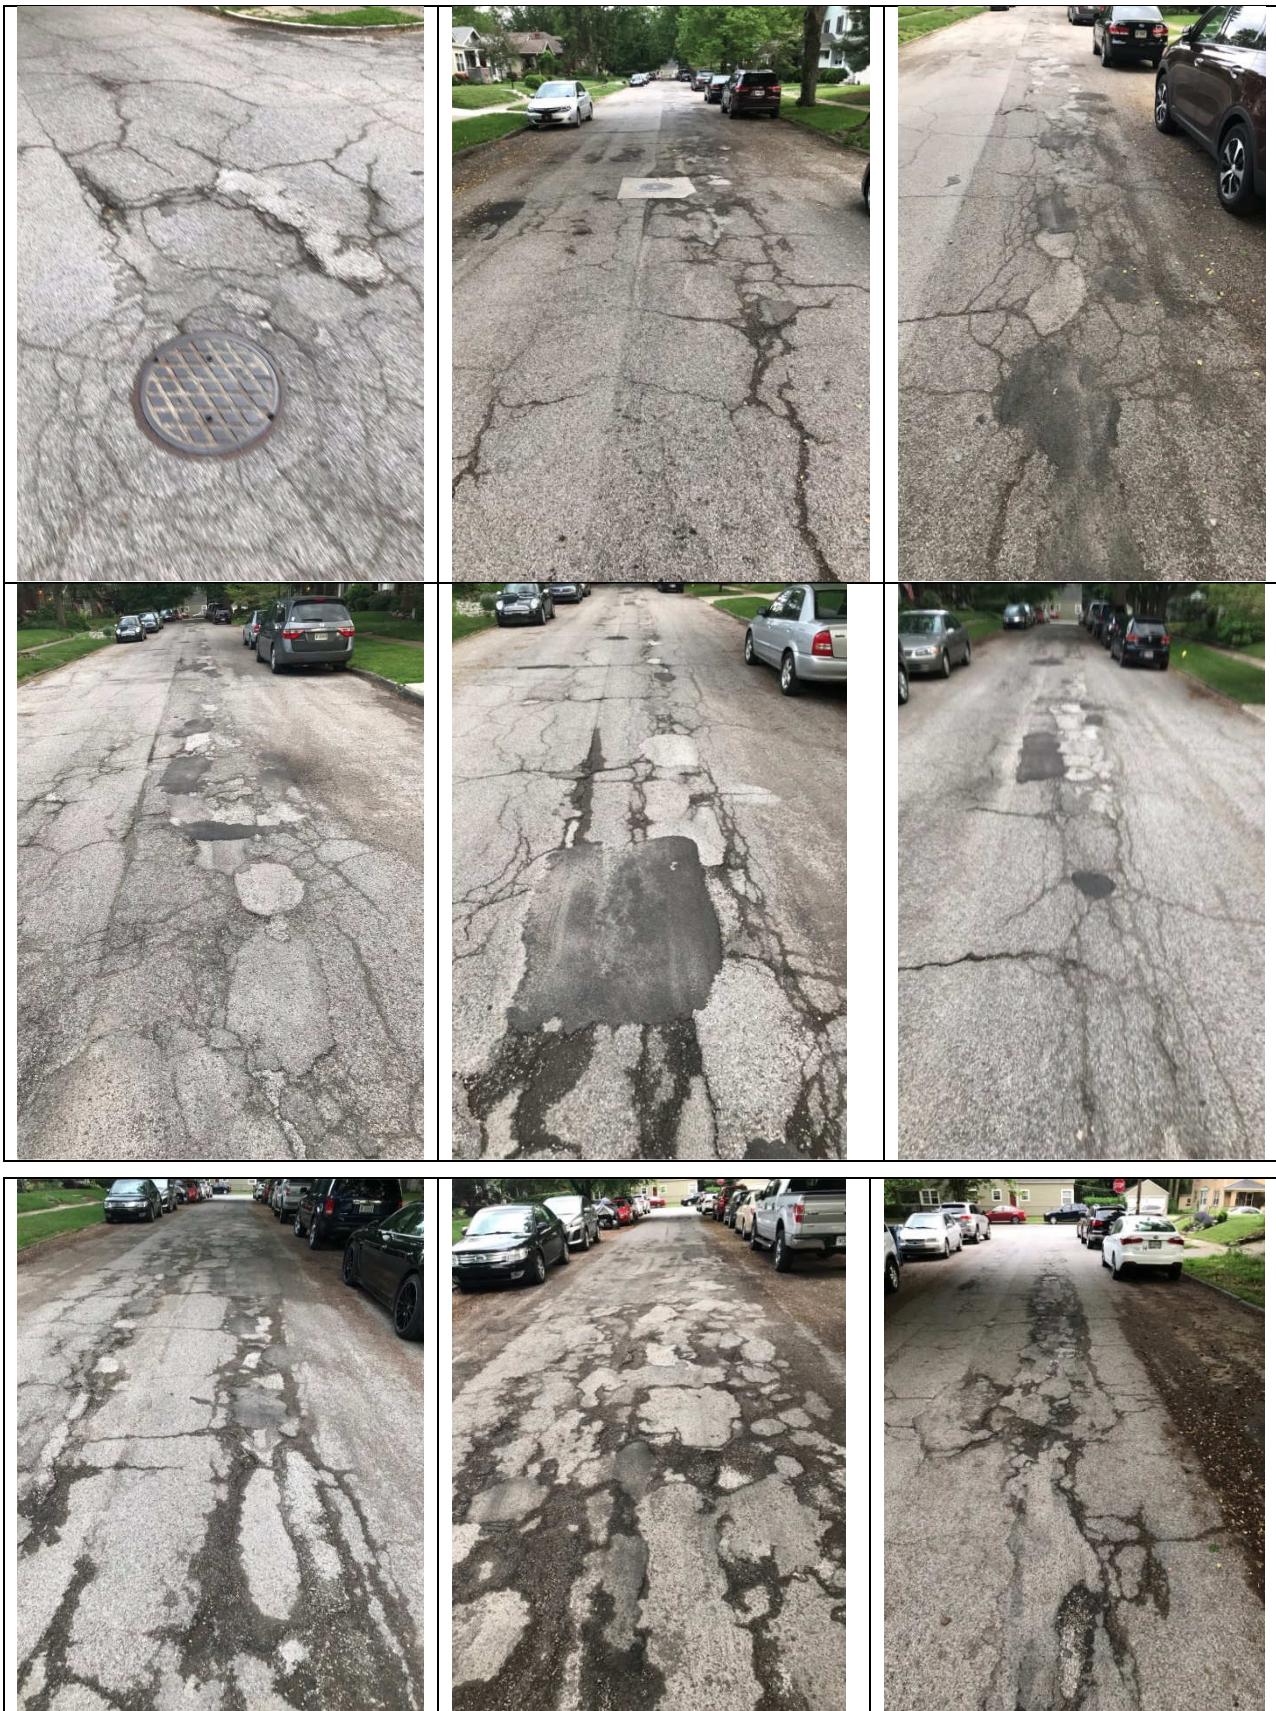
This section of Carrollton Ave has been deteriorating for years. This section of road is pockmarked by continuous potholes, large and small. It has been patched and re-patched multiple times due to pavement deterioration and cracking. Every winter the pothole patches fail and the street becomes more difficult to traverse. This street has been reported year after year but ignored. Now is the time to repave it. **This is only a 2 block distance!**

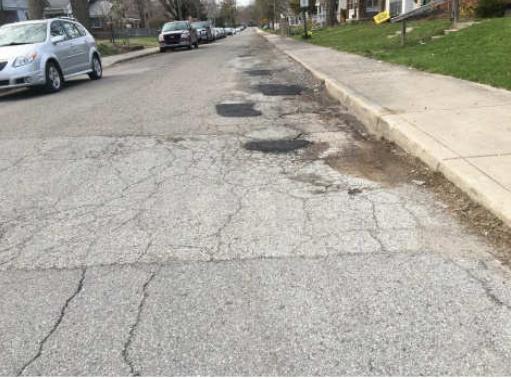
4600-4607	Extensive cracks and filled potholes along east side of road create very uneven pavement and hazardous conditions when potholes reopen.

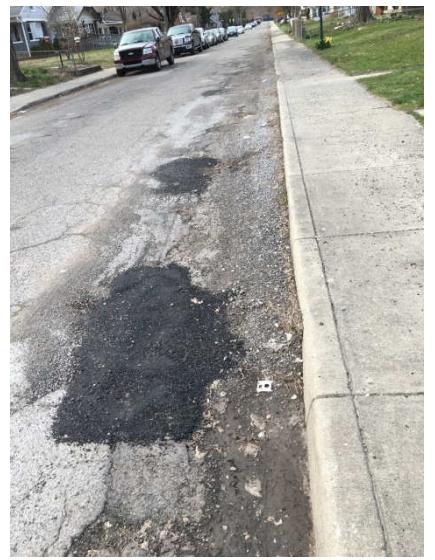
4601	<p>These conditions continue through the entire stretch of 46th-49th St.</p>

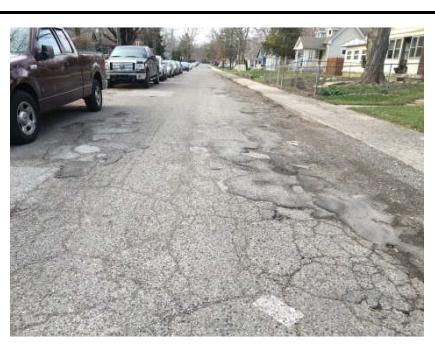
4607	<p>In addition to the potholes and general road deterioration themselves, Winthrop Ave. also has a noticeable slant, with the east side of the street lower than the west side. This is likely a factor for the poor condition of that side specifically, since water tends to pool in the depression along the east.</p>

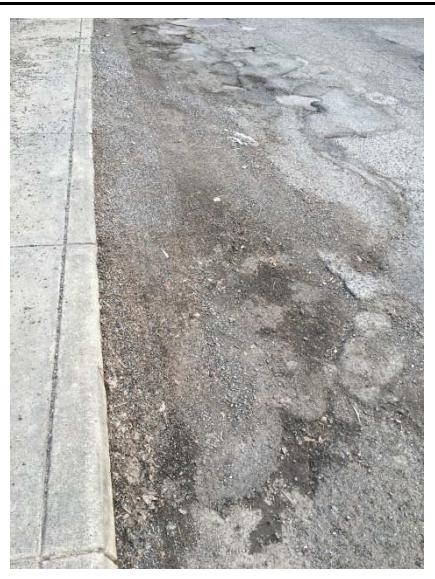
4611	<p>This close-up view shows how the sheer amount of gravel debris from the deteriorated surface and pothole patches is sidewalk-high (5-6 inches) in many areas, further contributing to the uneven, hazardous drive, as well as to the pooling of trapped water.</p>

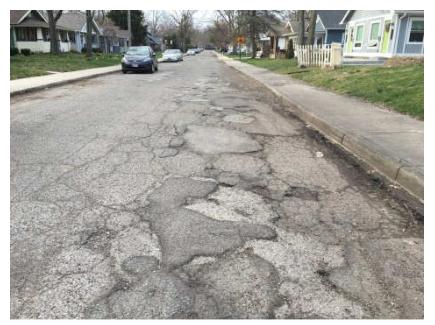
4702	Road continues to be pockmarked by pothole patches from past seasons.

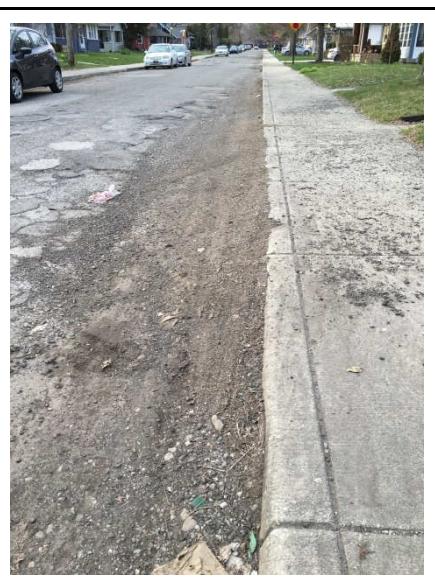
4702	Another example, just before the 48th St. intersection, of large humps forming from asphalt debris.

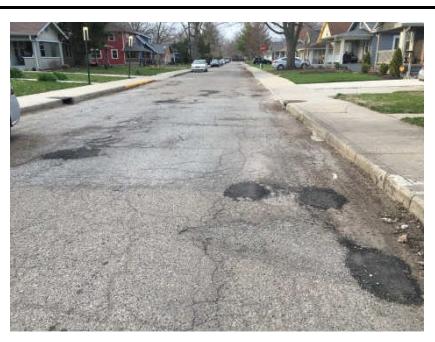
4710	More examples to show the extent of the cracking, potholes, and poor road condition.

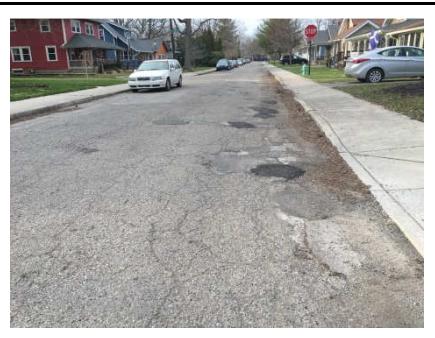
4718	More examples to show the extent of the cracking, potholes, and poor road condition.

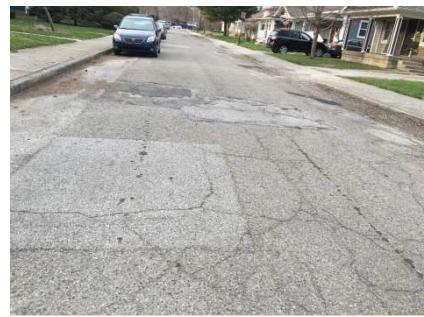
4802	<p>Though the east side of the road is clearly the worst, the poor conditions, including cracking, occasional potholes, and surface raveling, do also appear on the west side of Winthrop, as the picture taken in a gap between parked cars shows.</p>

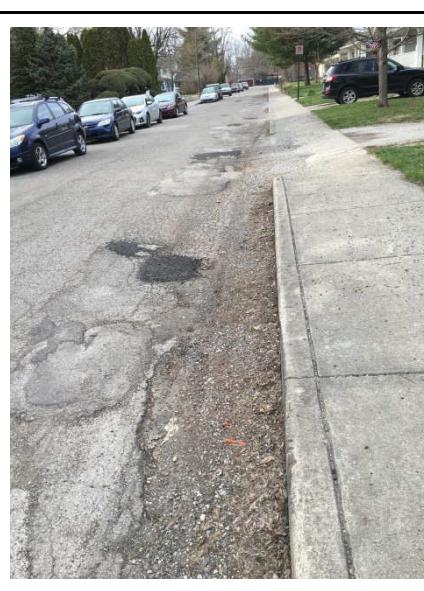
4805	<p>More examples to show the extent of the cracking, potholes, and poor road condition, including debris.</p>

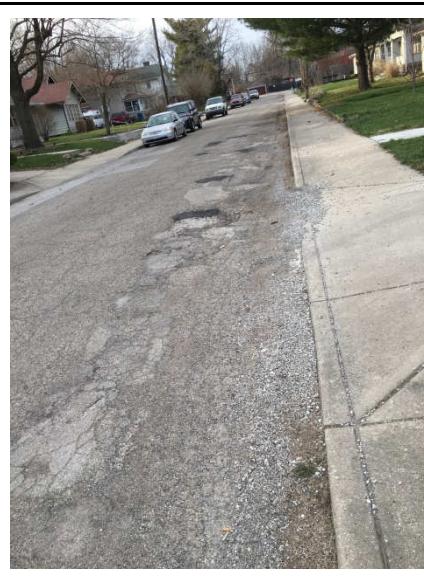
4815	<p>More examples to show the extent of the cracking, potholes, and poor road condition.</p>

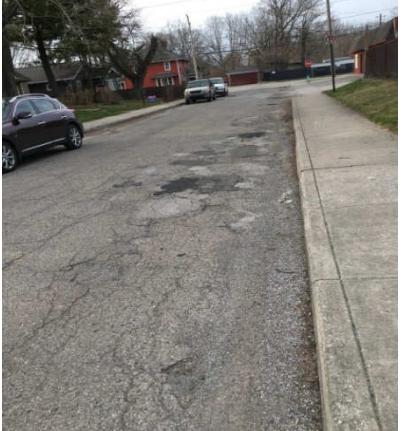
4837	The road condition continues to worsen as it gets closer to 49th St.

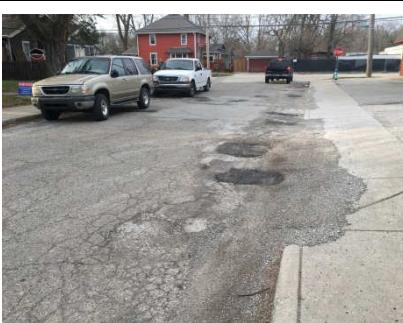
4845-4851	Road condition is especially poor in front of Winthrop Supply Co., which sees heavy traffic. Pictured is their driveway on the right side, leading into Winthrop Ave.

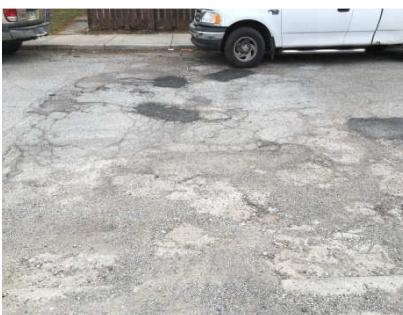
4851	Condition of road looking across from Winthrop Supply Co.

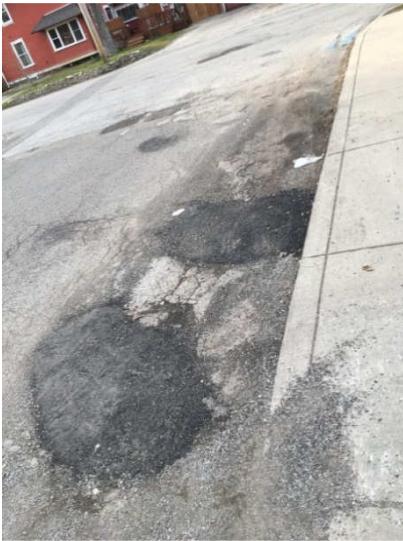
4851	Condition of road just before corner of Winthrop Ave. and 49th St., standing in front of Winthrop Supply Co.

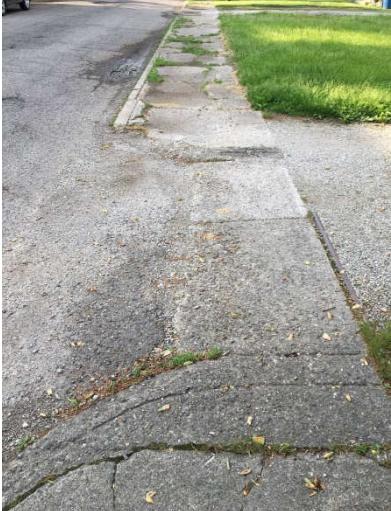
5011 E	<p>There are many driveways, especially on the east side of Winthrop from 50th to 52nd, with non-ADA crossings (too steep slope or simply a curb with dropoff).</p>

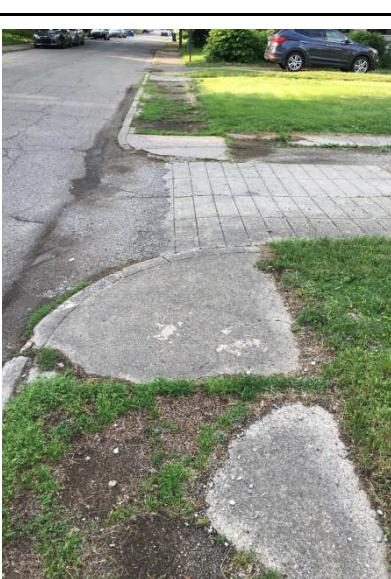
5019 E	<p>Driveway crossing with no accessibility</p>

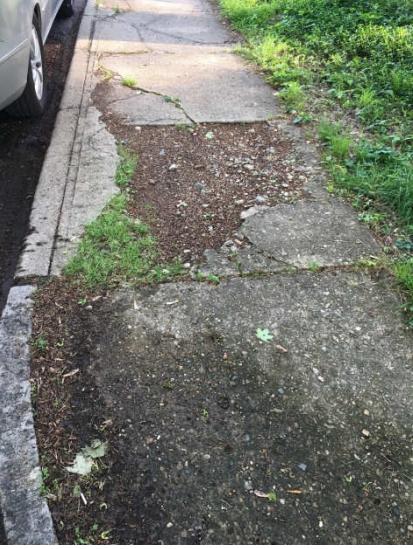
5028 W	Sidewalk panel completely deteriorated

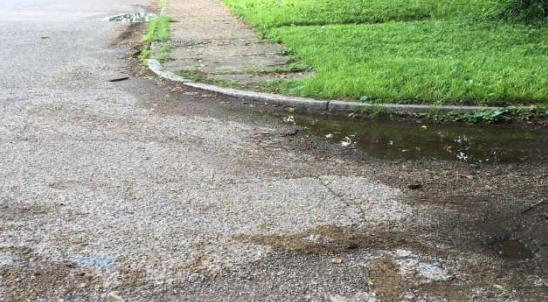
5028 W	Again at Winthrop and 51st St., all 4 corners are non-ADA compliant. No ramp at all.

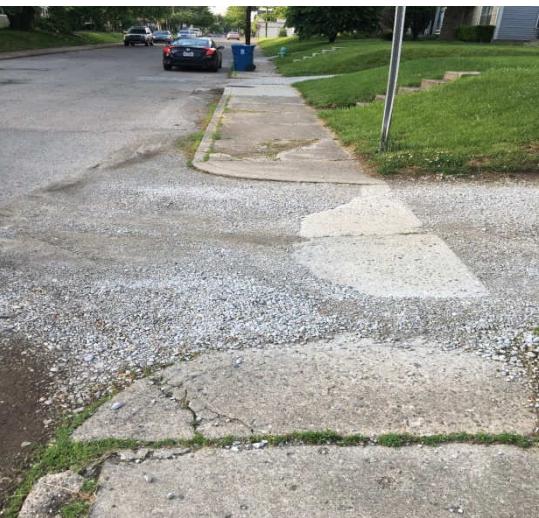
5125 E	Inaccessible driveway crossing

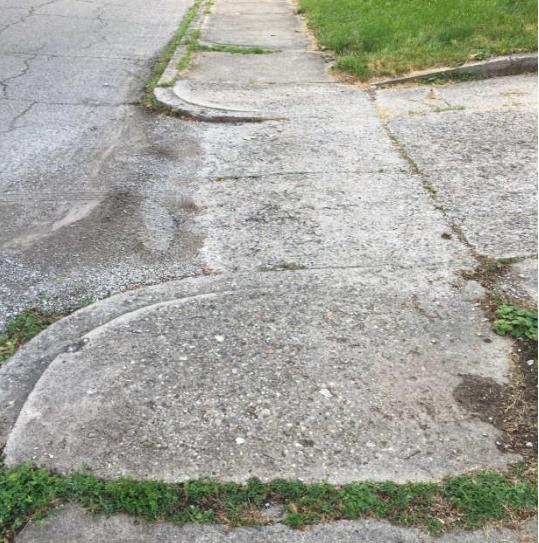
5147 E	Inaccessible driveway crossing

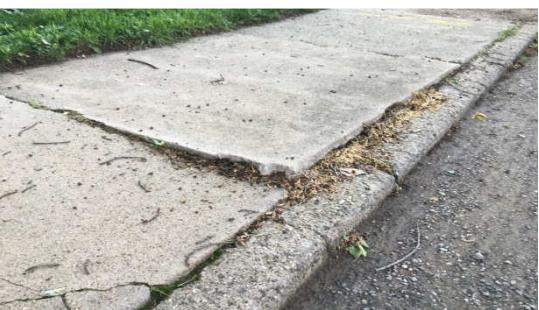
5140 W	1-inch vertical displacement of sidewalk panel

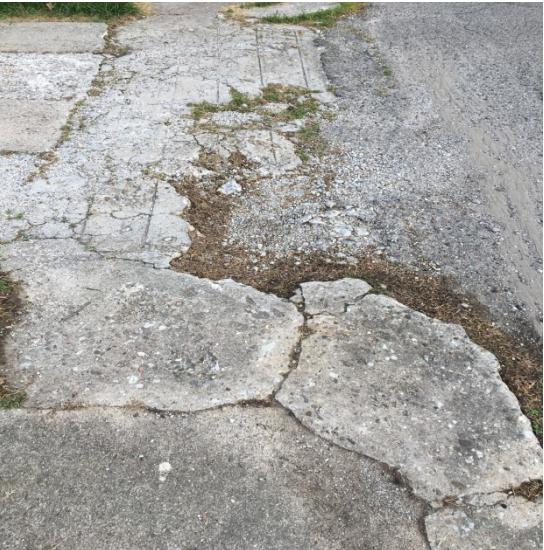
5155 E	Inaccessible driveway crossing with curb and also broken pavement

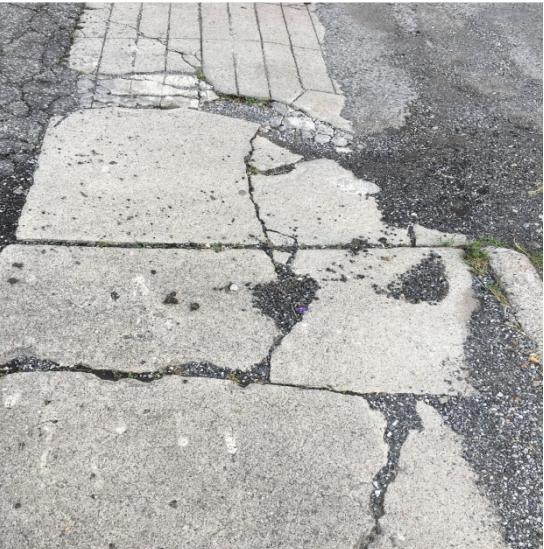
1055 E (52nd)	Inaccessible driveway crossing

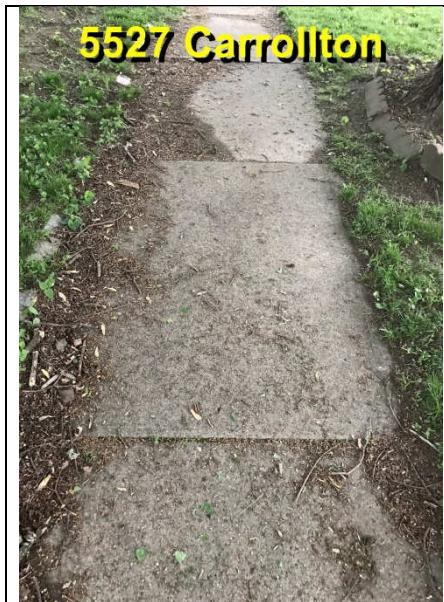
5527 Carrollton

Sidewalks on both sides have many trip hazards with many panels badly broken or heaved or both. Spalling is common. Walking on or using these sidewalks is hazardous for a baby stroller, walker, or a disabled person. There are no ADA ramps at the intersections with streets.

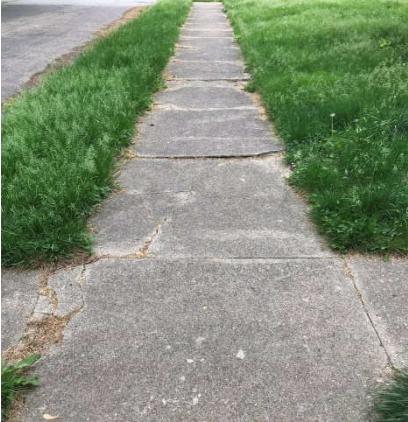
N	5655 College Ave along Northview Ave looking West	Sidewalk has multiple cracked panels that need to be replaced to avoid trip hazard and allow safe use by a disabled person

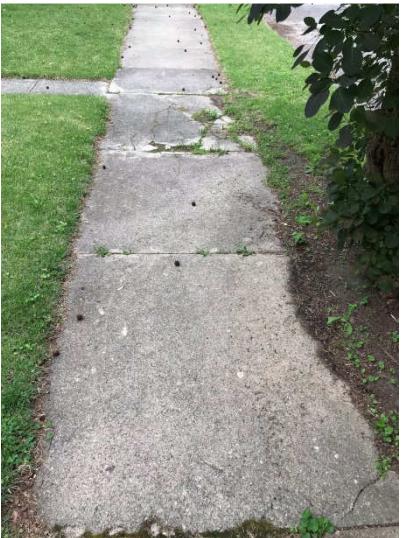
N	722 E Northview Ave	Sidewalk panels broken and creating a trip hazard

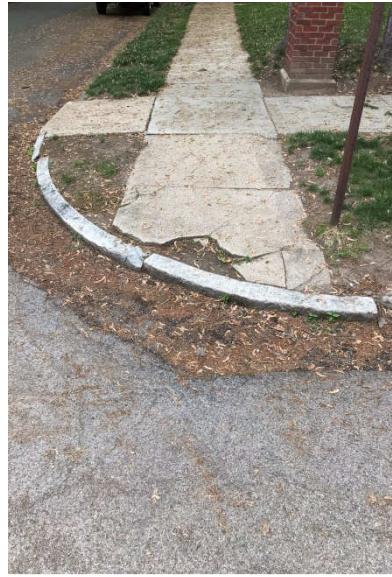
<p>N</p> <p>NW corner of Carrollton Ave and Northview Ave</p>	<p>Panel at curb is broken and cracked creating a trip hazard. No ADA ramp for accessibility by a disabled person</p>

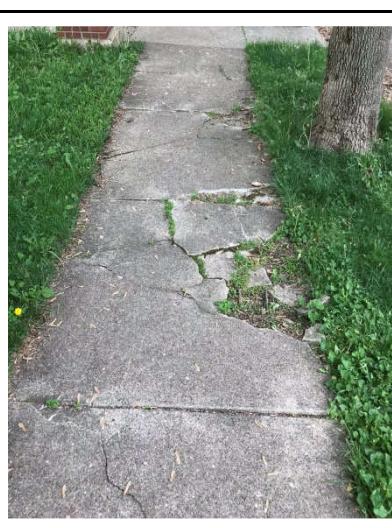
<p>N</p> <p>5633 Carrollton Ave on Northview Ave side close to Carrollton Ave</p>	<p>Panels broken creating a trip hazard and difficulty for a disabled person or someone with a stroller or a walker</p>

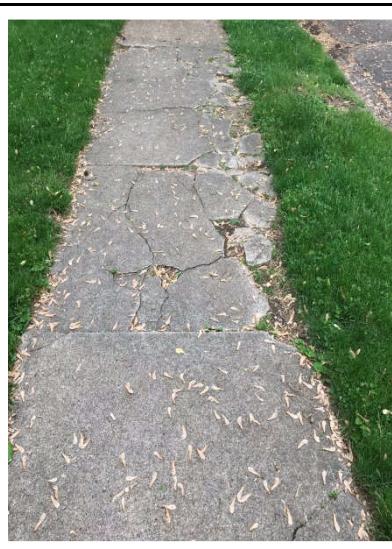
<p>N</p> <p>5633 Carrollton Ave on Northview Ave side further east of Carrollton Ave</p>	<p>Panels broken creating a trip hazard and difficulty for a disabled person or someone with a stroller or a walker</p>

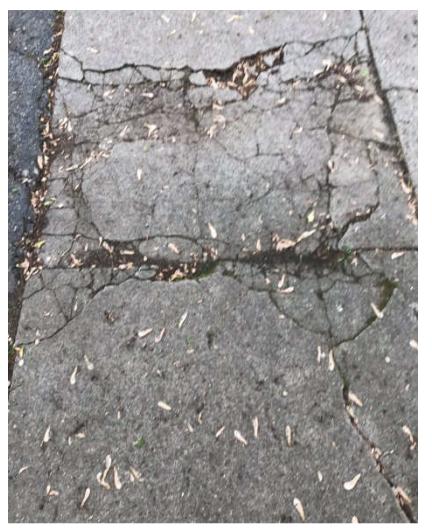
N 5633 Carrollton Ave on Northview Ave side further east of Carrollton Ave near 820 E Northview	Close up of broken panel creating a trip hazard and difficulty for a disabled person or someone with a stroller or a walker

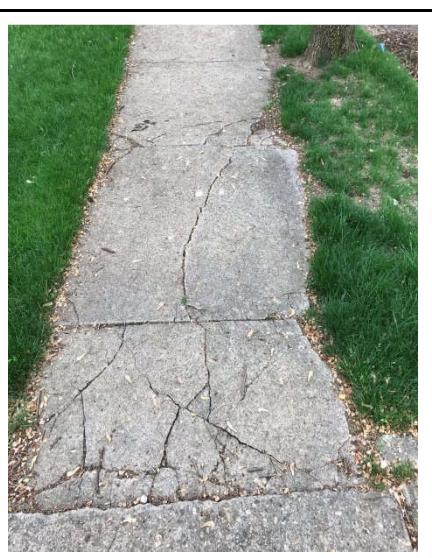
N 820 closer to Guilford	Broken and deteriorated panels creating disabled access issues, trip hazards, and difficulty for strollers or walkers.

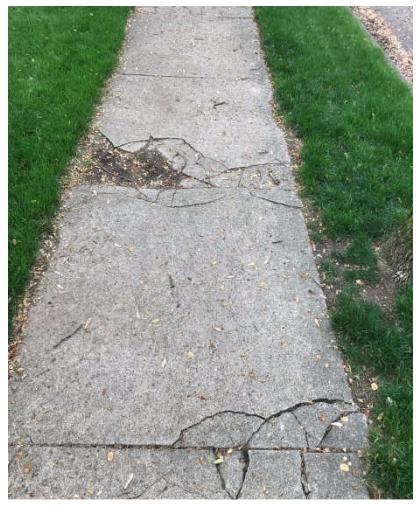
N	920 E Northview	Badly broken panels needing replacement; trip hazard and impediment to wheeled devices

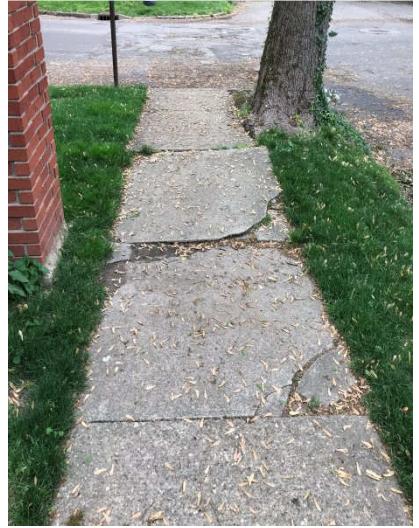
N	At NW corner of Northview at Winthrop Ave (5660)	Panels broken and heaved by tree resulting in trip hazard and being impassable by a stroller, walker or wheelchair. No ADA ramps at Winthrop for access to Monon Trail

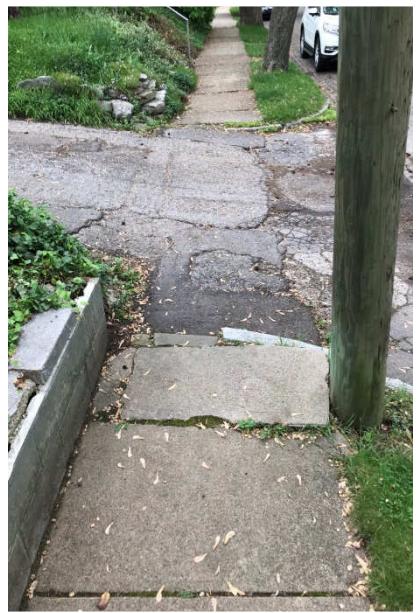
S	Alley ramp at 915 E Northview	Sidewalk panels on either side of alley are damaged and cracked. Alley ramp is not ADA compliant and breaking apart.

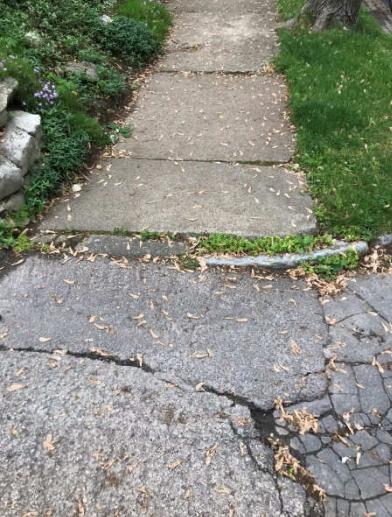
<p>S      851 E Northview at west end</p>	<p>Alley ramp is not ADA compliant and panels adjacent to alley have heaved causing trip hazards</p>

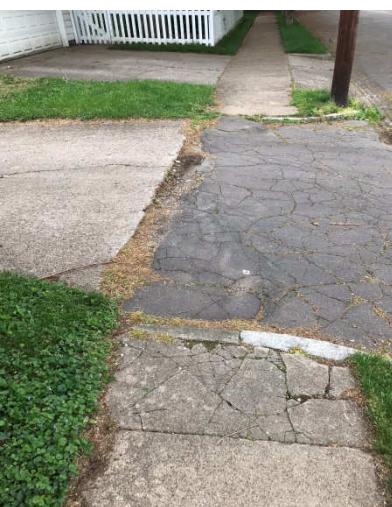
<p>S      723 E Northview</p>	<p>Curbs at alley are not ADA compliant making sidewalk unusable by a disabled person with a wheeled device. Panels on east side of alley is broken and unsafe.</p>

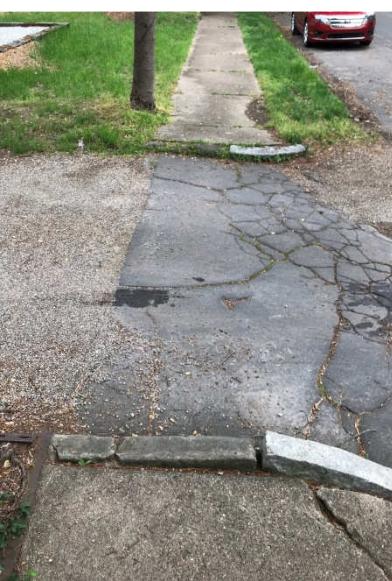
<p>S      Driveway entrance at 715 E Northview</p>	<p>Curb cuts are not ADA compliant making sidewalk almost unusable for a disabled person with a wheeled device.</p>
