QREF 13/12/2025-2
Kind Attn: Ms. Tara Gearing	SUBJECT: Fresh Air Duct Repair
E-Mail: taragearing@hotmail.co.uk	Location: Main Majlis (Dehumidifier Unit)
DATE: 13/12/2025	E-Mail: mes@mes.qa

DEFECTIVE PART DISCRIPTION

Equipment:-	DE-Humidifier	Location:-	Main Majilis (Outdoor Machine Area)
Part Name:-	PIR DUCT	Date:-	12/13/2025

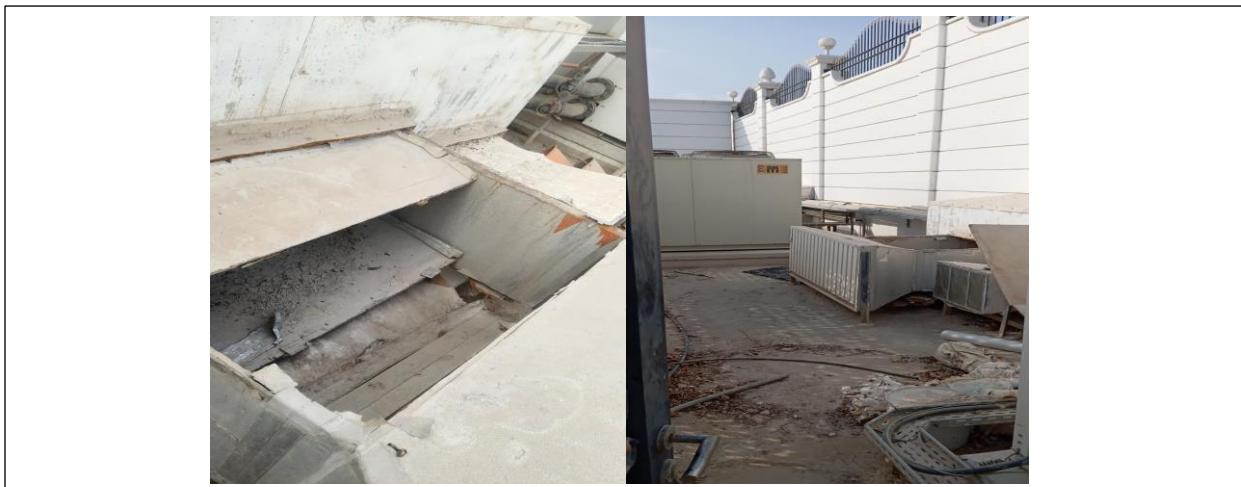
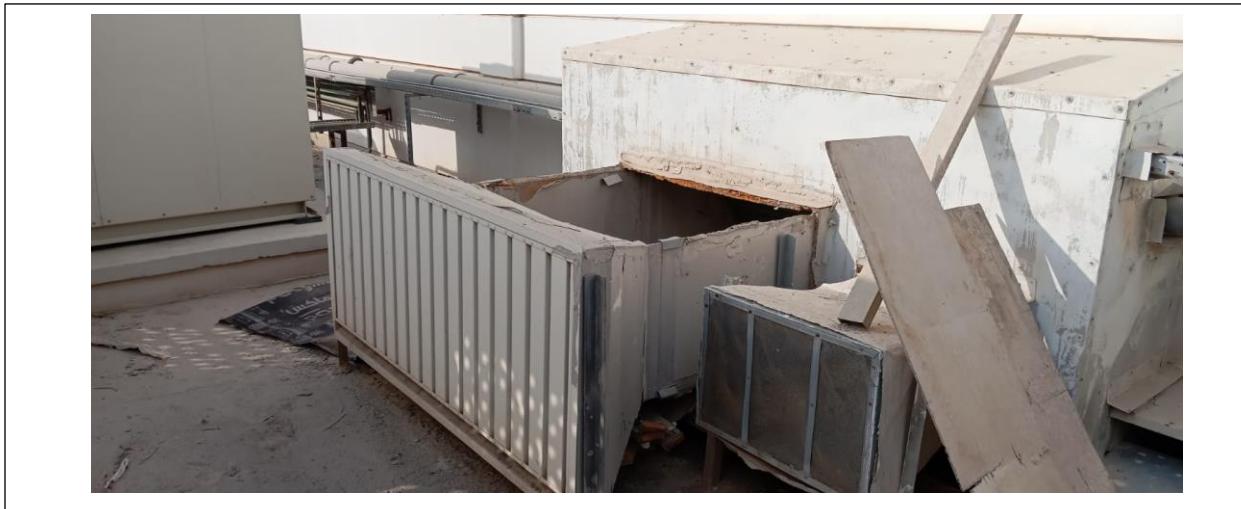
PICTURE OF DEFECTIVE DUCT: -

DISCRIPTION OF ISSUE OBSERVED: - During Service of condensing units noticed that **FRESH AIR DUCT** appears to be broken or fractured near its midpoint, this damage creates a direct & exposed opening, significantly increasing the risk of rainwater infiltration directly into Main Majilis basement mechanical room.

Sr.	
1	Fresh Air Duct Repair
PRICE FOR ABOVE Q.R. 374 + 7% = <u>400 Q.R.</u>
