A robotics and computer-aided procedure for defect evaluation in bridge inspection

Francesco Potenza¹ · Cecilia Rinaldi¹ · Erika Ottaviano² · Vincenzo Gattulli³

Received: 30 October 2019 / Revised: 29 February 2020 / Accepted: 20 March 2020 / Published online: 4 April 2020
© Springer-Verlag GmbH Germany, part of Springer Nature 2020

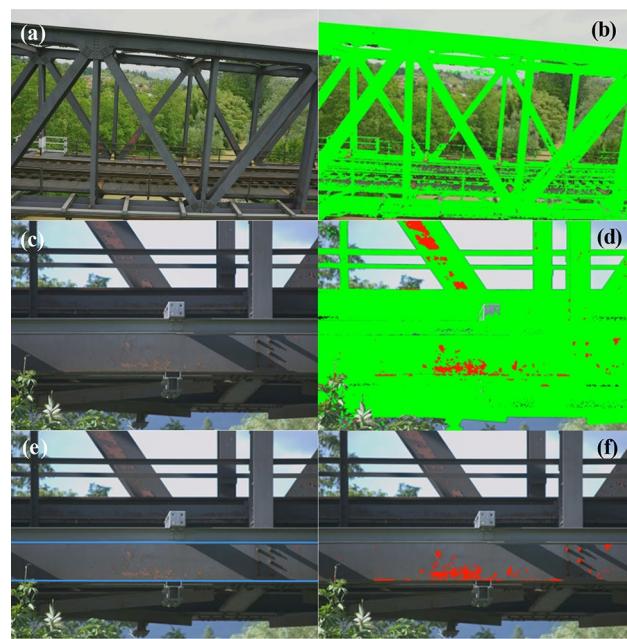
Figure 5a, c and e are related to the original images while Fig. 5b, d and f are the processed ones. Three different targets have been pursued in these analyses: in the first case (Fig. 5a, b) only the element recognition, in the second both element and defect, while in the third one only defect. It is worth to note that in all processed images, the green color is referred to the element, while the red one to the defect. This is only a choice of the authors to better identify and highlight the corresponding areas and so it has no relation with the RGB values.

In particular, in Fig. 5d it is shown the ability to capture also paint absence in structural elements not in foreground as the red area found also in the diagonal brace in the background.

Fig. 5 Steel bridge A: **a**, **c** and **e** original and **b**, **d**, and **f** processed images: structure and defect recognition

Instead, the third processing concerns only one structural element, i.e. the longitudinal and horizontal beams picked out by the blue lines in Fig. 5e. In this case, the method can be also used to investigate the evolution of a local material degradation.

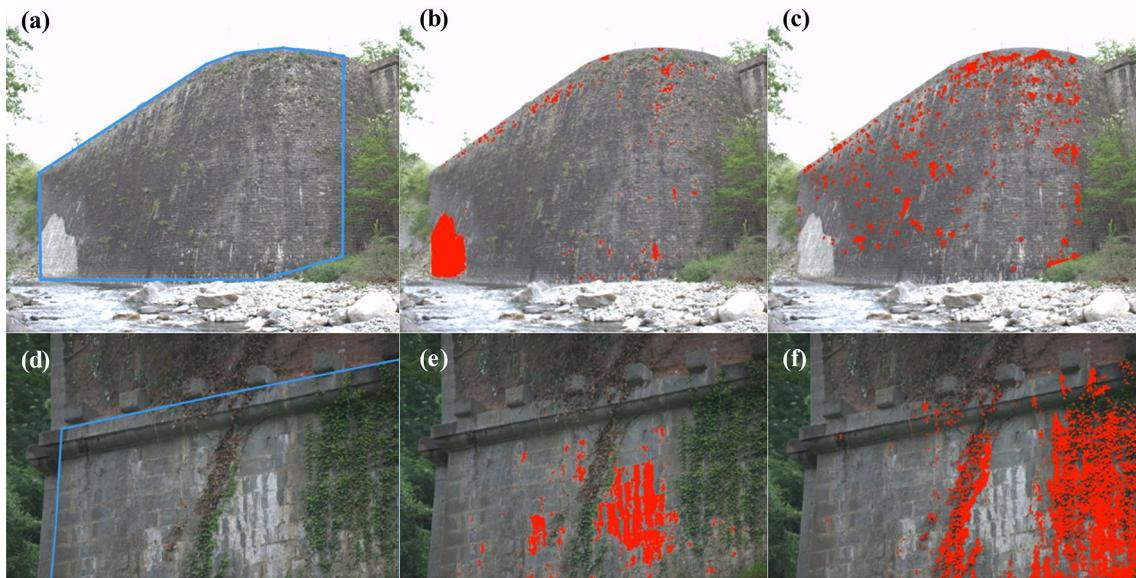
Figure 6 shows the obtained results in the defects analysis conducted on the masonry retaining wall of the shoulder and the pier of the arch for a masonry bridge. Even in this case, in Fig. 6a and d the original images are given. The aim of the image processing is to show the ability of the procedure to recognize two typical masonry defects: contemporary presence of both efflorescence and vegetation. The exact area to be investigated has been indicated by a contour with blue lines (Fig. 6a, d). Fig. 6b, e try to identify the efflorescence. In the literature, this physical effect is related to the migration of a salt on the porous masonry surface phenomenon where it forms a coating. Usually, these occurrences are transient events especially at the end of the construction phase but they can become chronic due to the presence of the surrounding terrain, behind the porous material or due

Fig. 6 Elements and defects of masonry bridge B and C: **a, d** original images, **b, e**, efflorescence, **c, f** vegetation

to polluted rains. In particular, this damage is primarily aesthetic, but it can induce also degradation in the mortar and bricks. For example, in Fig. 6a is well-visible a wide zone affected by efflorescence (lower left) while other smaller parts are spread especially in the top of the masonry. Such areas have been taken looking to the results in Fig. 6b. For the same image, the vegetation is widespread in all surface and even in this case there is a correspondence between defect and the highlighted pixels (Fig. 6c). Interesting it is to note how in the masonry C (Fig. 6d) the efflorescence defect is collocated between two areas defected by vegetation.

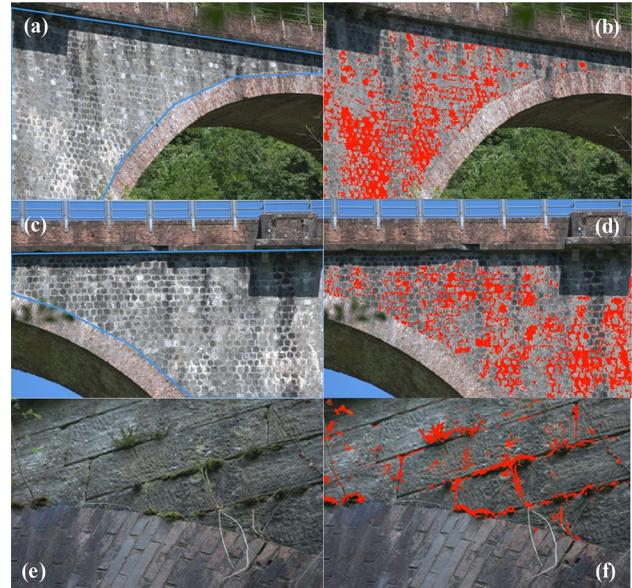
The defect highlights the shape of the brick and it is clearly identified in the corresponding processed images (Fig. 7b, d). In the left part of Fig. 7c and d, where is depicted the masonry arch, a portion of the element is hidden by leafs that are in foreground and blurred due to the distance with respect to the observed object. However, the element for which the defect is evaluated is not affected by this disturbance. In Fig. 7e and f, the vegetation in the brick joints is precisely evaluated.

Fig. 7 Masonry bridge D: **a-d** original images and efflorescence defect. Masonry bridge E: **e, f** original image and vegetation defect

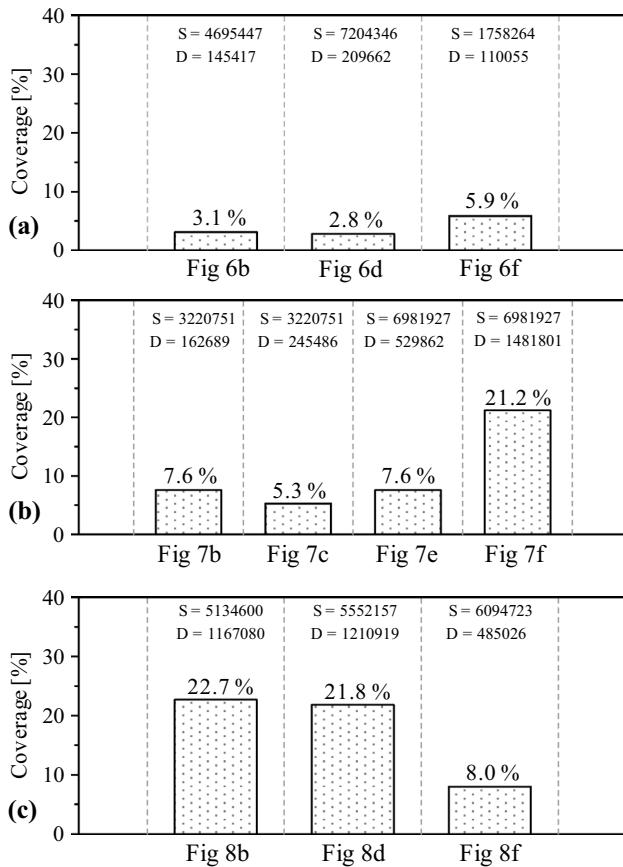
Figure 8 reports a quantitative evaluation of the defect extension conducted through the newly developed software DEEP. For each analyzed image previously presented, the percentage of surface covered by the defect has been calculated with respect to the relative structural element. Such

Fig. 8 Presence of the defect in percentage for the processed images. *S* and *D* indicate the number of pixels for structure and defect, respectively

to low portion of the area affected by the painting absence determining the percentage of defective area.

Differently, in Fig. 8b a relatively large portion of the considered element has been found affected by a defect of vegetation.

The result agrees with a rough visual estimation of the inspector, which can look directly at the original image (Fig. 6d). Instead, in Fig. 8c the displayed results show that looking at two different portions of the same bridge an exact comparison of defect extension can be done only through the proposed procedure, which permits to determine, in a situation difficult to analyze by the inspector, which is the portion of the bridge more affected by the efflorescence defect. The developed tool permits a fast evaluation of the defect extension based on the RGB method. The procedure appears reasonable for the aim of the entire process and for its capacity to be automated in the processing of a large number of images. The proposed DEEP software can be used for other types of defects, which are characterized by evident superficial color change by properly setting the ranges of the parameters.

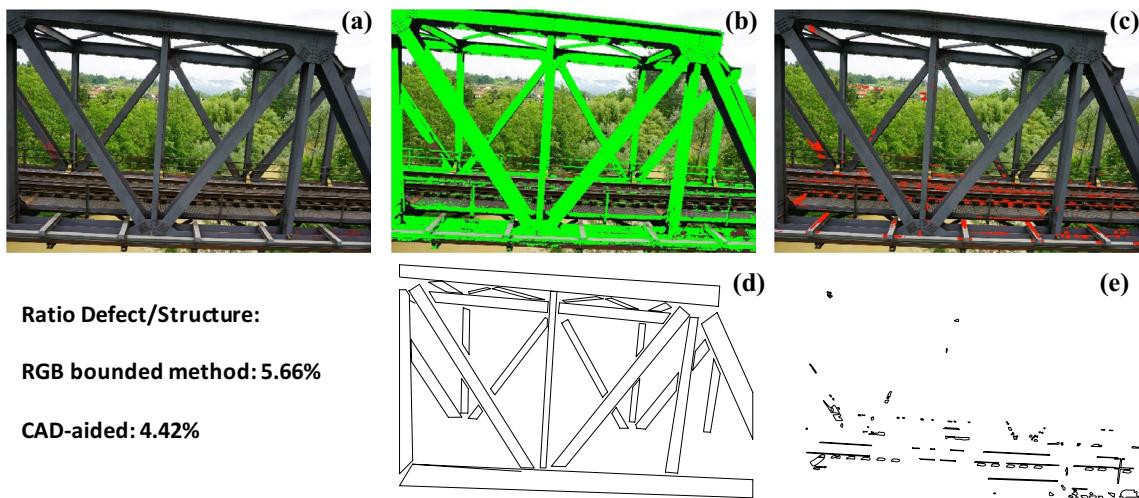
Figure 9 shows a comparison between the results obtained in the defect extension evaluation using the RGB bounded method (Fig. 9b, c) and a CAD-aided procedure (i.e. by tracing the edges of the structure and defect in computer-aided design, CAD, environment from the original image, as provided in Fig. 9d and e).

1. both methods depend on the image resolution;
2. regarding the area related to the elements, a manual selection provides more accurate results, while the RGB bounded one is faster;
3. differences between the two procedures can be assumed as minimal (indeed, the ratio between the defected area over the structure is 5.66% and 4.42% for the RGB bounded method and the manual one, respectively);
4. RGB bounded method provides a greater percentage value because a few number of pixels have been associated with other objects, highlighted in the background.

Fig. 9 Comparison between the results obtained through the RGB bounded method and a CAD-aided one: **a** original image, **b** structure and **c** defect detection in RGB bounded method; CAD-aided procedure: **d** structure and **e** defect

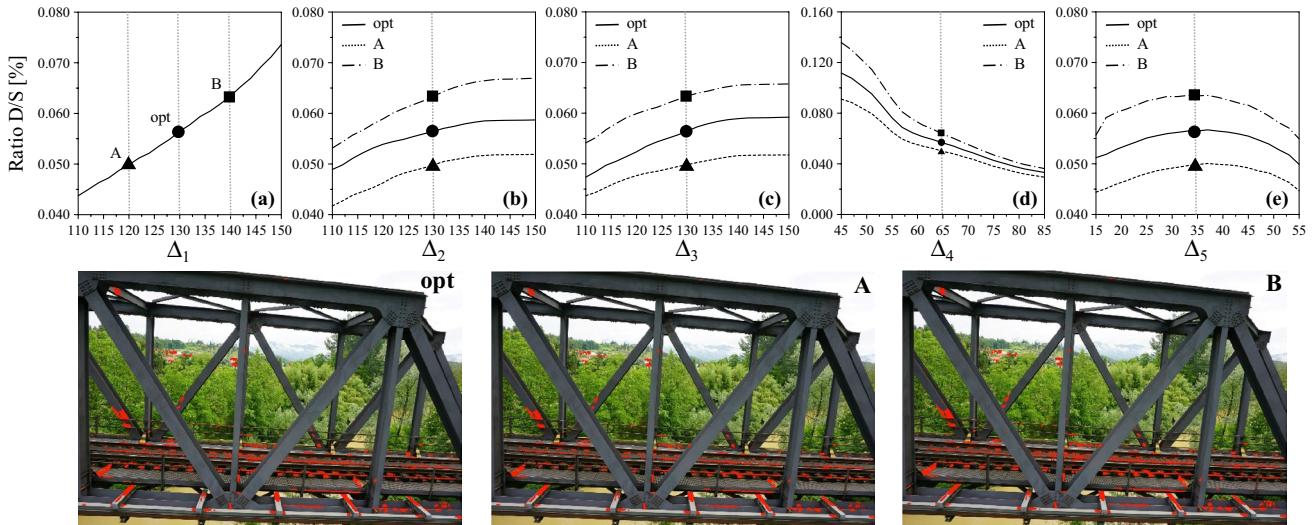
The defect percentage D/S has been evaluated by varying one of the range variable defined by Eqs. (4)–(8) and keeping the other ones fixed to the values used in Table 4. In Fig. 10 are reported the results of this analysis related to the case of the Paint Absence defect. Figure 10a shows the variation of the first variable Δ_1 corresponding to the interval of the red color of Eq. (1). The label “opt” is used for optimal value Δ_1 of the Paint Absence defect (in Table 4, $\Delta_1 = 130$). The label “A” represents the varied value $\Delta_1 = 120$ and “B” the varied value $\Delta_1 = 140$.

- from the first three figures, it can be observed that among the RGB-parameters, the one more sensitive to the analyzed defect extraction is the Red color.
- even if there are differences in the choice of the range Δ_1 (from 120, A-point, to 140 B-point) large changes of the evaluated damage percentage are not observed. Indeed, looking at the reasonable minimum and maximum val-

Fig. 10 Sensibility analysis of the Paint Absence defect conducted by varying the limits of the intervals in the Eqs. (1)–(3). The images below are related to the ranges defined in the corresponding of points opt, A and B

ues that should be considered, which are correspondent to the triangle and square symbols respectively, the difference in the obtained results in terms of defect extension is about 1%. This observation can be supported by looking at the processed images reported in the lower row of Fig. 10. The paths corresponding to the ranges of the A-point, opt-point and B-point are very similar each other in Fig. 10a–e.

3. when the range for the choice of the R-parameter is very large (B-point) the damage percentages assume the highest values vice versa in the A-point (narrow range).
4. finally, in the Fig. 10e three maximum points can be observed, one for each path. The optimum in the Δ_5 parameter is independent with respect to the other parameters, which is a feature that permits to highlight the importance of the introduction of the inequality expressed by Eqs. (2)–(3). The results indicate that the color pattern associated with the defect has its own structure.
