# Inspection of the *MV Example* to determine the level of biofouling and detect Invasive Marine Species

**Date:** 19 September, 2018

**Location:** Singapore Cruise Centre, Singapore

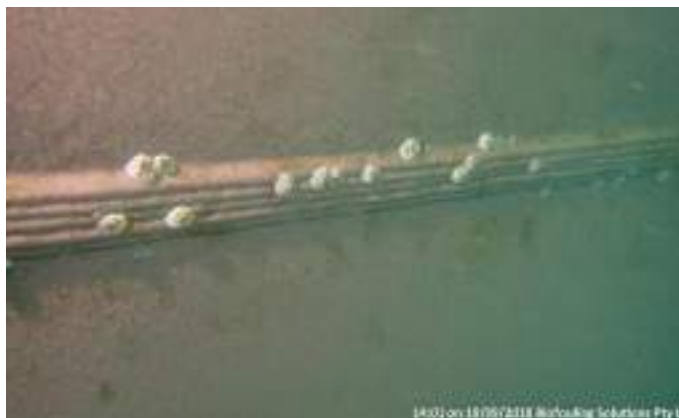
**Plate 1** Acorn barnacles >1% associated with weld seam. Forward of Frame 198, port, waterline to 5m.

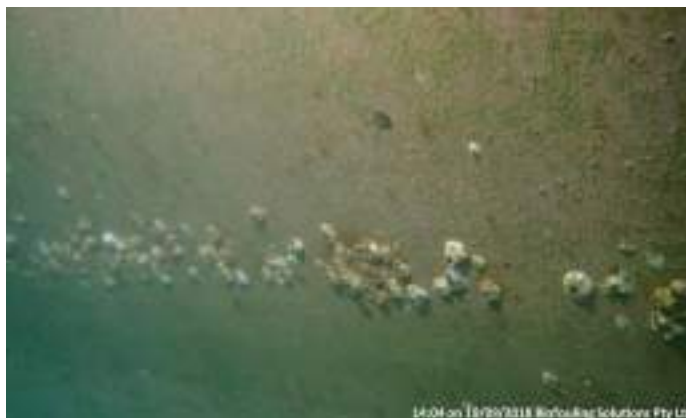
**Plate 2** Band of acorn barnacles >1%. Forward of Frame 198, port, waterline to 5m.

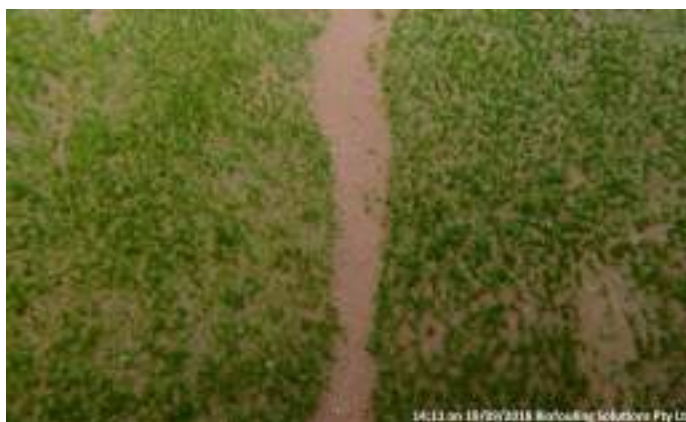
**Plate 4** Band of green algae. Port, waterline.

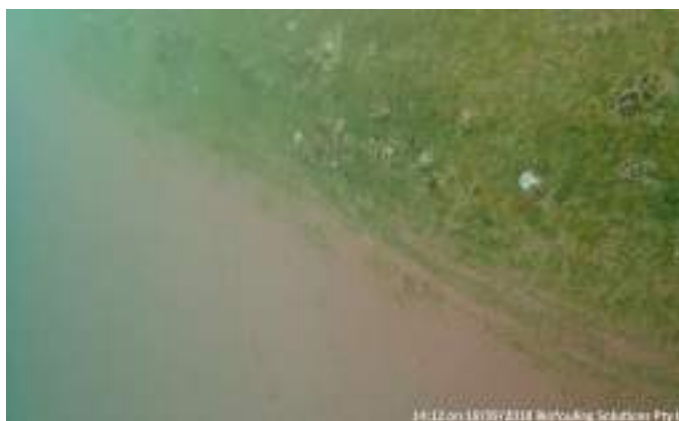
**Plate 5** Interface between band of biofouling and clean hull. Forward of Frame 198, port, Approximately 5m depth.

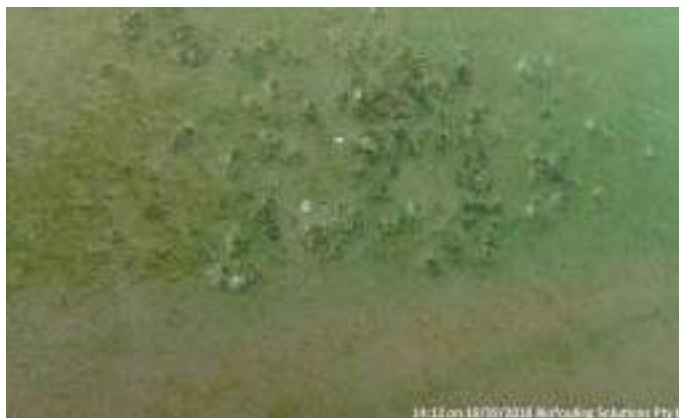
**Plate 7** Band of acorn barnacles >1%. Forward of Frame 198, starboard, waterline to 5m.

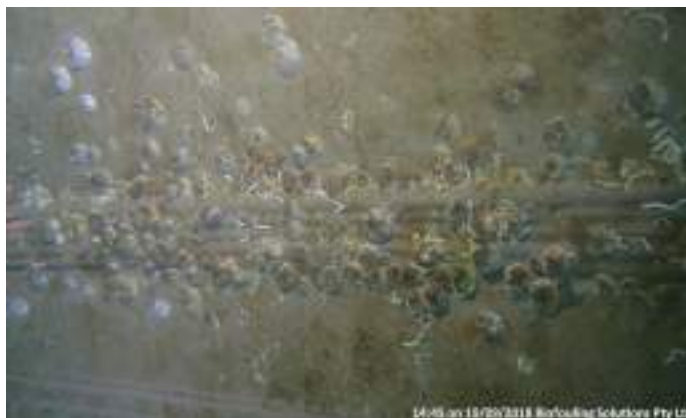
**Plate 8** Acorn barnacles and tubeworms >1% associated with weld seam. Forward of Frame 198, starboard, waterline to 5m.

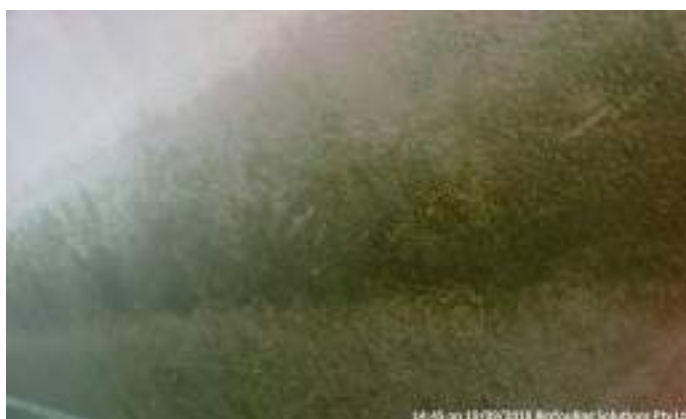
**Plate 10** Band of green algae without secondary biofouling. Starboard waterline aft of Frame 198.

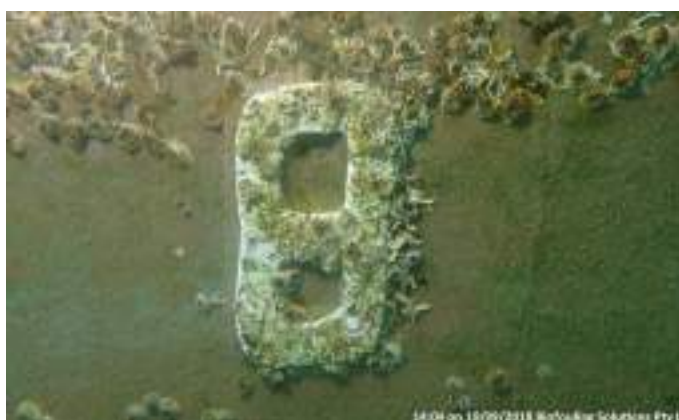
**Plate 11** Port side forward draft markers showing secondary biofouling > 5%.

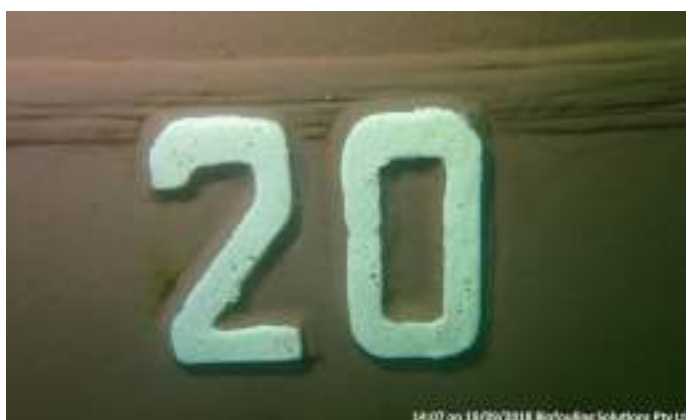
**Plate 12** Port side forward draft markers deeper than 5m with no secondary biofouling.

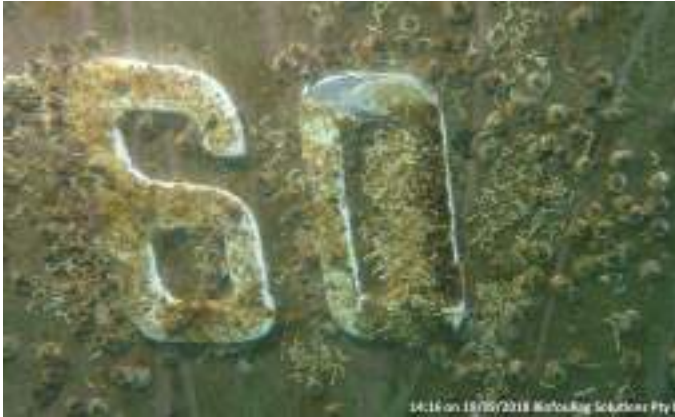
**Plate 13** Starboard side forward draft markers showing secondary biofouling > 5%.

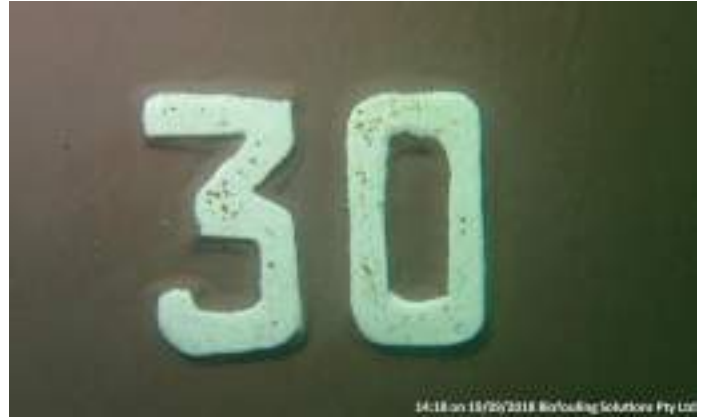
**Plate 14** Starboard side forward draft markers deeper than 5m with no secondary biofouling.

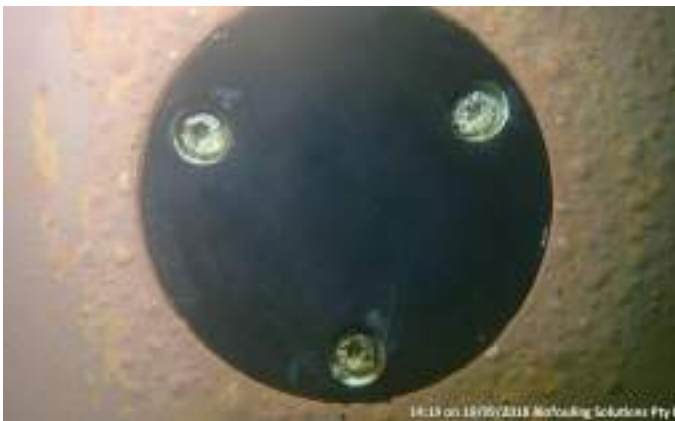
**Plate 15** Depth sounder with <5% secondary biofouling restricted to bolts. Forward amidships.

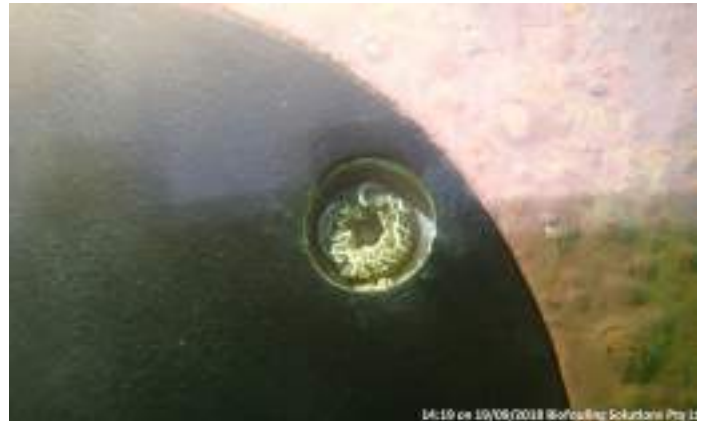
**Plate 16** Detail of secondary biofouling restricted to bolts of depth sounder. Forward amidships.

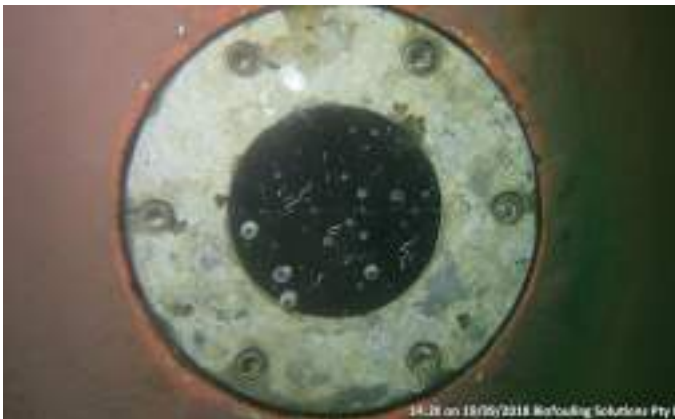
**Plate 17** Speed log with <5% secondary biofouling. Forward amidships.

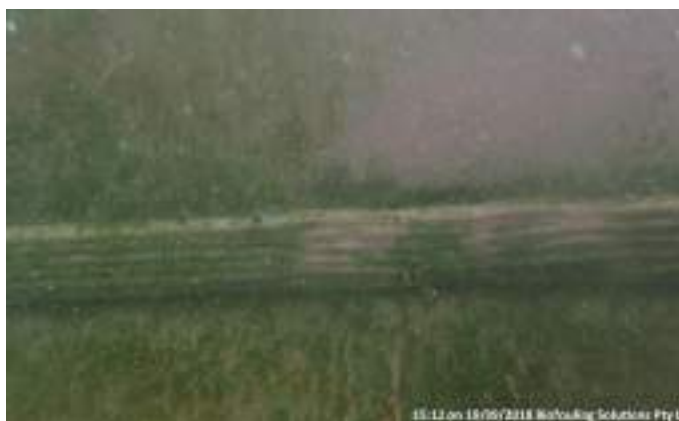
**Plate 23** Amidships waterline algae free of secondary biofouling. Port.

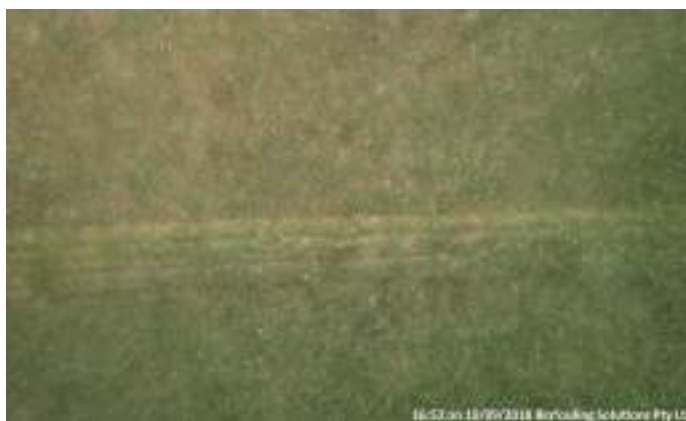
**Plate 24** Amidships waterline algae free of secondary biofouling. Starboard.

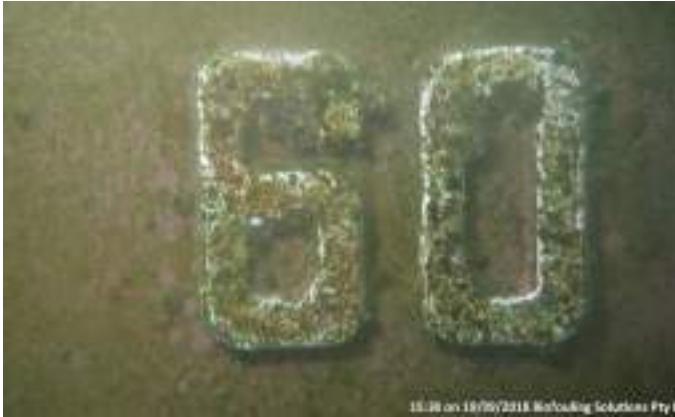
| Niche Type | No, inspected/<br>No. present | Biofouling Level<br>(C/P/S/T) <sup>5</sup> | Biofouling in excess of CRMS detected?<br>(Y/N) | Comments |
|---|---|---|---|---|
| Amidships Draft Markers | 1/2 | S | N | Port side draft markers inspected and found to have biofouling consisting of algae, barnacles (~5%) and tubeworms (~1%). As a niche area this is considered compliant with the CRMS thresholds for short-stay vessels. |

**Plate 25** Port side amidships draft markers showing secondary biofouling  $\leq 5\%$ .

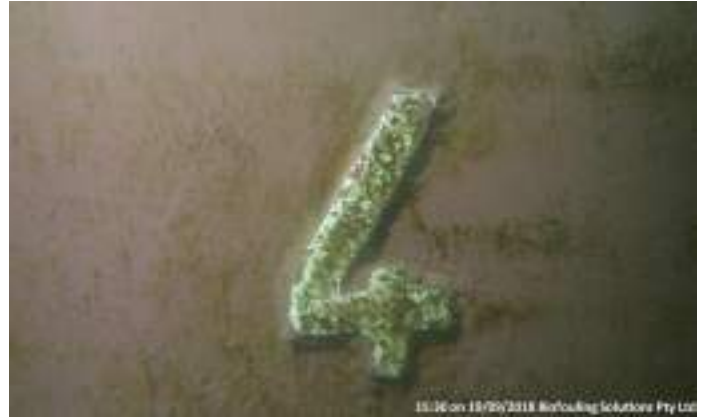
**Plate 26** Port side amidships draft markers showing secondary biofouling  $< 5\%$ .

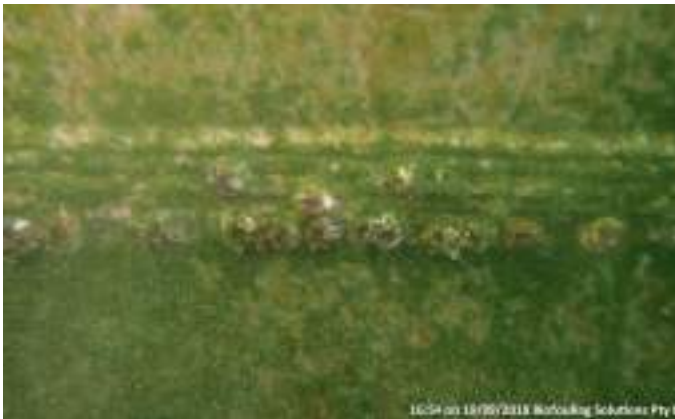
**Plate 27** Port aft shell plating with secondary biofouling  $>1\%$  associated with weld seam (aft of Frame 14).

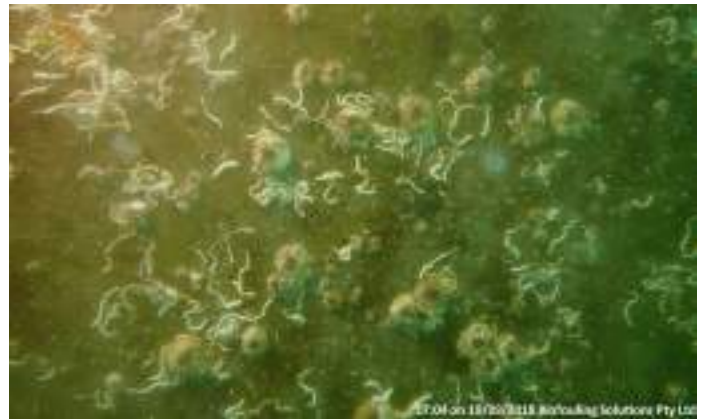
**Plate 28** Port aft shell plating with secondary biofouling  $>5\%$  associated with weld seam (aft of Frame 14).

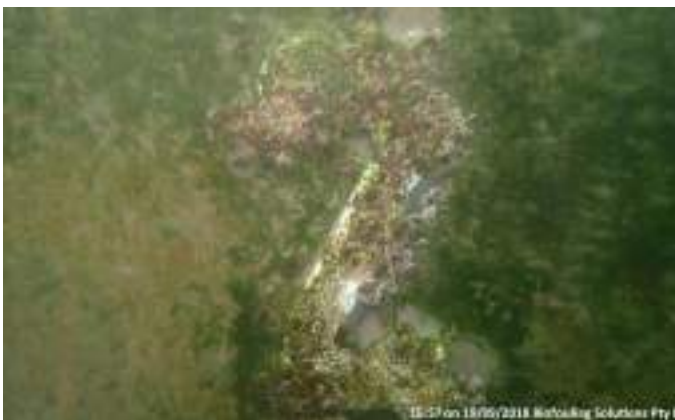
**Plate 29** Port side aft draft markers showing secondary biofouling  $> 5\%$ .

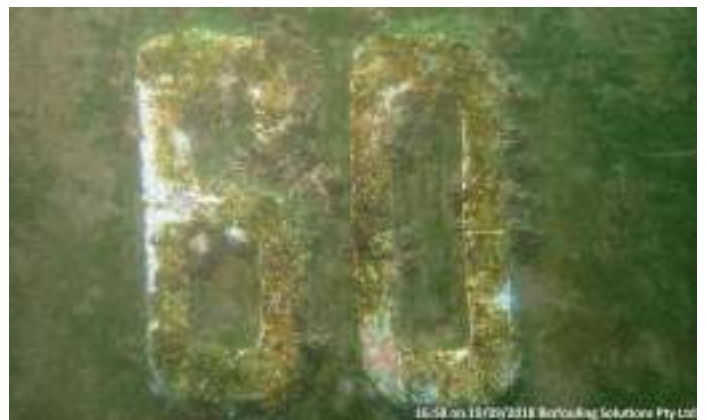
**Plate 30** Port side aft draft markers showing secondary biofouling  $> 5\%$ .

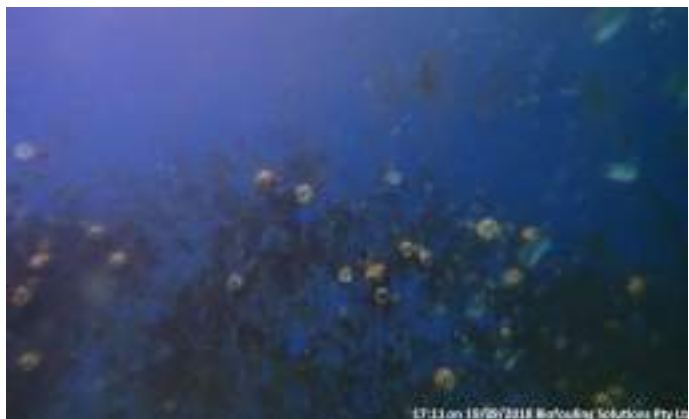
**Plate 31** Transom showing secondary biofouling >1% (restricted to starboard quarter). NB: boot-top below waterline.

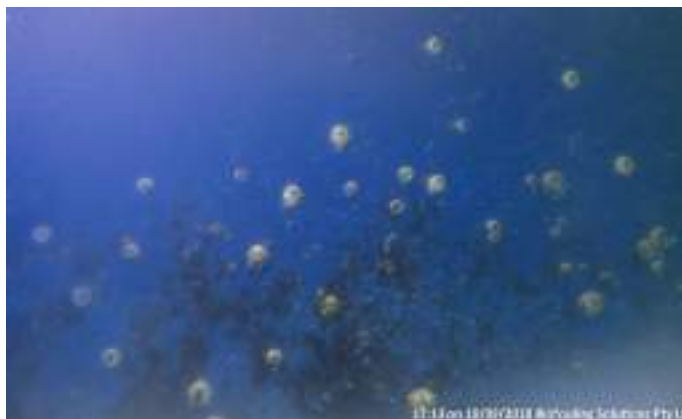
**Plate** Transom showing secondary biofouling >1% (restricted to starboard quarter). NB: boot-top below waterline.

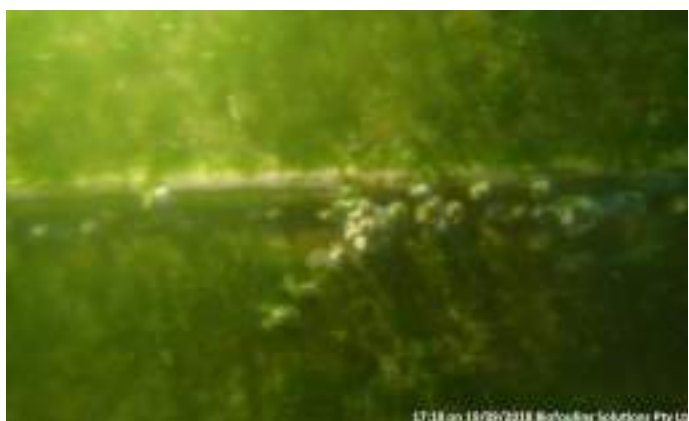
**Plate 33** Starboard aft shell plating with secondary biofouling >1% associated with weld seam (aft of Frame 14).

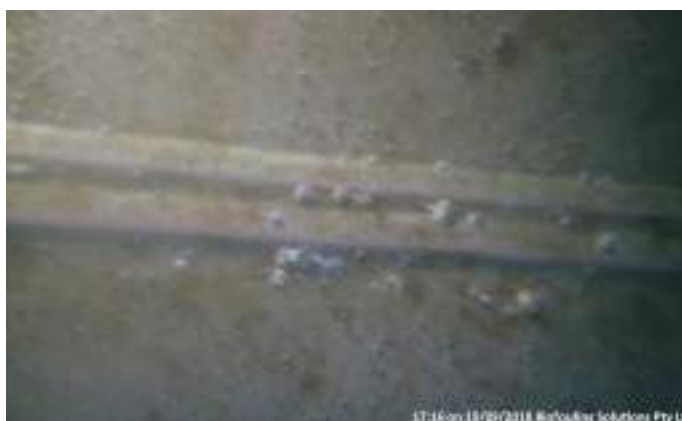
**Plate 34** Starboard aft shell plating with secondary biofouling >1% associated with weld seam (aft of Frame 14).

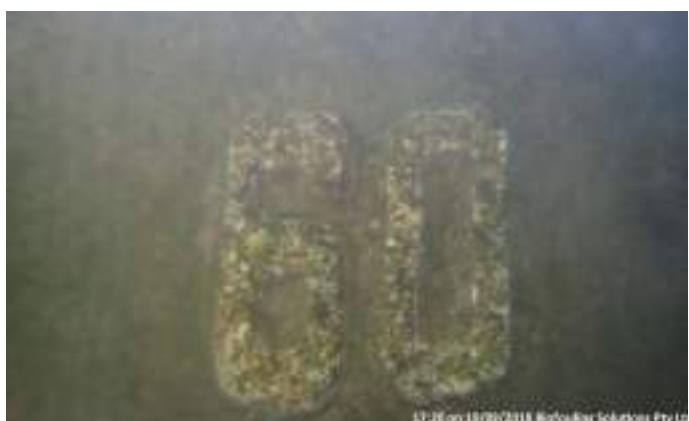
**Plate 35** Starboard side aft draft markers showing secondary biofouling  $\geq$  5%.

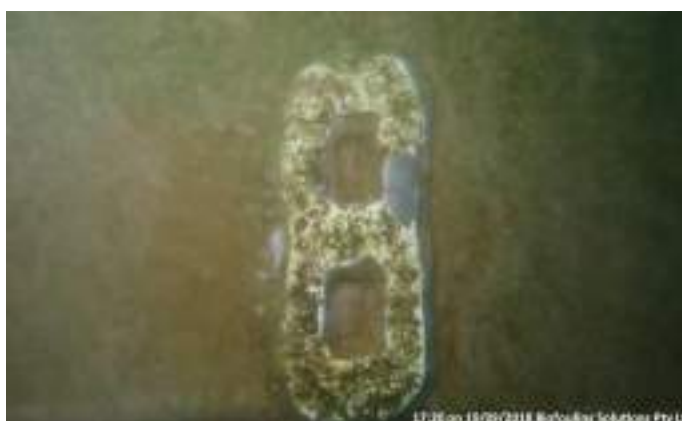
**Plate 36** Starboard side aft draft markers showing secondary biofouling  $\geq$  5%.

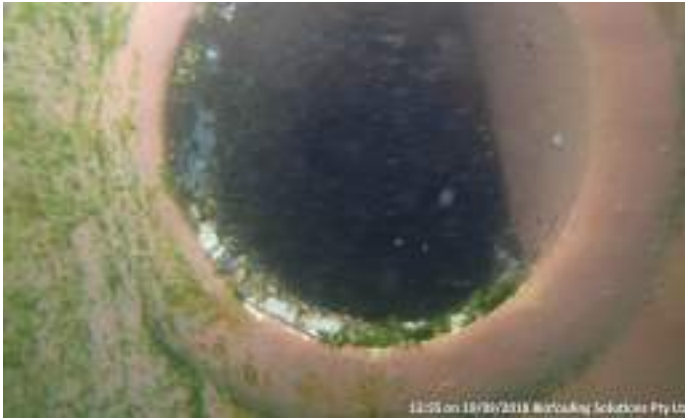
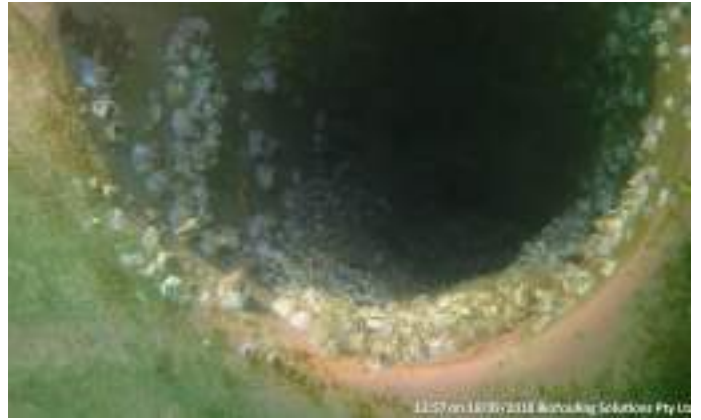
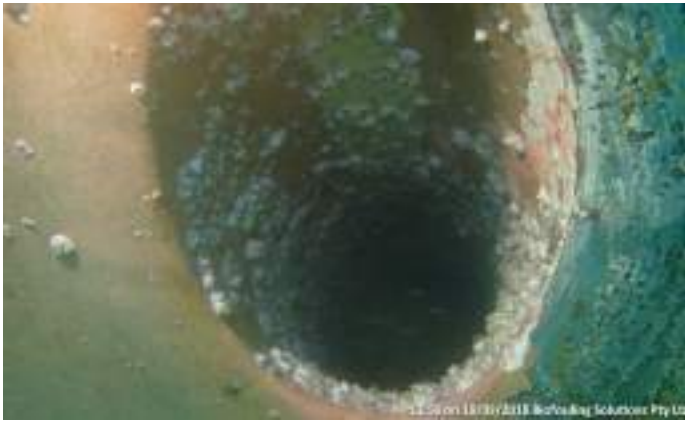
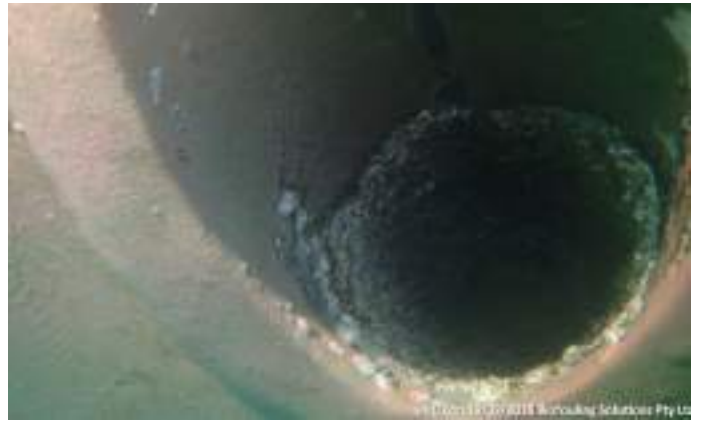
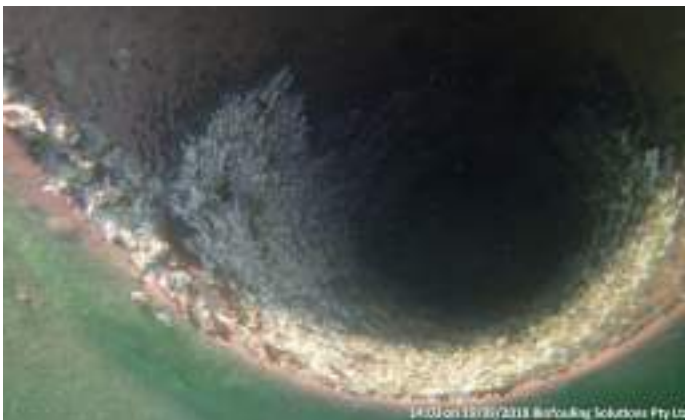
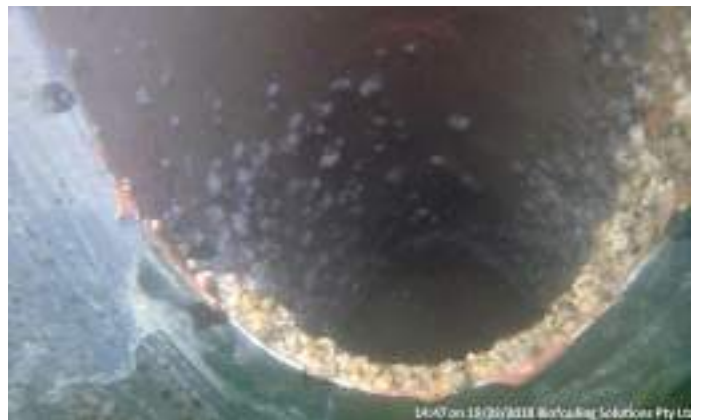
| Niche Type | No, inspected/<br>No. present | Biofouling Level<br>(C/P/S/T) <sup>5</sup> | Biofouling in excess of CRMS detected?<br>(Y/N) | Comments |
|---|---|---|---|---|
| Overboard pipes | 13/? | S | Y | All inspected overboard pipes found to have significant biofouling consisting of 60 – 90% acorn barnacles, tubeworms, bryozoans and hydroids. |

**Plate 37** Selection of overboard pipes showing secondary biofouling >5%.

**Plate 38** Selection of overboard pipes showing secondary biofouling >5%.

**Plate 39** Selection of overboard pipes showing secondary biofouling >5%.

**Plate 40** Selection of overboard pipes showing secondary biofouling >5%.

**Plate 41** Selection of overboard pipes showing secondary biofouling >5%.

**Plate 42** Selection of overboard pipes showing secondary biofouling >5%.

| # | Hull Location | Description | Cleaning approach |
|---|---|---|---|
| 3 | Overboard pipes | All inspected overboard pipes found to have significant biofouling consisting of 60 – 90% acorn barnacles, tubeworms, bryozoans and hydroids. | Clean using high pressure wand or cavi-blaster. |

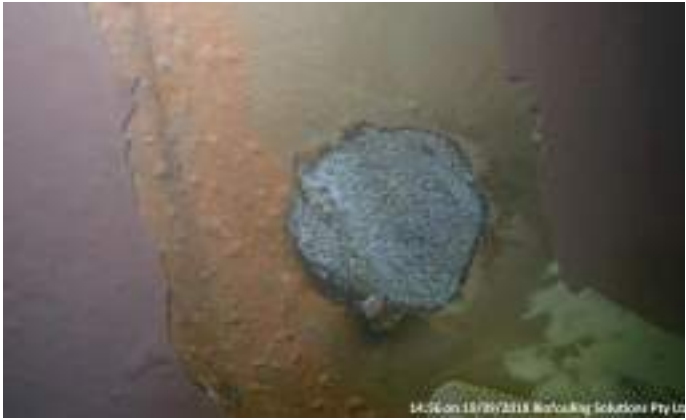
**Plate 43** Area of damages paint, turn of bilge, starboard, forward.

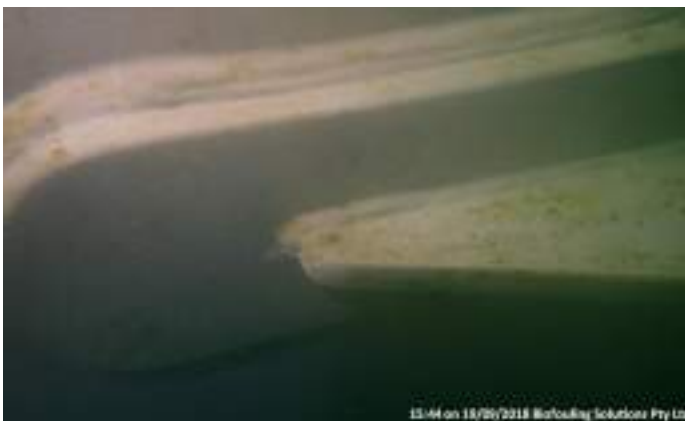
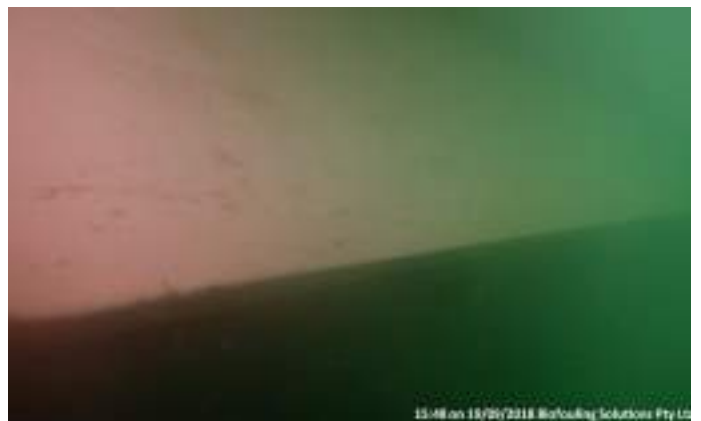
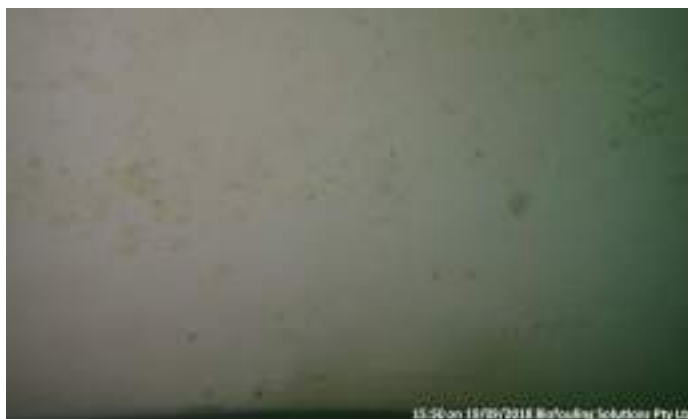
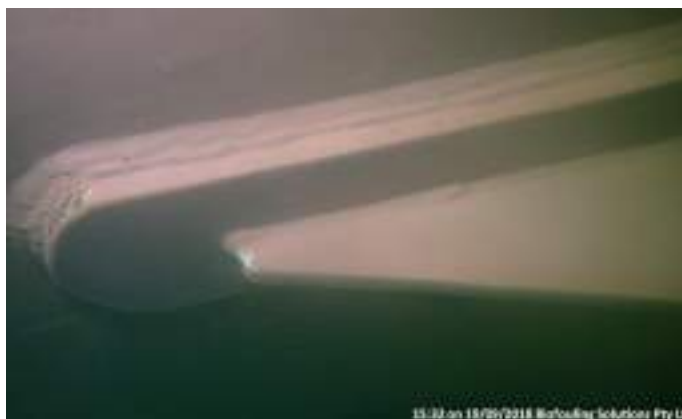
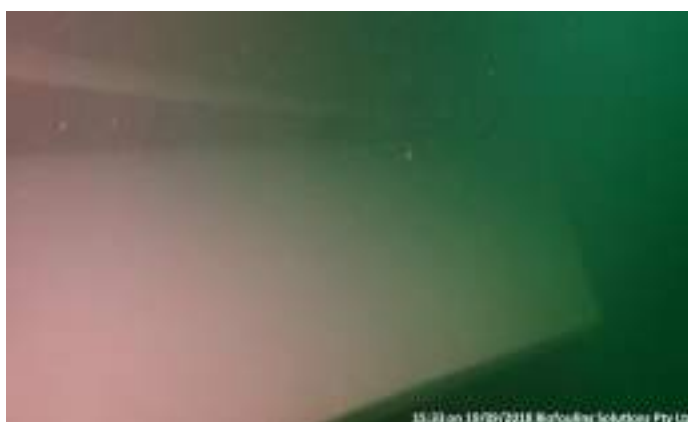
| Niche Type | No, inspected/<br>No. present | Biofouling Level<br>(C/P/S/T) <sup>5</sup> | Biofouling in excess of CRMS detected?<br>(Y/N) | Comments |
|---|---|---|---|---|
| Bilge keels | 2/2 | S | N | Mostly clean with diatomaceous slime only. Some small areas of damaged paint (<1%). |

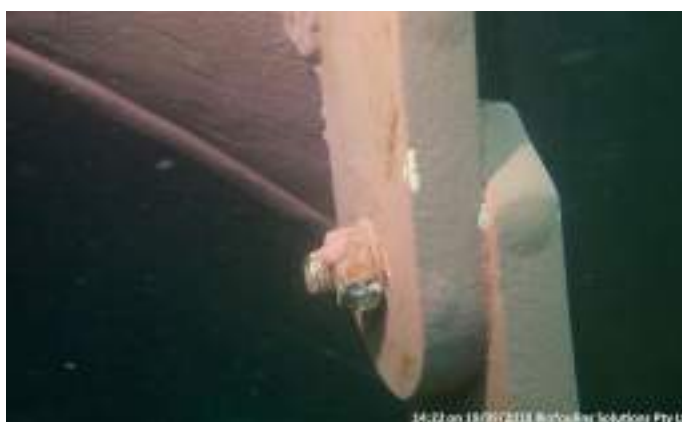
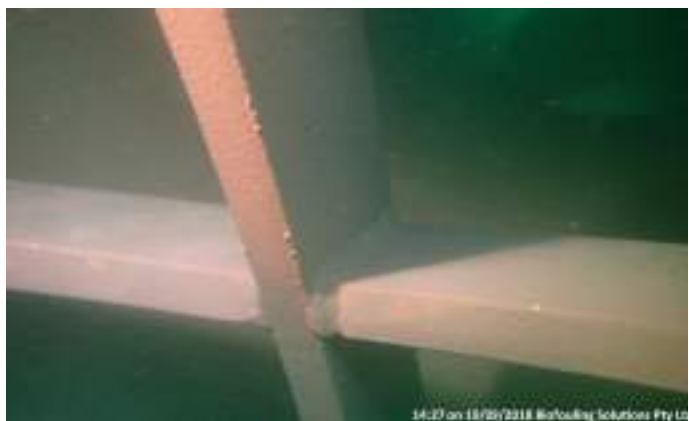
| Niche Type | No, inspected/<br>No. present | Biofouling Level<br>(C/P/S/T) <sup>5</sup> | Biofouling in excess of CRMS detected? (Y/N) | Comments |
|---|---|---|---|---|
| Bow thrusters | 2/2 | S | Y | Inspected through gratings only. Gratings with <1% acorn barnacles and tubeworms mostly associated with damages paint surfaces. Thruster tunnels, gear housings and anodes were clean with biofouling restricted to diatomaceous slime. Thruster propellers with ~50% biofouling consisting of acorn barnacles, tubeworms, hydroids and algae. |

**Plate 52** Bow thruster #1 grating. Starboard side.

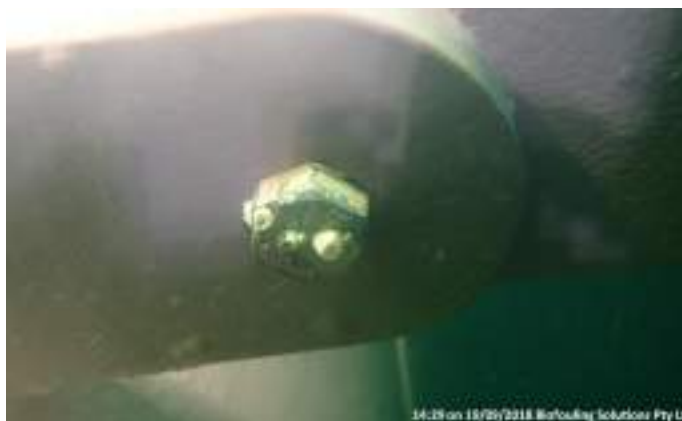
**Plate 54** Bow thruster #1 grating. Port side showing secondary biofouling <5%.

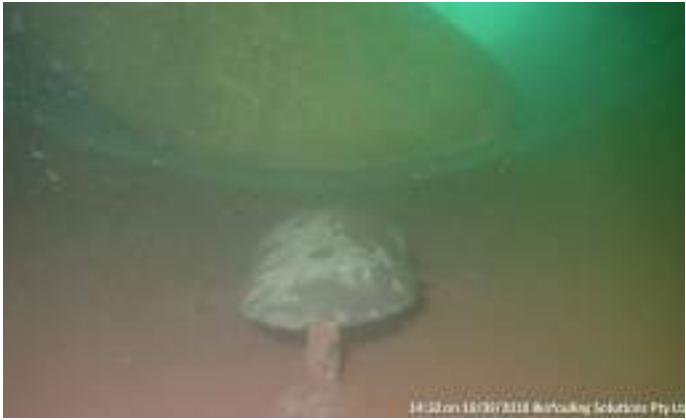
**Plate 55** Bow thruster #1. Anode and prop viewed through grating. Divers observed ~50% Secondary biofouling on prop and boss.

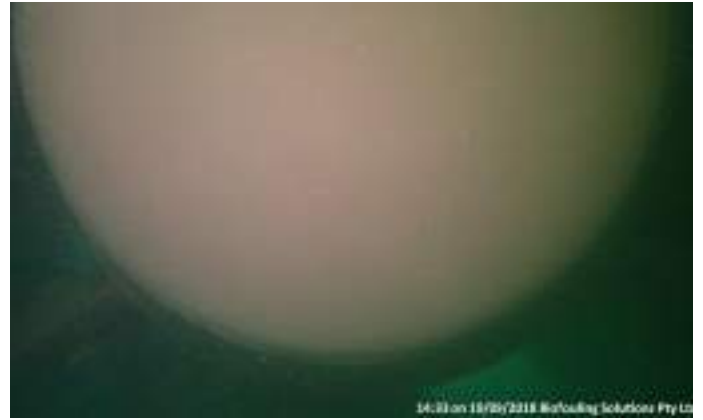
**Plate 56** Bow thruster #1. Gear housing viewed through grating.

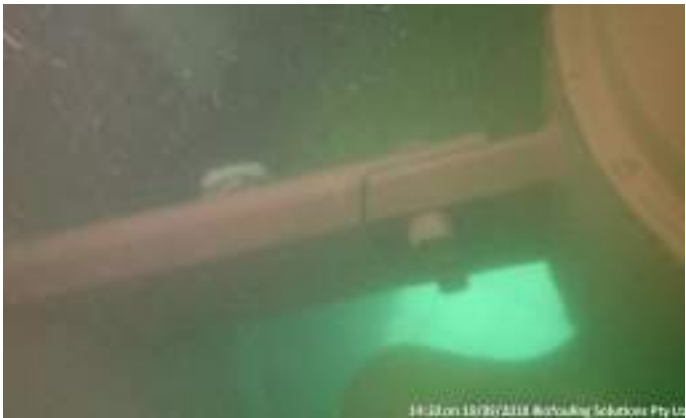
**Plate 57** Bow thruster #1. Mounting support viewed through grating.

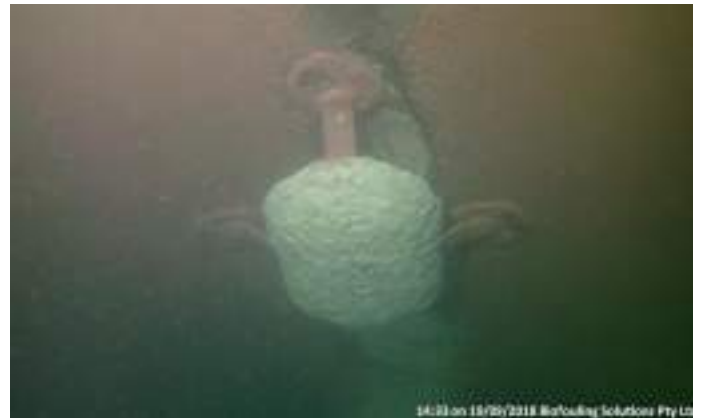
**Plate 58** Bow thruster #1. Anode and tunnel wall viewed through grating.

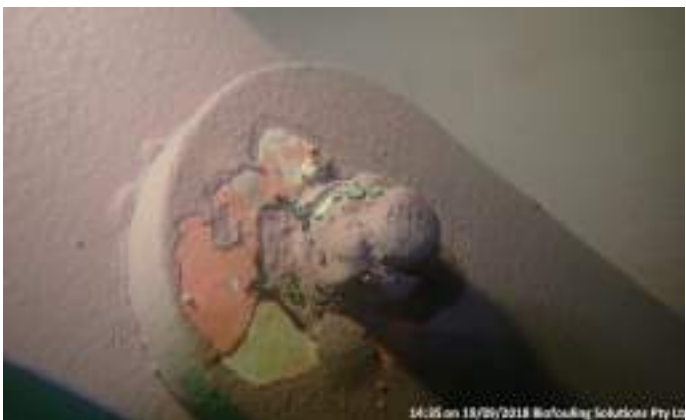
**Plate 59** Bow thruster #2 grating. Port side.

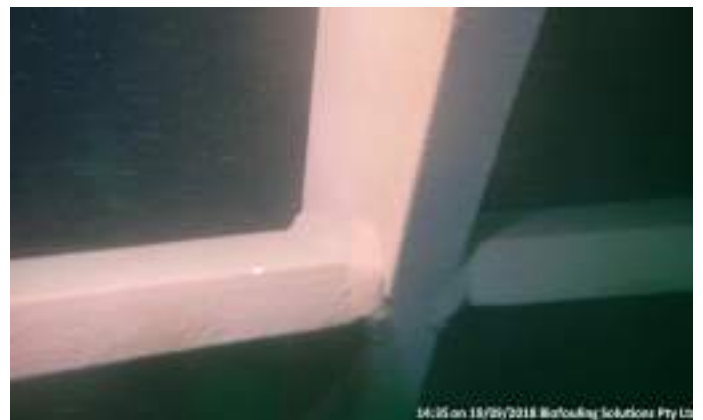
**Plate 60** Bow thruster #2 grating. Port side.

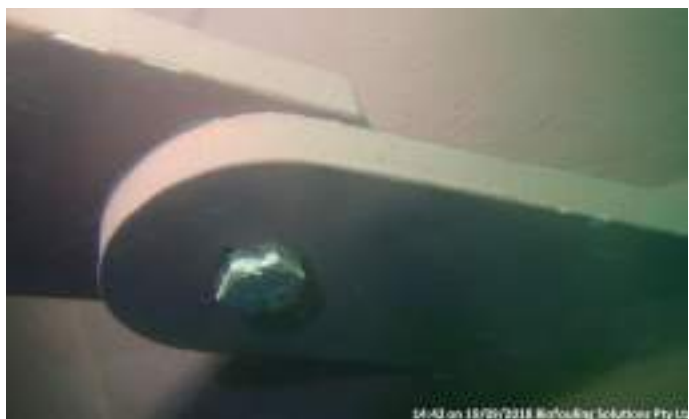
**Plate 61** Bow thruster #2 grating. Starboard side.

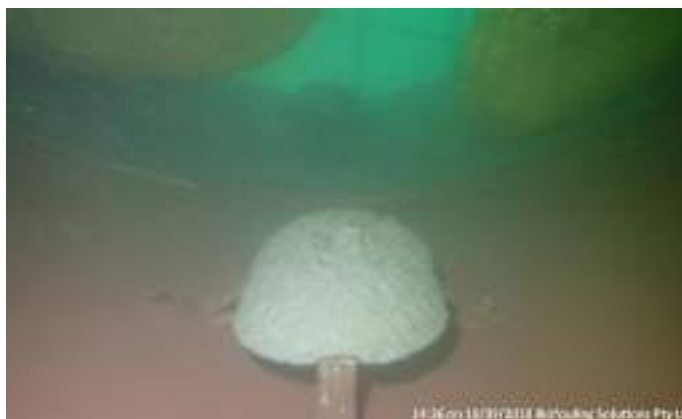
**Plate 62** Bow thruster #2. Anode and prop viewed through grating.

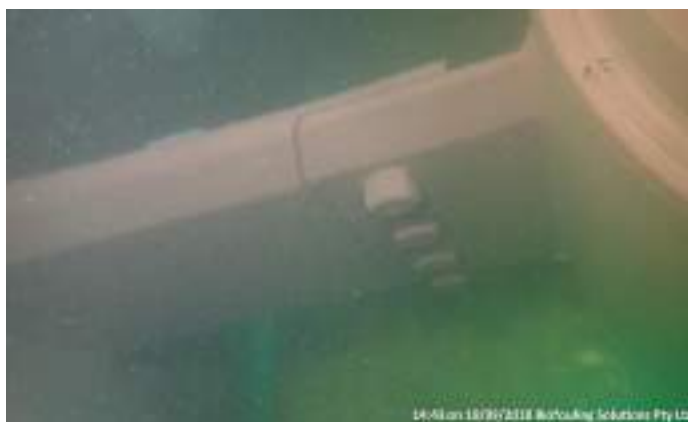
**Plate 65** Bow thruster #2. Mounting support viewed through grating.

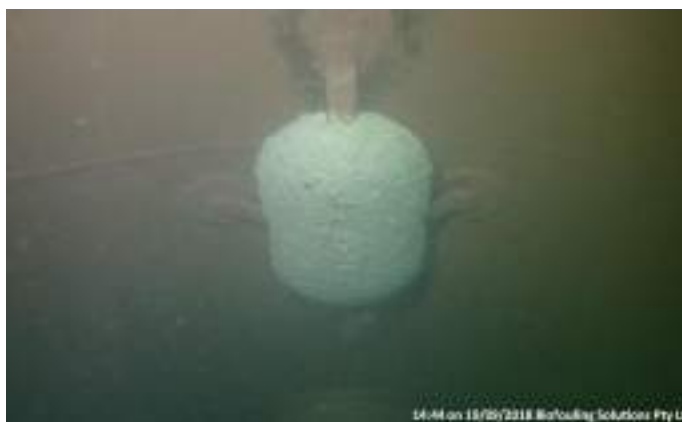
**Plate 66** Bow thruster #2. Anode and tunnel wall viewed through grating.

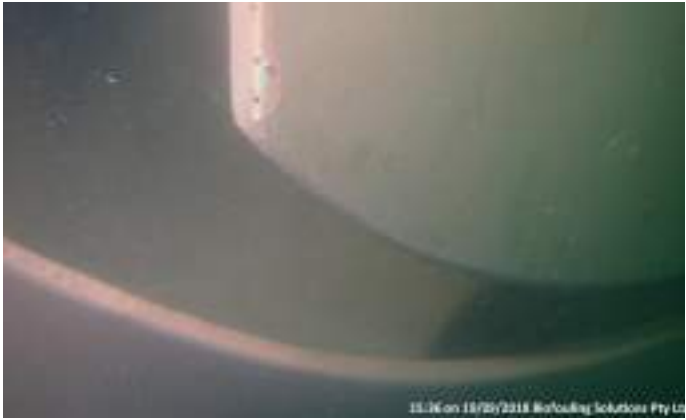
**Plate 67** Port side stabilising fin. Inspected in retracted position.

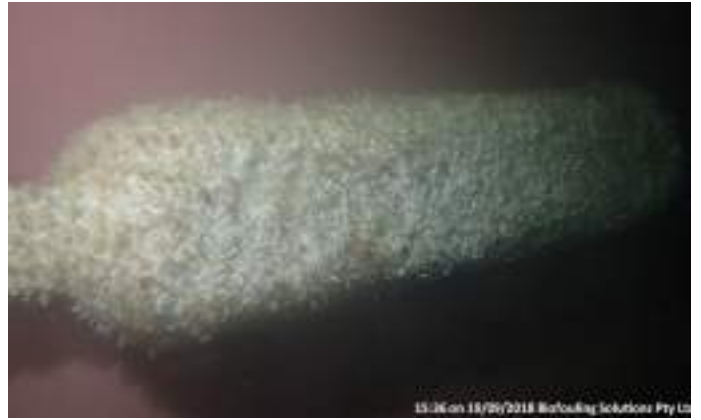
**Plate 68** Anode with secondary biofouling (>5%) on port side stabilising fin. Inspected in retracted position.

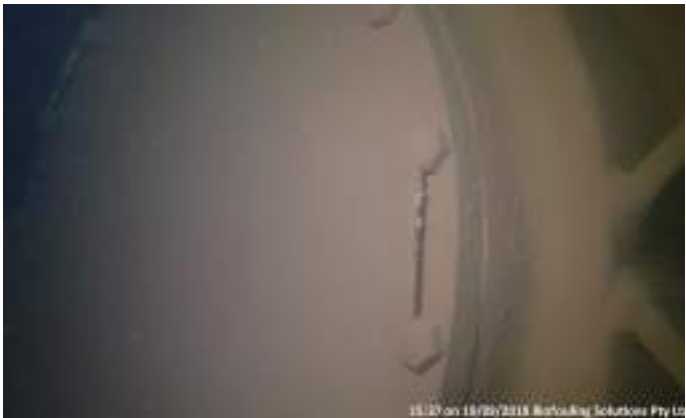
**Plate 69** Port side stabilising fin. Inspected in retracted position.

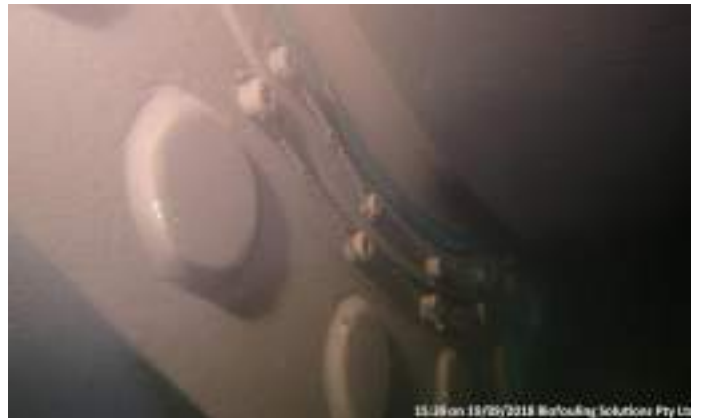
**Plate 70** Port side stabilising fin. Inspected in retracted position.

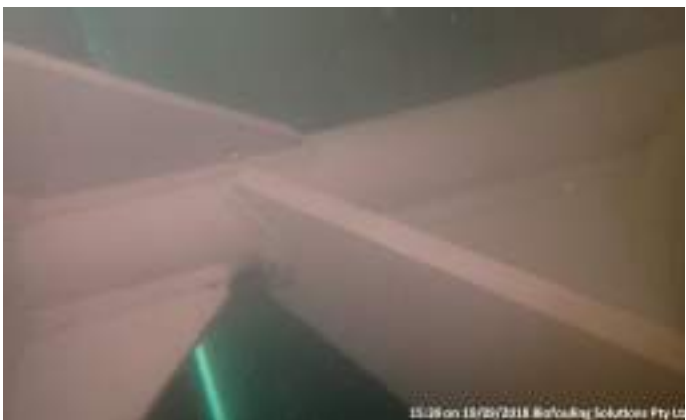
**Plate 71** Port side stabilising fin. Inspected in retracted position.

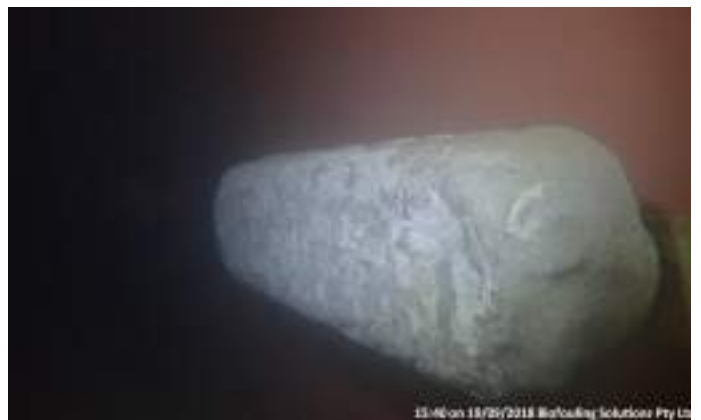
**Plate 72** Clean anode on port side stabilising fin. Inspected in retracted position.

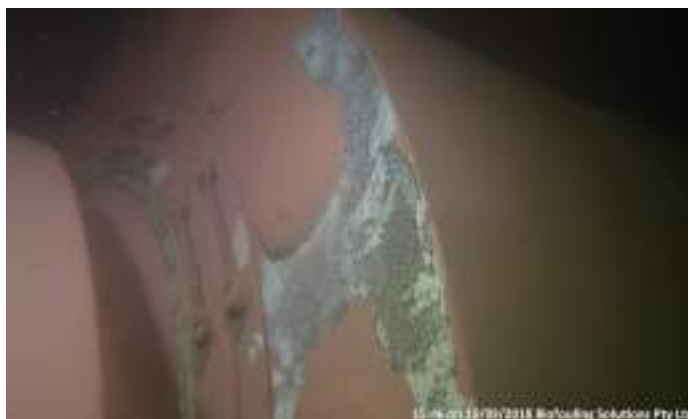
**Plate 73** Starboard side stabilising fin. Inspected in retracted position.

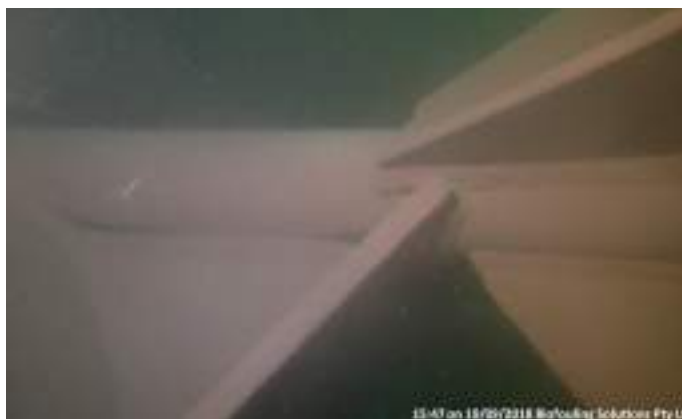
**Plate 74** Starboard side stabilising fin. Inspected in retracted position.

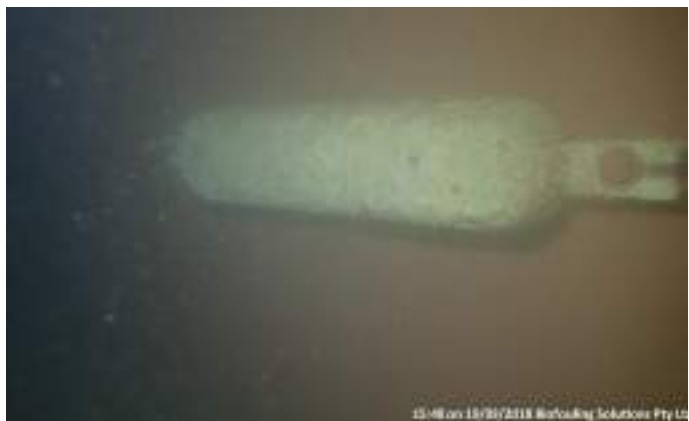
**Plate 75** Clean anode on Starboard side stabilising fin. Inspected in retracted position.

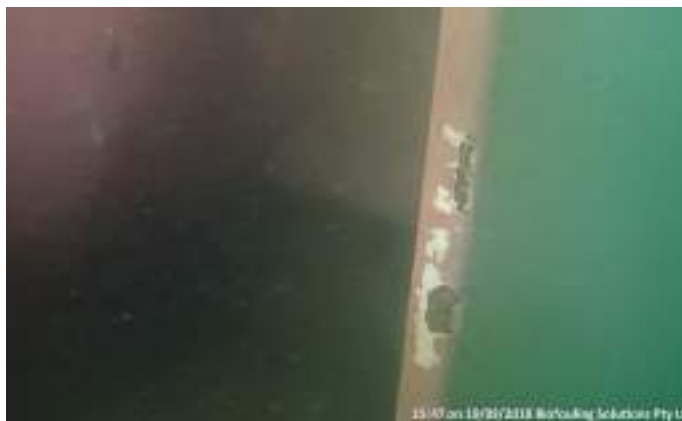
**Plate 76** Starboard side stabilising fin. Inspected in retracted position.

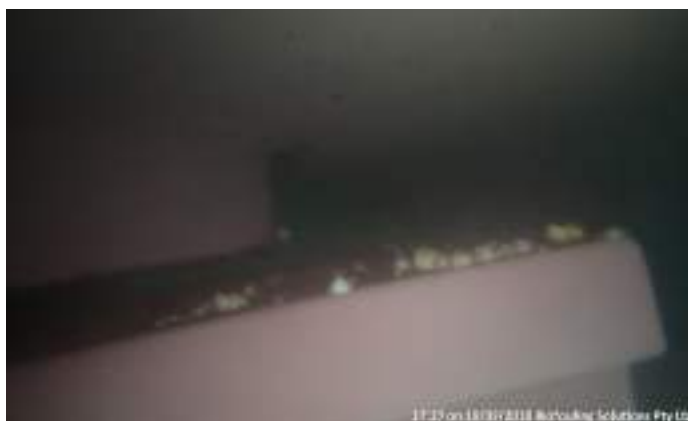
| # | Hull Location | Description | Cleaning approach |
|---|---|---|---|
| 8 | Rudders | Rudder hinges and void spaces with ~60% secondary biofouling consisting of acorn barnacles and tubeworms. Anodes with 20-40% secondary biofouling consisting of acorn barnacles and tubeworms. | Clean using high pressure wand or cavi-blaster. |

**Plate 77** Port rudder with >5% secondary biofouling. Top of rudder stock.

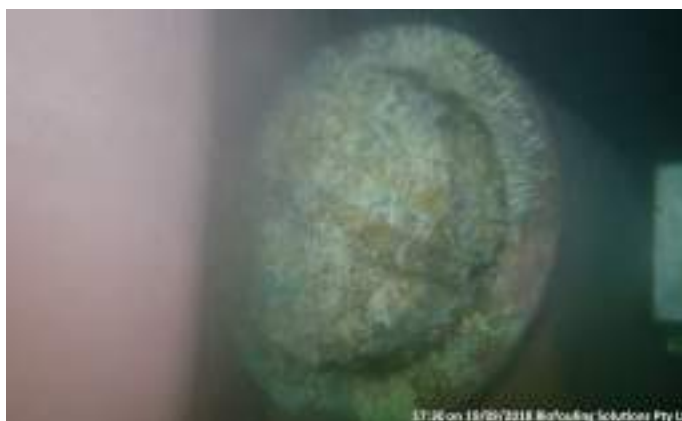
**Plate 78** Port rudder with >5% secondary biofouling.

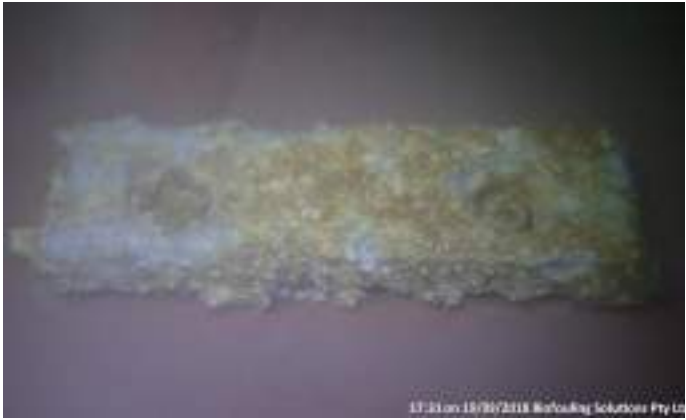
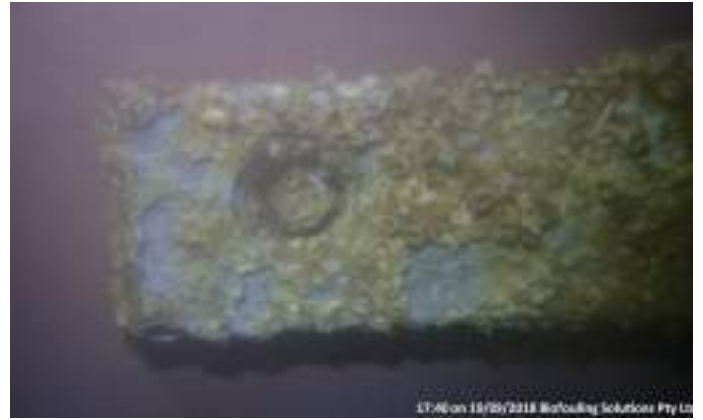
**Plate 79** Port rudder anode with >5% secondary biofouling.

**Plate 80** Port rudder anode with >5% secondary biofouling.

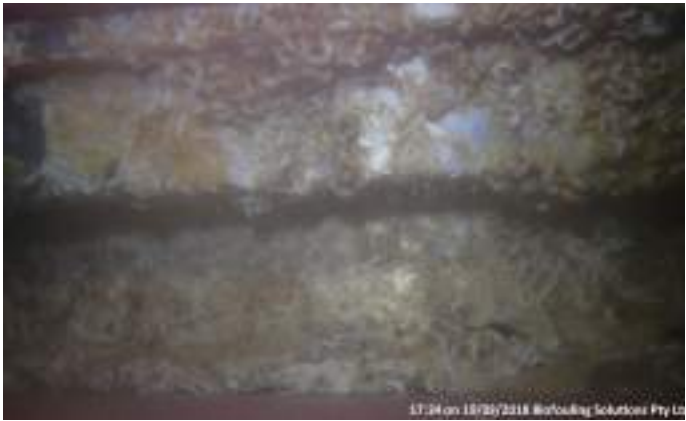
| | | Non-toxic surfaces associated with top of rudder and rudder stock with 20-60% secondary biofouling.<br>Scattered individual mussels ( <i>Mytilus</i> sp.) present around rudder stock of both rudders (~10%). | |

**Plate 81** Top of port rudder stock with >5% secondary biofouling.

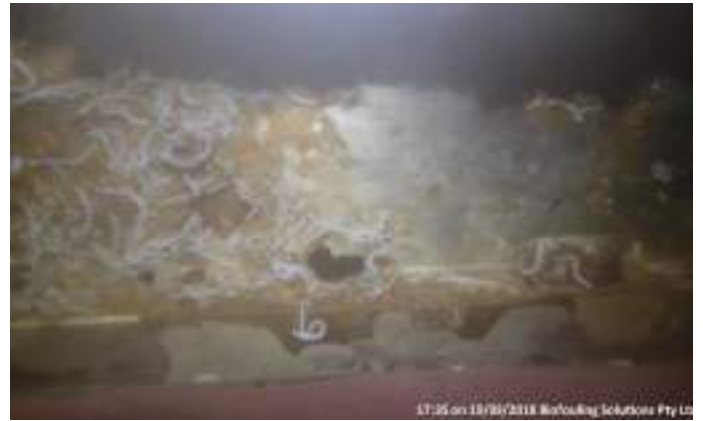
**Plate 82** Top of port rudder stock with >5% secondary biofouling and scattered tertiary biofouling (mussels)

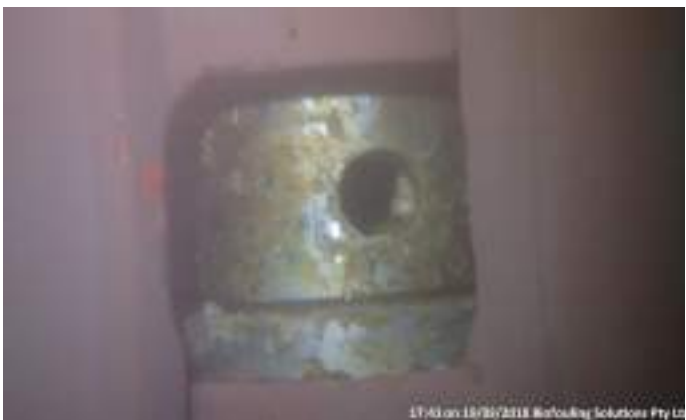
**Plate 83** Port rudder hinge.

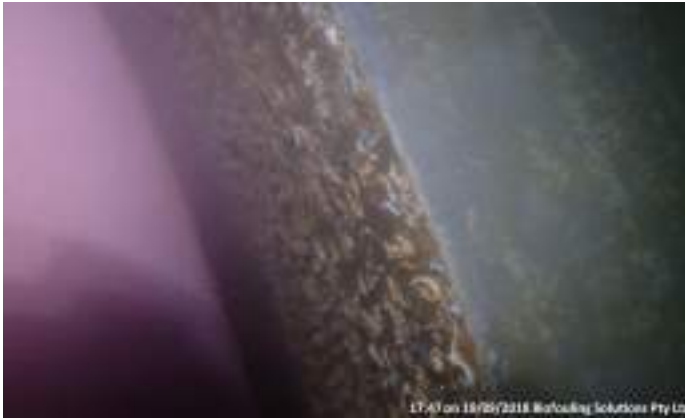
**Plate 85** Port Promes propeller showing interface surface with >5% secondary biofouling.
