# Inspection of the *MV Example* to determine the level of biofouling and detect Invasive Marine Species

**Date:** 19 September, 2018

**Location:** Singapore Cruise Centre, Singapore

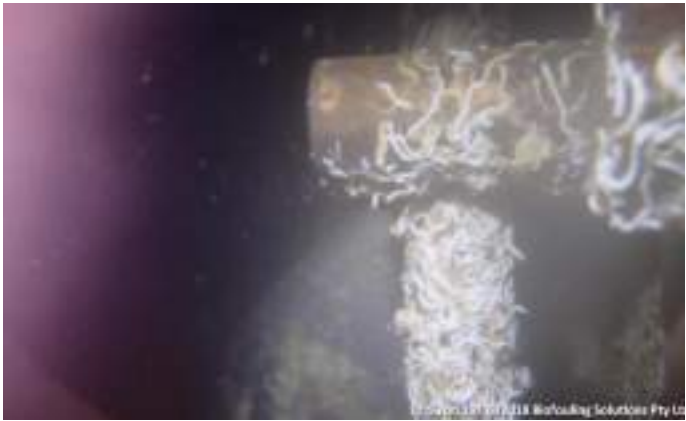
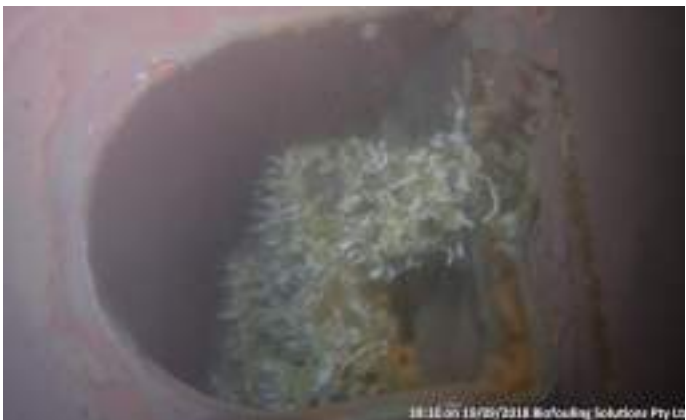
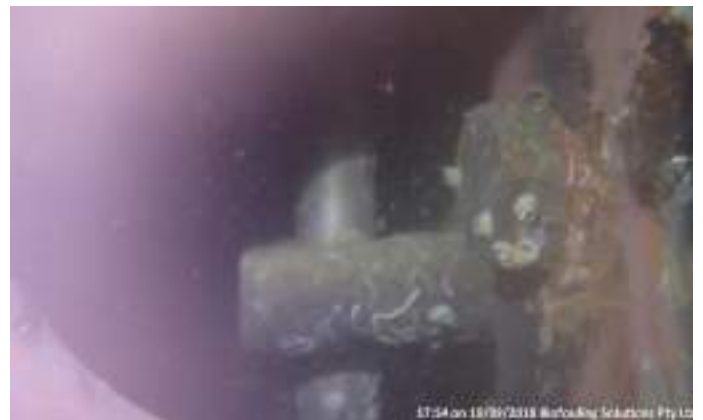
**Plate 87** Port side rope guard void showing >5% secondary biofouling.

**Plate 88** Port side rope guard void showing >5% secondary biofouling.

**Plate 89** Port side rope guard void showing >5% secondary biofouling.

**Plate 90** Port side rope guard void showing >5% secondary biofouling.

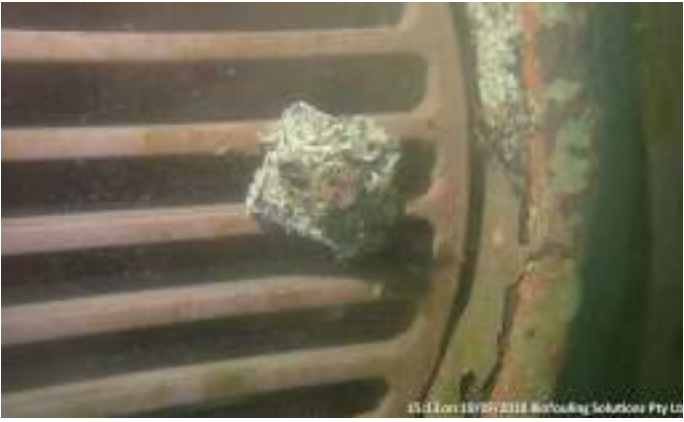
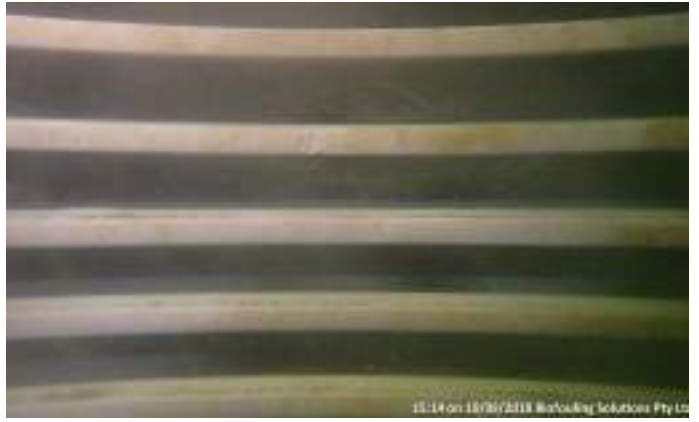
| Niche Type | No, inspected/<br>No. present | Biofouling Level<br>(C/P/S/T) <sup>5</sup> | Biofouling in excess of CRMS detected? (Y/N) | Comments |
|---|---|---|---|---|
| Sea chest grates | 3/6 | S | N | Only non-operational sea chests could be inspected. Biofouling restricted to 1-5% acorn barnacles and tubeworms (<1%), generally associated with bolts or areas of damaged paint. As a niche area this is considered compliant with the CRMS thresholds for short-stay vessels. |

**Plate 91** Forward high sea chest grating showing <5% secondary biofouling restricted to bolts. Starboard.

**Plate 92** Forward high sea chest grating showing <5% secondary biofouling restricted to bolts. Starboard.

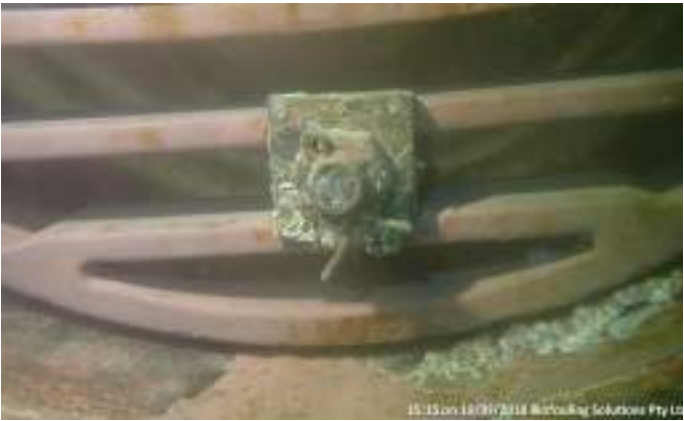
**Plate 93** Forward high sea chest grating showing <5% secondary biofouling restricted to bolts. Starboard.

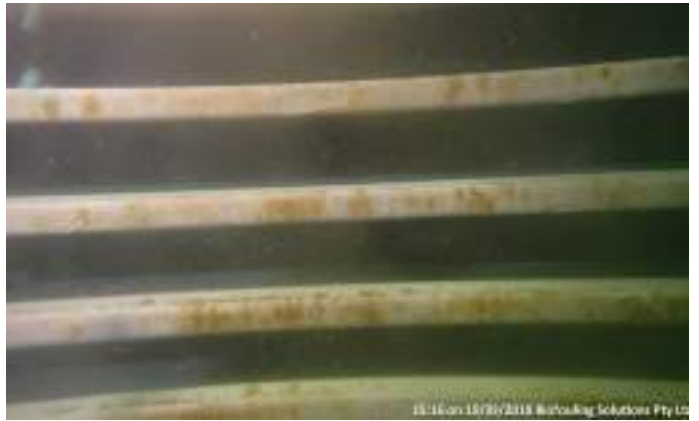
**Plate 94** Forward high sea chest grating showing <5% secondary biofouling restricted to bolts. Starboard.

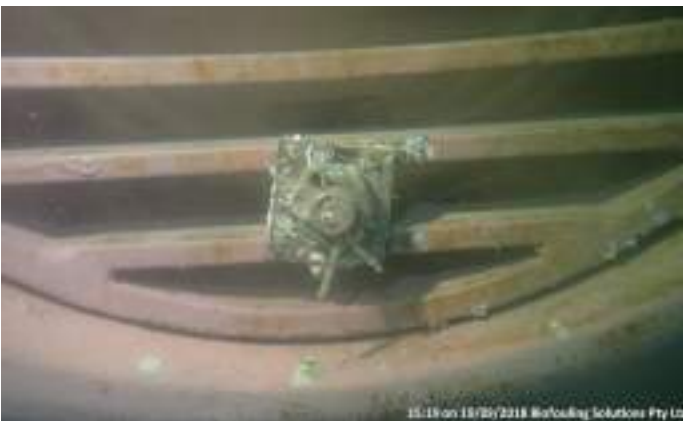
**Plate 95** Amidships high sea chest grating showing <5% secondary biofouling restricted to bolts. Starboard.

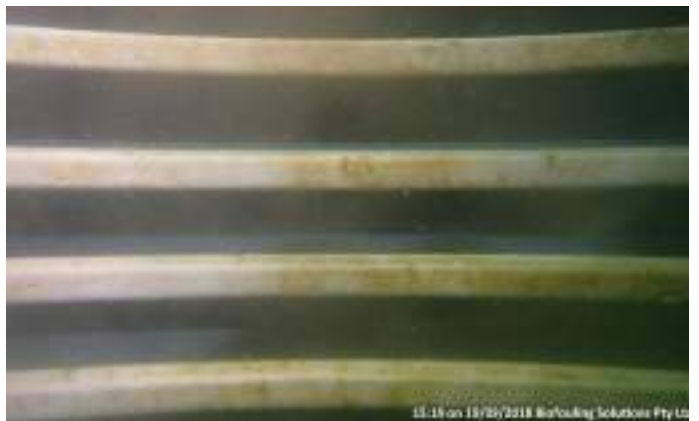
**Plate 96** Amidships high sea chest grating showing <5% secondary biofouling restricted to bolts. Starboard

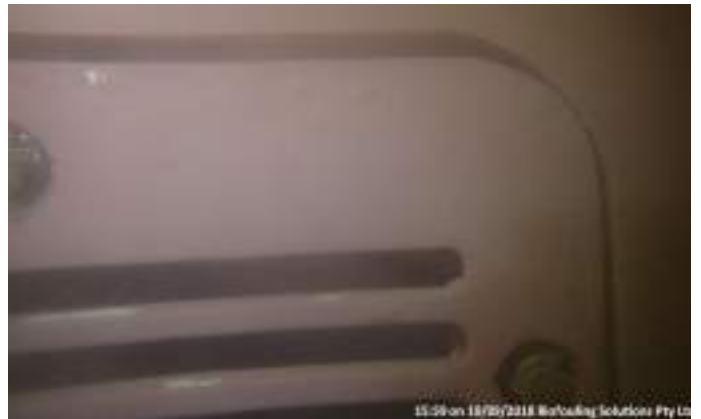
**Plate 100** Aft low Sea chest grating. Port.

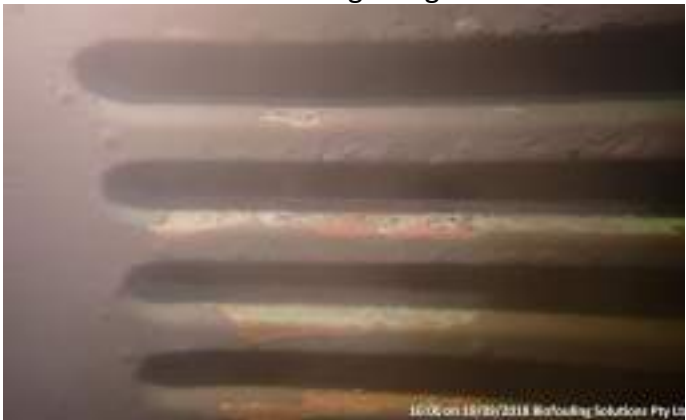
**Plate 101** Aft low Sea chest grating. Port.

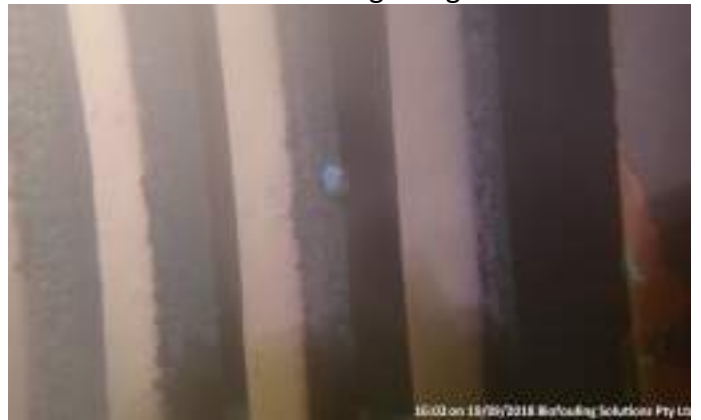
**Plate 102** Aft low Sea chest grating with <1% secondary biofouling. Port.
