# In-water clean and biofouling inspection of the *MV Example* to demonstrate compliance with New Zealand and Australian biofouling regulations

Initial Inspection: 19/09/18: Singapore Cruise Centre, Singapore  
In-water clean: 17/11/18: Laem Chabang, Thailand.  
Final inspection: 23/11/18: Singapore Cruise Centre, Singapore

Prepared for **Company X**

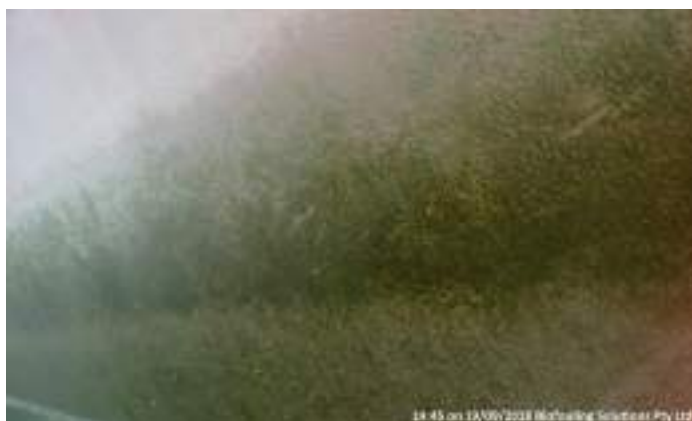
**Plate 4** Band of green algae without secondary biofouling. Starboard waterline aft of Frame 198.

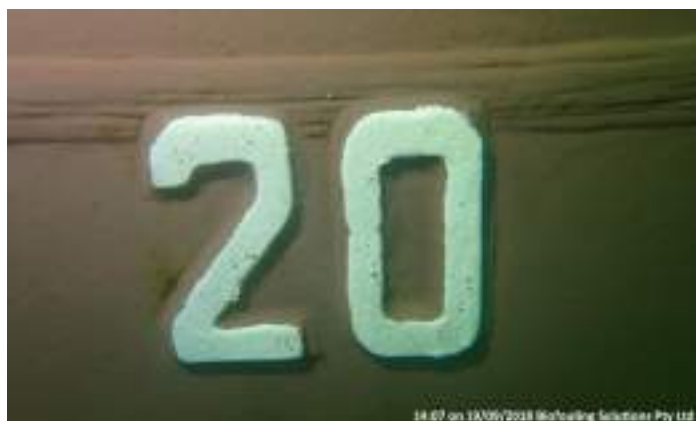
**Plate 5** Port side forward draft markers deeper than 5m with no secondary biofouling.

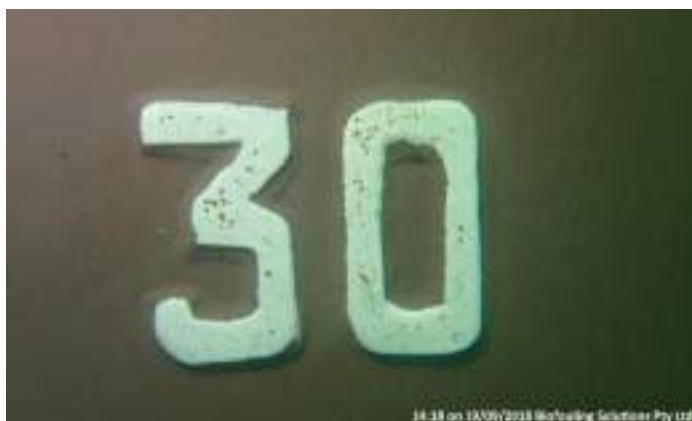
**Plate 6** Starboard side forward draft markers deeper than 5m with no secondary biofouling.

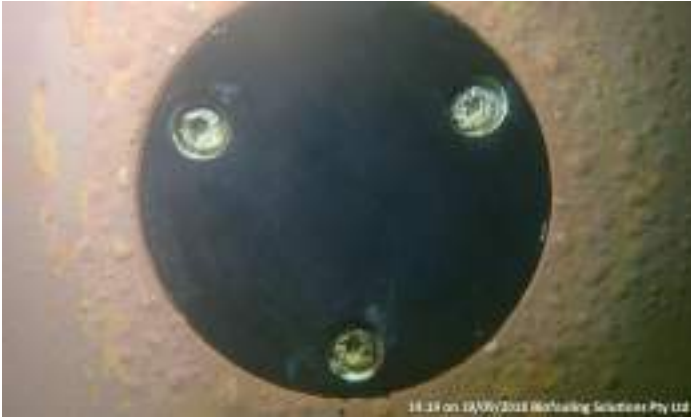
**Plate 7** Depth sounder with <5% secondary biofouling restricted to bolts. Forward amidships

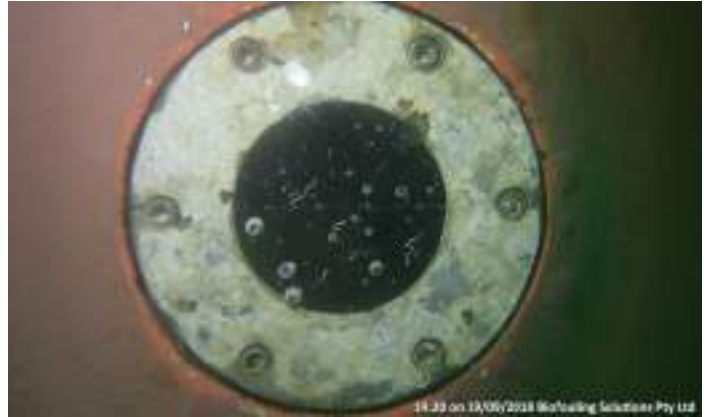
**Plate 8** Speed log with <5% secondary biofouling. Forward amidships.

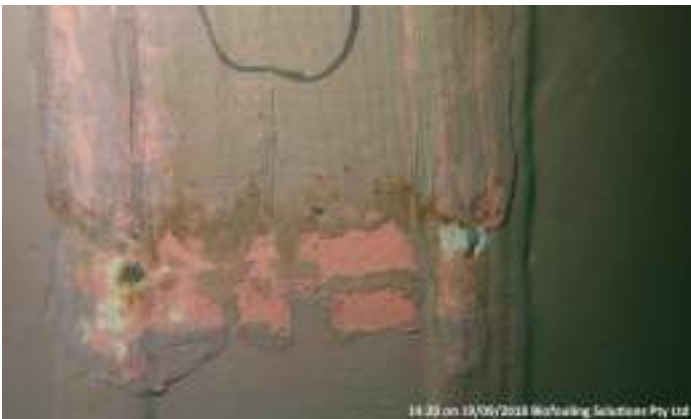
**Plate 11** Dry Dock Support Strip, amidships.

| Niche Type | No, inspected/<br>No. present | Date cleaned | Final inspection | Compliant with CRMS | Status after cleaning |
|---|---|---|---|---|---|
| Dry-Dock Support Strips (DDSS) | various | 19/09/18 | 19/09/18 | Y | DDSS mostly clean with only diatomaceous slime and occasional examples of either tubeworms or acorn barnacles (<1%). |

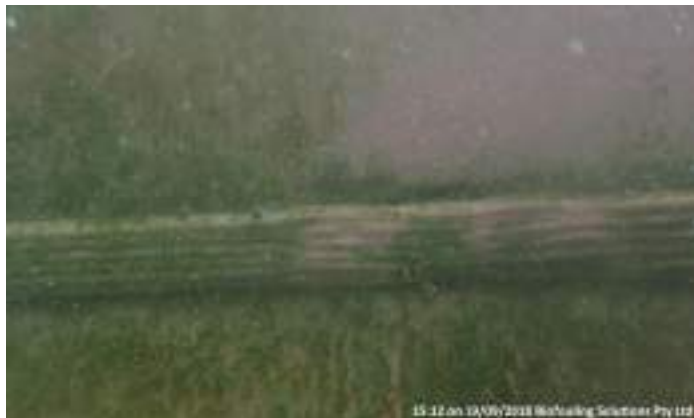
**Plate 14** Amidships waterline algae free of secondary biofouling. Port.

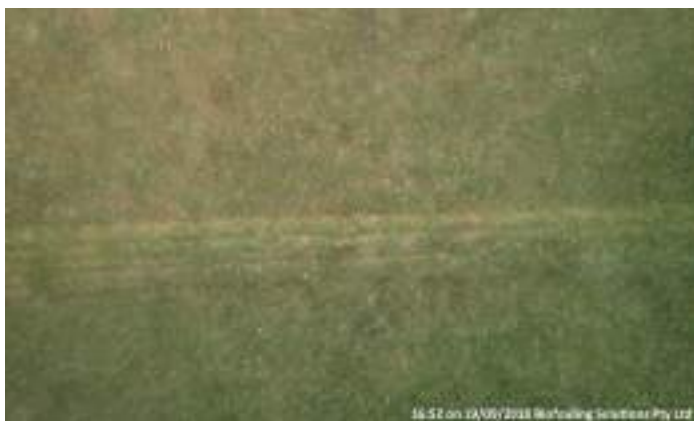
**Plate 15** Amidships waterline algae free of secondary biofouling. Starboard.

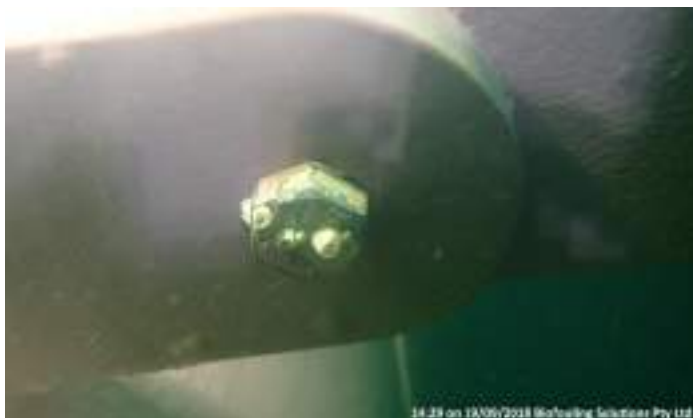
**Plate 26** Bow thruster #1 grating. Port side showing secondary biofouling <5%.

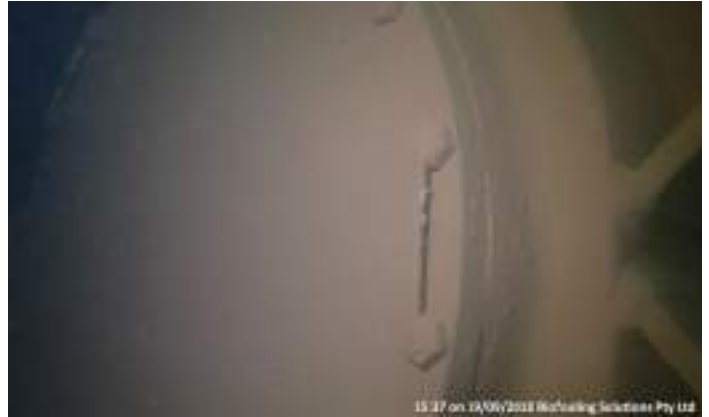
**Plate 38** Port side stabilising fin. Inspected in retracted position.

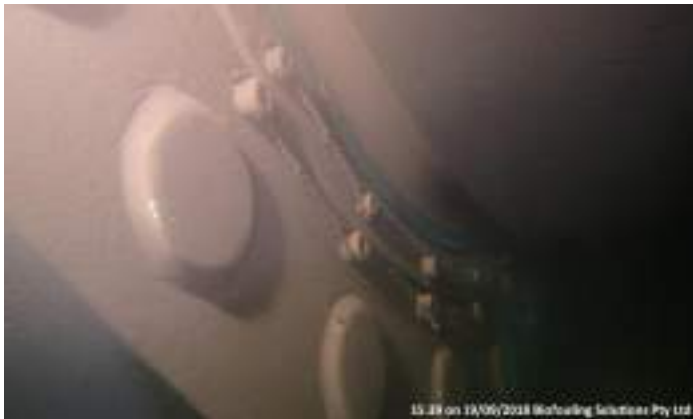
**Plate 39** Port side stabilising fin. Inspected in retracted position.

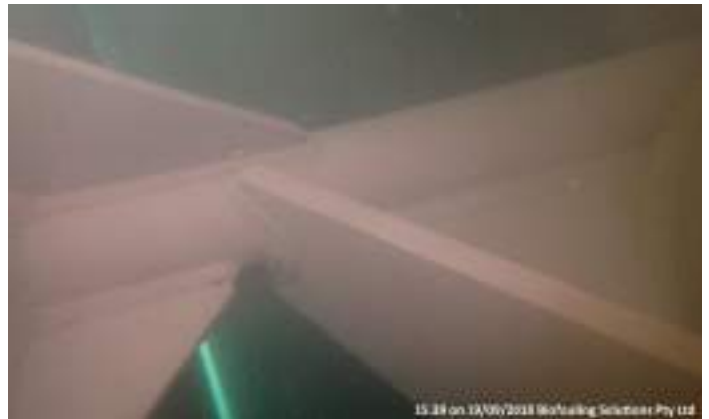
**Plate 40** Port side stabilising fin. Inspected in retracted position.

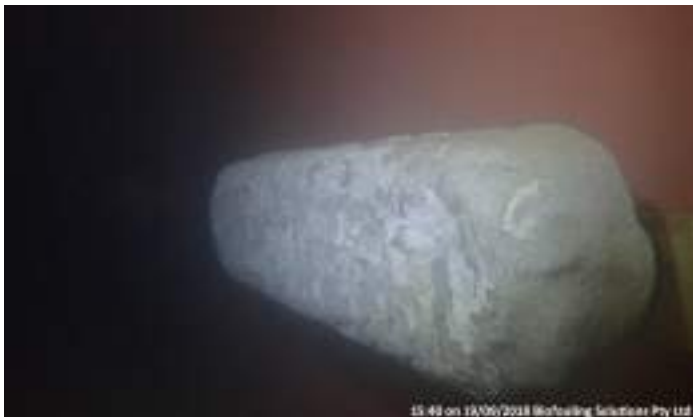
**Plate 41** Clean anode on port side stabilising fin. Inspected in retracted position.

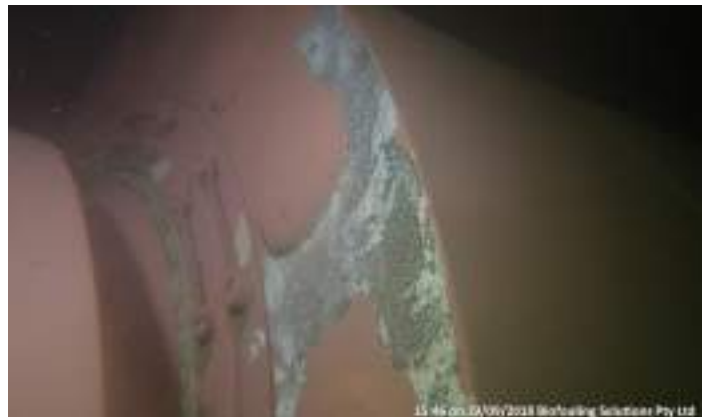
**Plate 42** Starboard side stabilising fin. Inspected in retracted position.

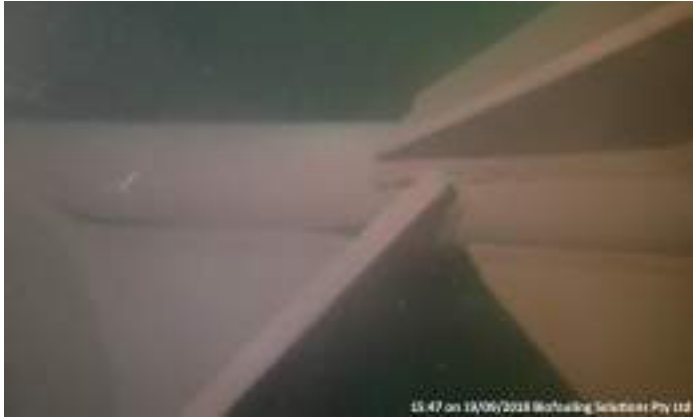
**Plate 43** Starboard side stabilising fin. Inspected in retracted position.

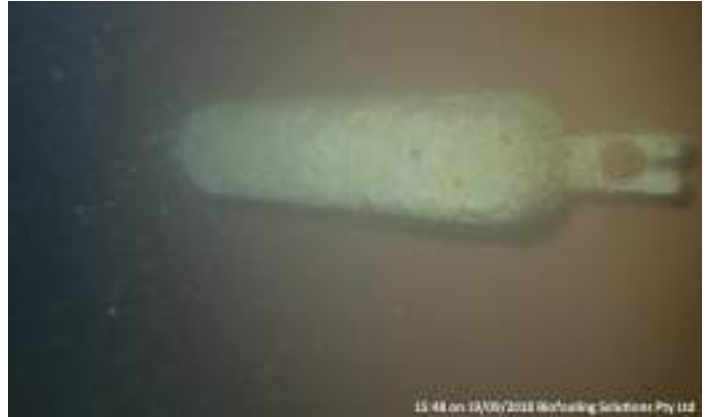
**Plate 44** Clean anode on Starboard side stabilising fin. Inspected in retracted position.

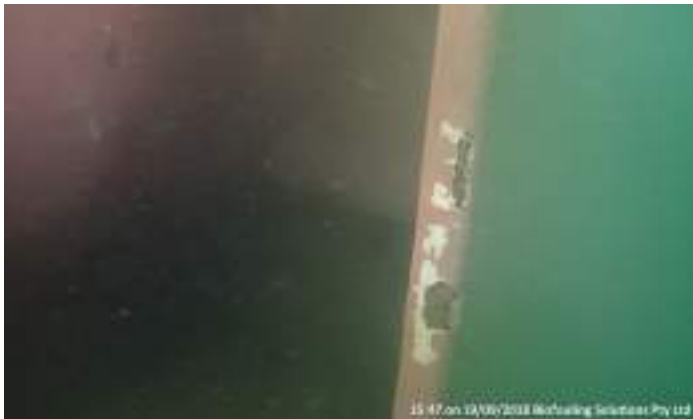
**Plate 45** Starboard side stabilising fin. Inspected in retracted position.

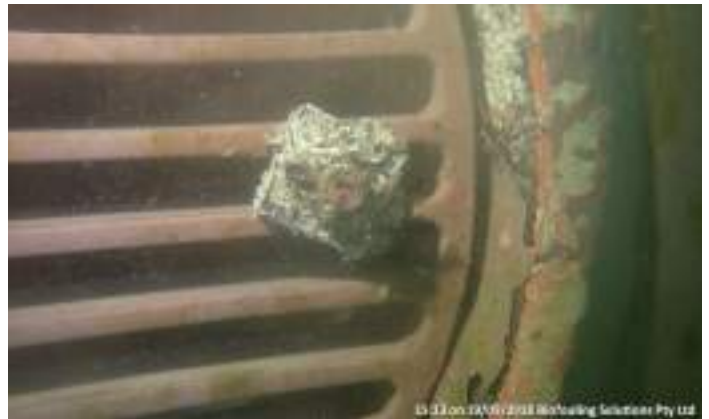
**Plate 46** Forward high sea chest grating showing <5% secondary biofouling restricted to bolts. Starboard.

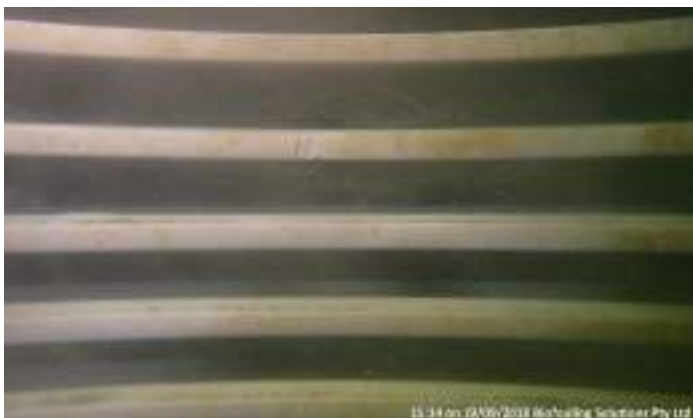
**Plate 47** Forward high sea chest grating showing <5% secondary biofouling restricted to bolts. Starboard.

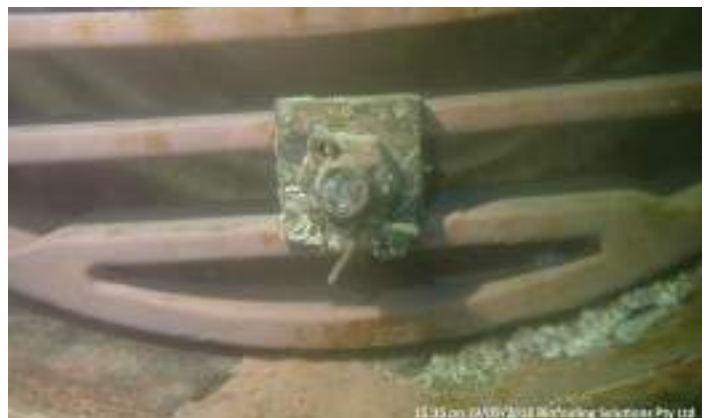
**Plate 48** Forward high sea chest grating showing <5% secondary biofouling restricted to bolts. Starboard.

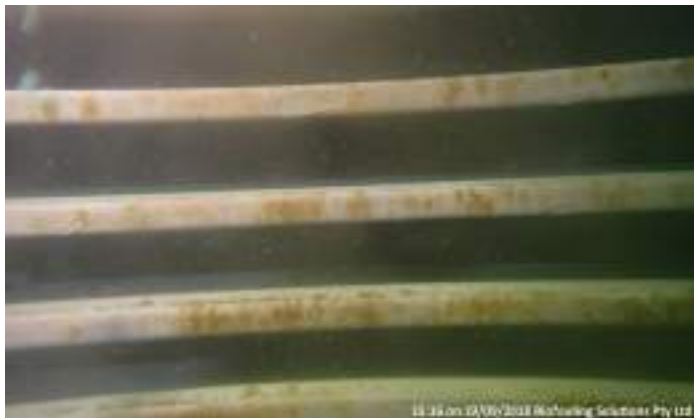
**Plate 49** Forward high sea chest grating showing <5% secondary biofouling restricted to bolts. Starboard.

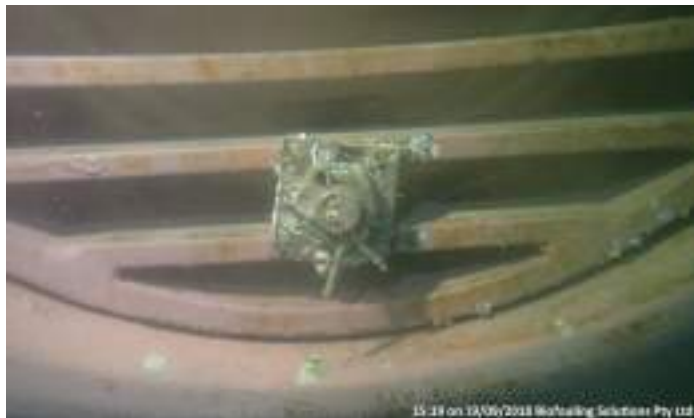
**Plate 50** Amidships high sea chest grating showing <5% secondary biofouling restricted to bolts. Starboard.

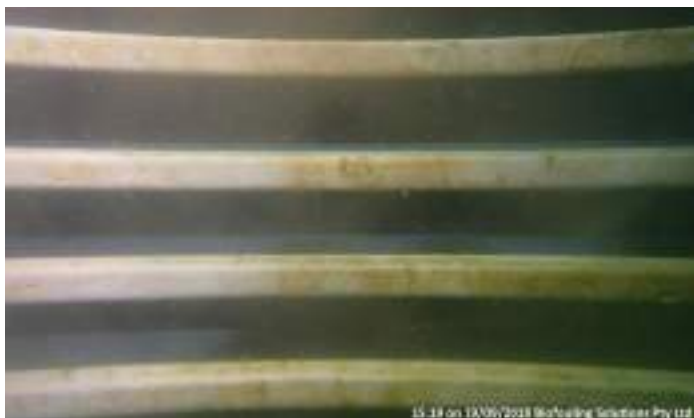
**Plate 51** Amidships high sea chest grating showing <5% secondary biofouling restricted to bolts. Starboard

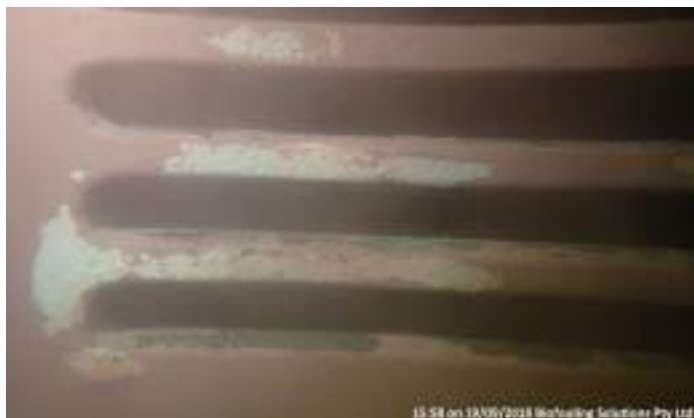
**Plate 52** Aft low sea chest grating. Port.

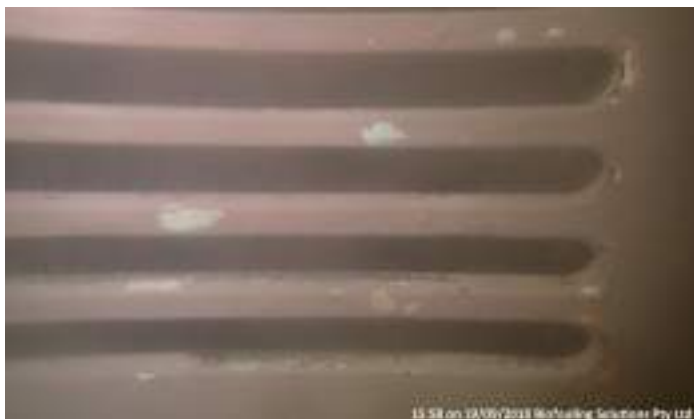
**Plate 53** Aft low sea chest grating. Port.

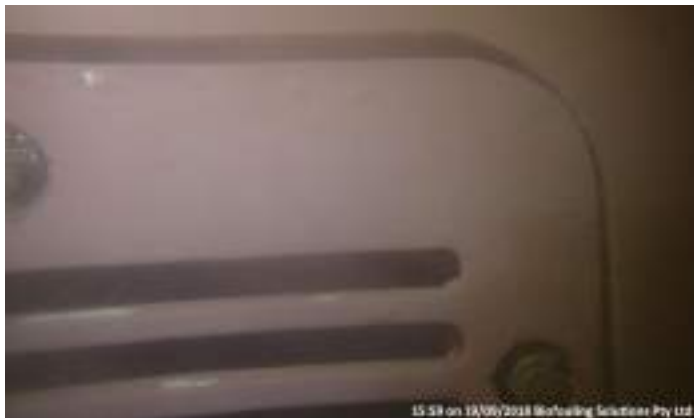
**Plate 55** Aft low sea chest grating. Port.

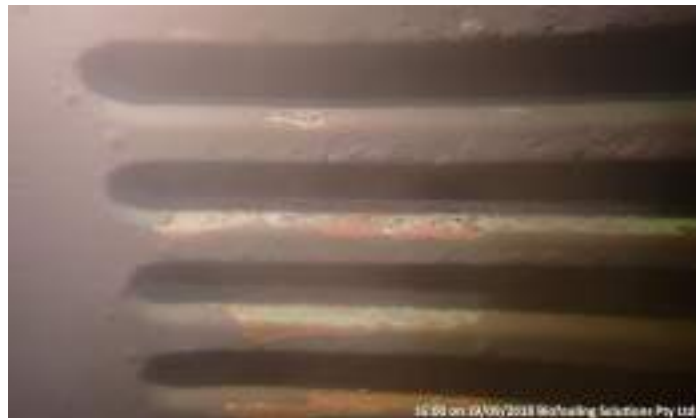
**Plate 56** Aft low sea chest grating. Port.

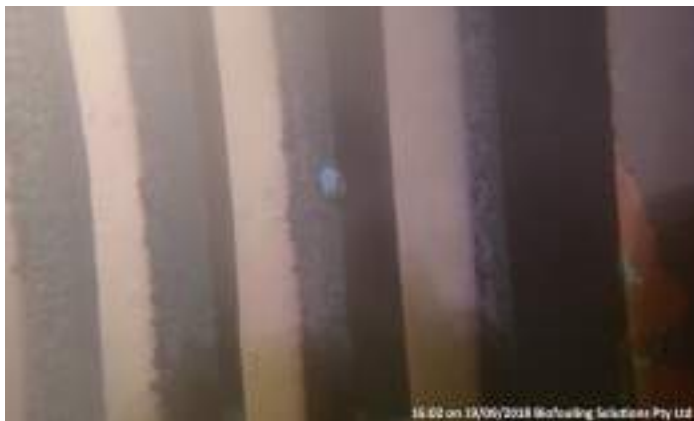
**Plate 57** Aft low sea chest grating with <1% secondary biofouling. Port.

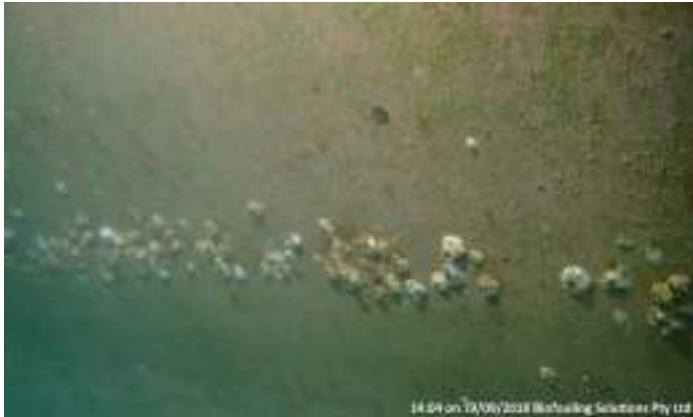
**Plate 1 PRIOR TO CLEANING:** Band of acorn barnacles >1%. Forward of Frame 198, port, waterline to 5m.

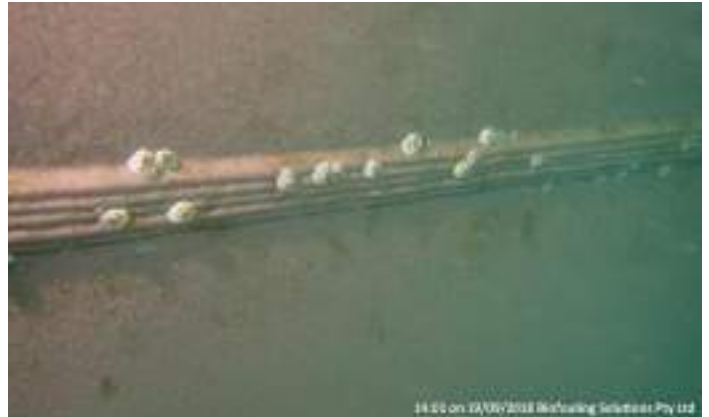
**Plate 2 PRIOR TO CLEANING:** Acorn barnacles >1% associated with weld seam. Forward of Frame 198, port, waterline to 5m.

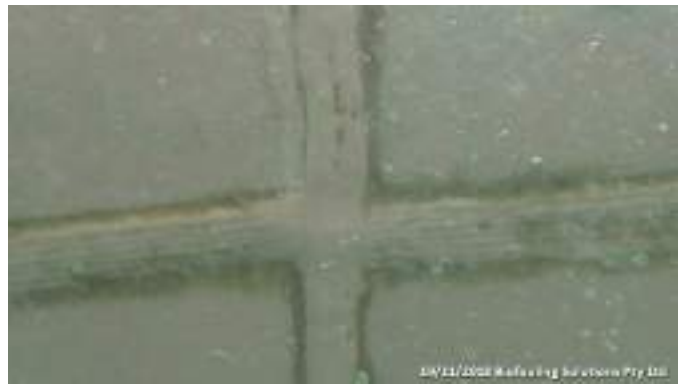
**Plate 4 AFTER CLEANING:** Forward port waterline weld-seam after cleaning. Forward of Frame 198.

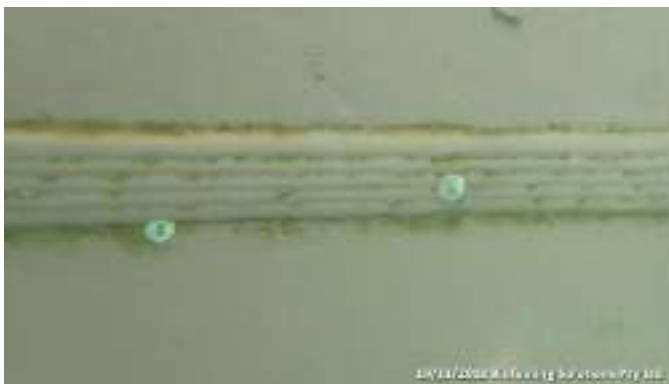
**Plate 5 AFTER CLEANING:** Residual acorn barnacles on forward port waterline weld-seam with coverage less than 1%. Forward of Frame 198.

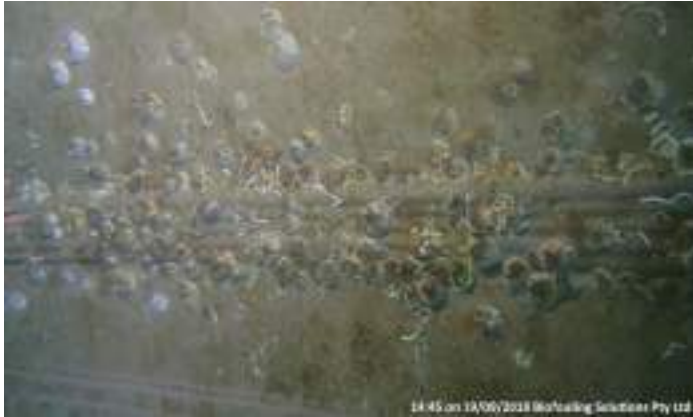
**Plate 7 PRIOR TO CLEANING** Acorn barnacles and tubeworms >1% associated with weld seam. Forward of Frame 198, starboard, waterline.

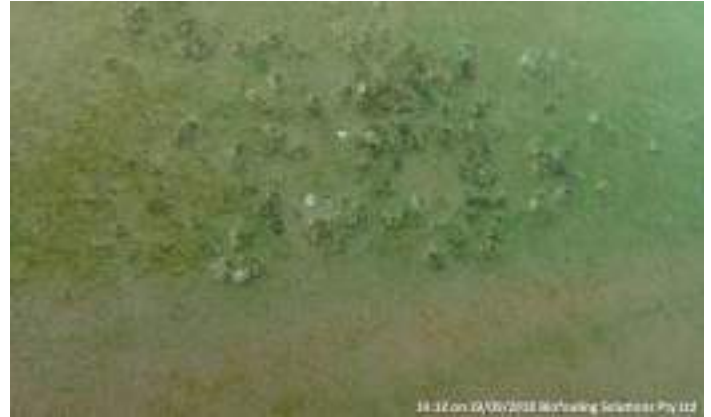
**Plate 8 PRIOR TO CLEANING:** Band of acorn barnacles >1%. Forward of Frame 198, starboard, waterline.

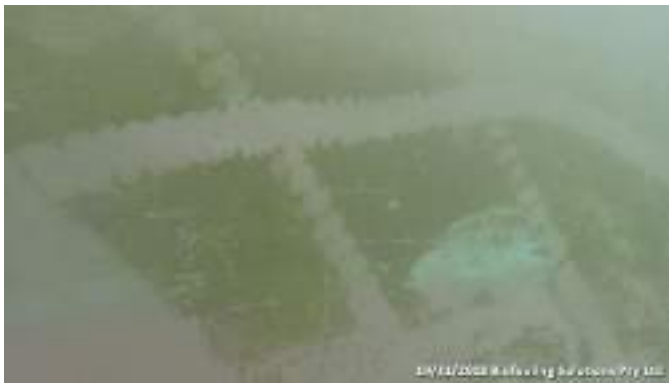
**Plate 9 AFTER CLEANING:** Forward starboard waterline after cleaning with residual algae. Forward of Frame 198.

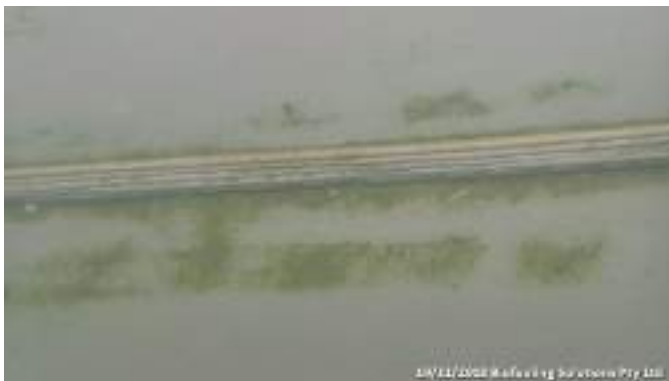
**Plate 11 AFTER CLEANING:** Forward starboard waterline weld-seam after cleaning. Forward of Frame 198.

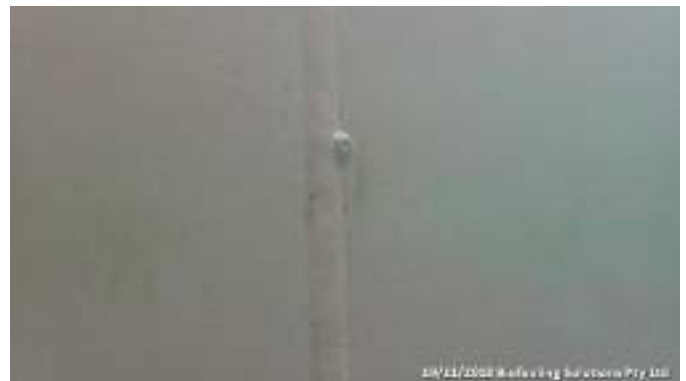
**Plate 12 AFTER CLEANING:** Residual acorn barnacles on forward starboard waterline weld-seam with coverage less than 1%. Forward of Frame 198.

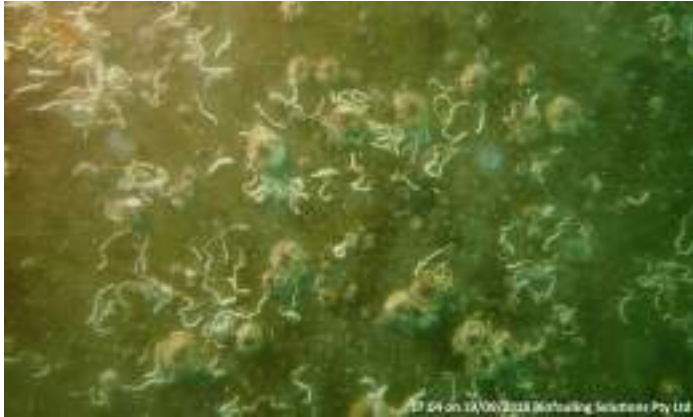
**Plate 13 PRIOR TO CLEANING** Port aft shell plating with secondary biofouling >5% associated with weld seam (aft of Frame 14).

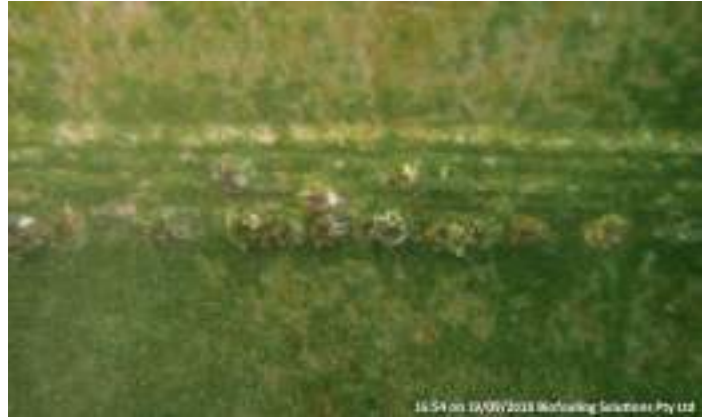
**Plate 14 PRIOR TO CLEANING** Port aft shell plating with secondary biofouling >1% associated with weld seam (aft of Frame 14).

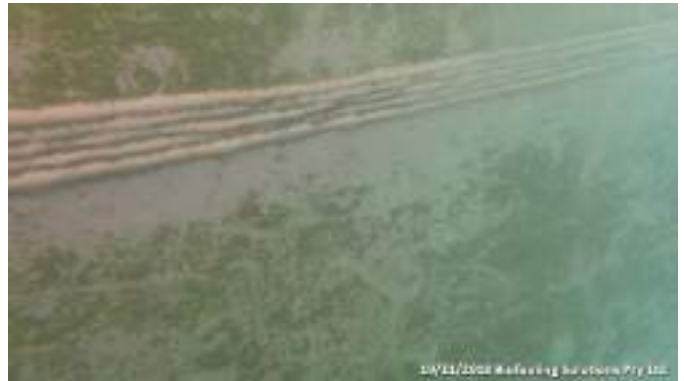
**Plate 16 AFTER CLEANING:** Aft port waterline after cleaning showing weld seam. Aft of Frame 14.

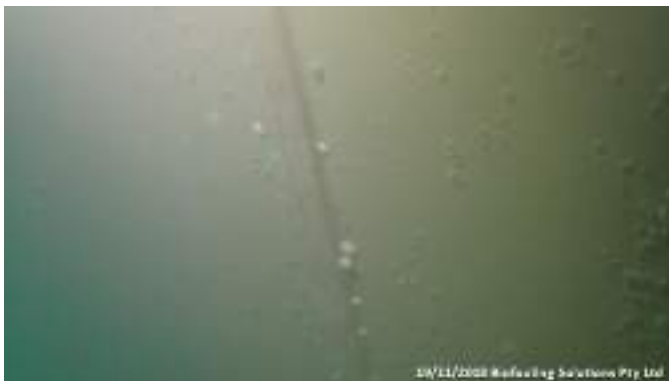
**Plate 17 AFTER CLEANING:** Aft port waterline after cleaning showing residual barnacles associated with weld seam (<1%). Aft of Frame 14.

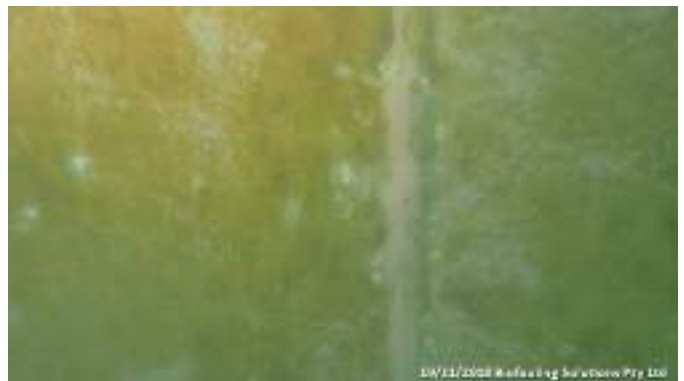
**Plate 18 AFTER CLEANING:** Aft port waterline after cleaning showing residual barnacles associated with weld seam (<1%). Aft of Frame 14.

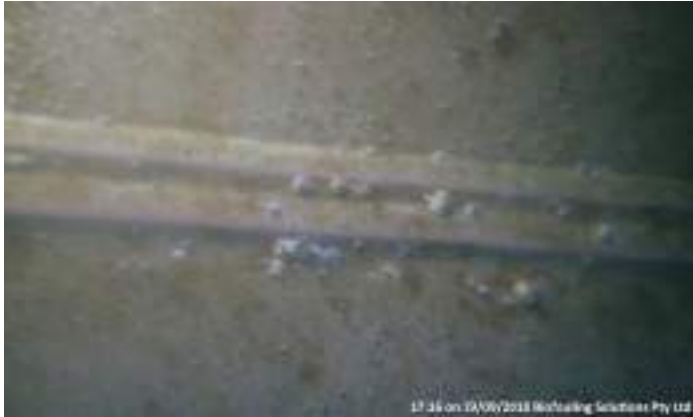
**Plate 19 PRIOR TO CLEANING** Starboard aft shell plating with secondary biofouling >1% associated with weld seam (aft of Frame 14).

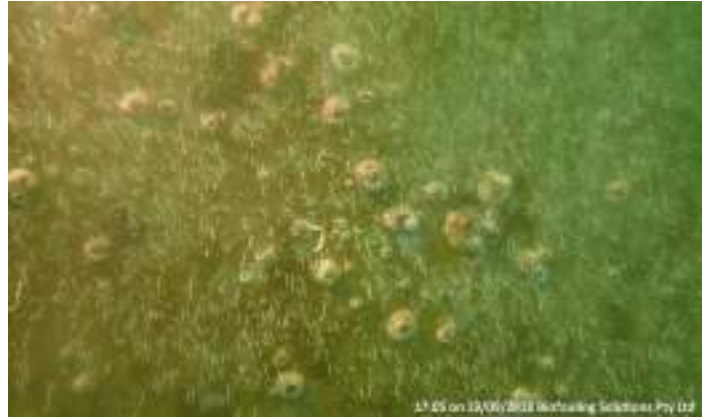
**Plate 20 PRIOR TO CLEANING** Starboard aft shell plating with secondary biofouling >1% associated with weld seam (aft of Frame 14).

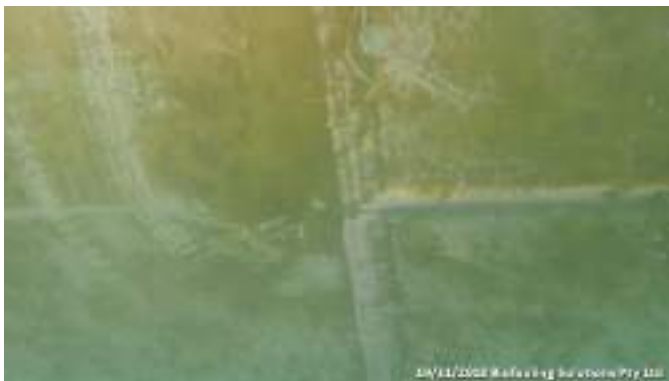
**Plate 23 AFTER CLEANING:** Aft starboard waterline after cleaning showing weld seam. Aft of Frame 14.

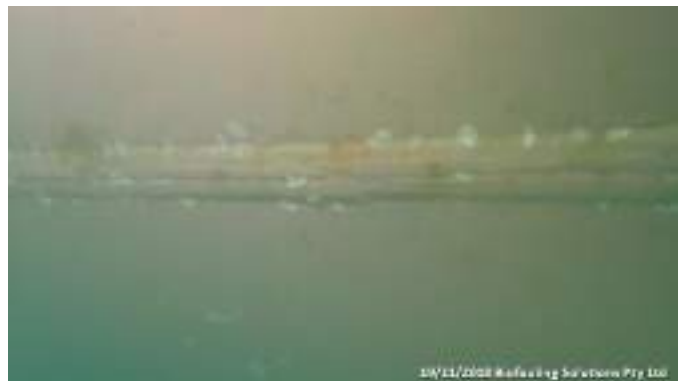
**Plate 24 AFTER CLEANING:** Aft starboard waterline after cleaning showing residual non-viable barnacle bases associated with weld seam (<1%). Aft of Frame 14.

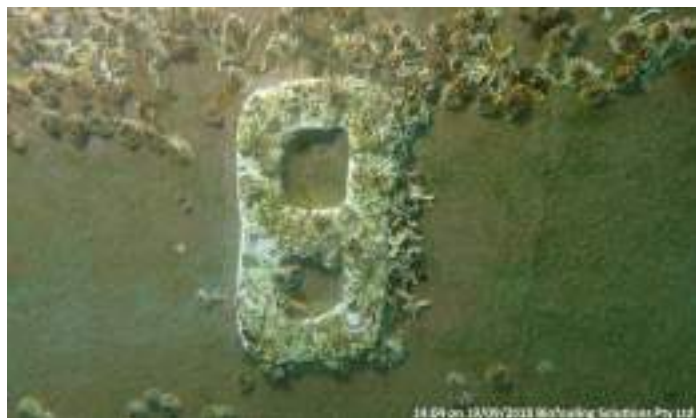
**Plate 25 PRIOR TO CLEANING:** Port side forward draft markers showing secondary biofouling > 5%.

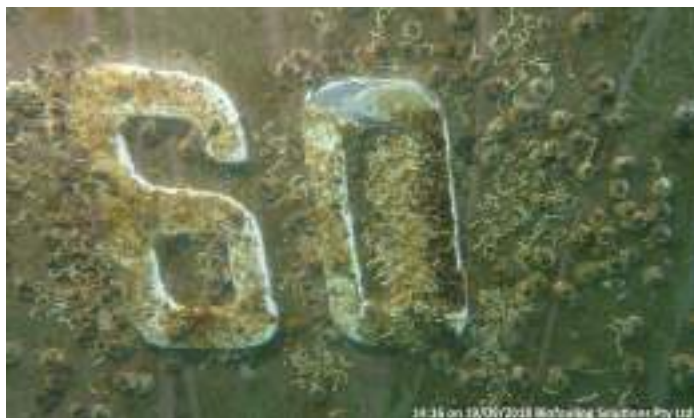
**Plate 26 PRIOR TO CLEANING:** Starboard side forward draft markers showing secondary biofouling > 5%.

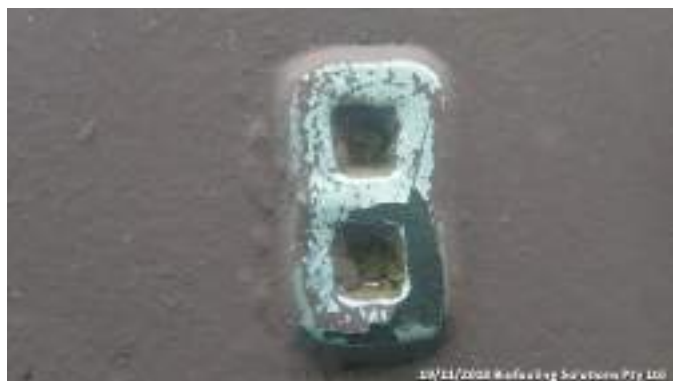
**Plate 27 AFTER CLEANING:** Port side forward draft.

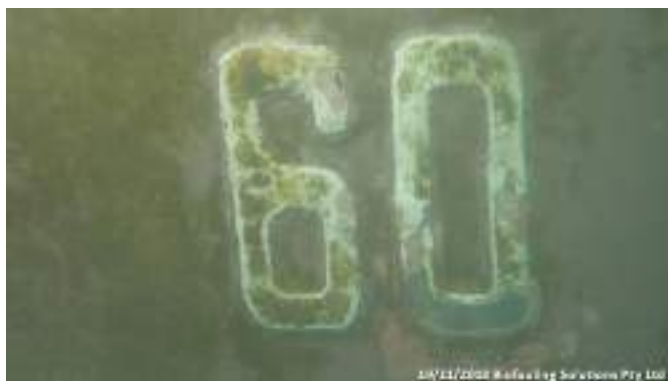
**Plate 28 AFTER CLEANING:** Port side forward draft markers.

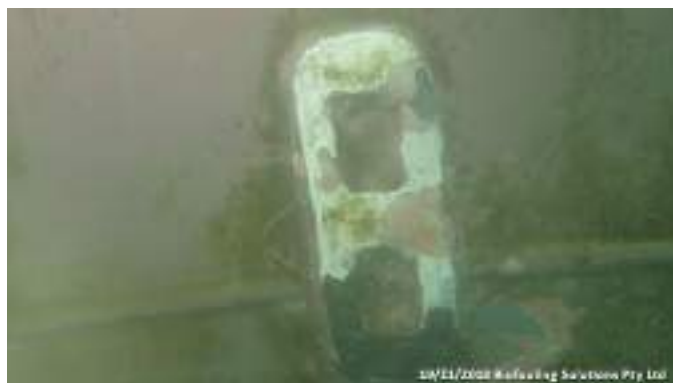
**Plate 29 AFTER CLEANING:** Starboard side forward draft markers.

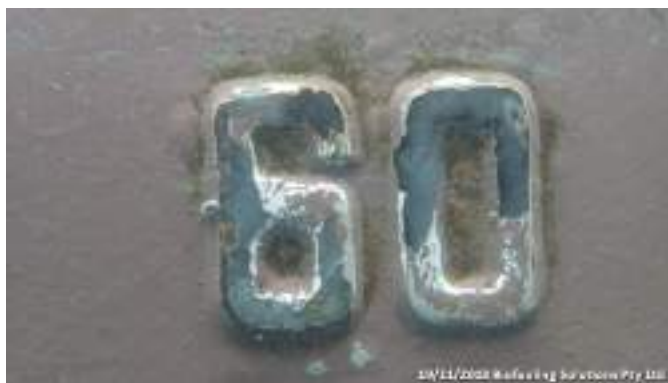
**Plate 30 AFTER CLEANING:** Starboard side forward draft markers.

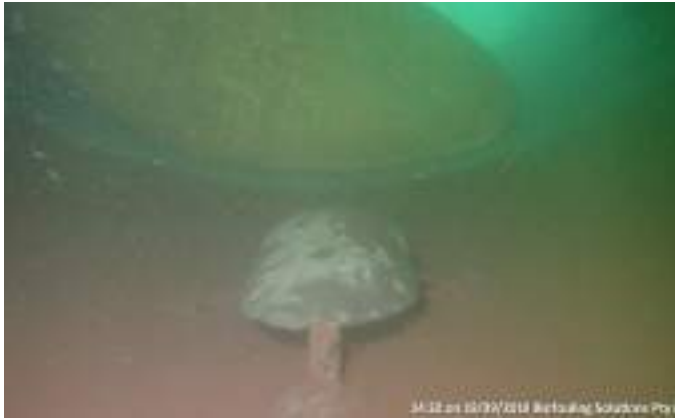
**Plate 31 PRIOR TO CLEANING:** Bow thruster #1. Prop viewed through grating. Divers observed ~50% Secondary biofouling on prop and boss.

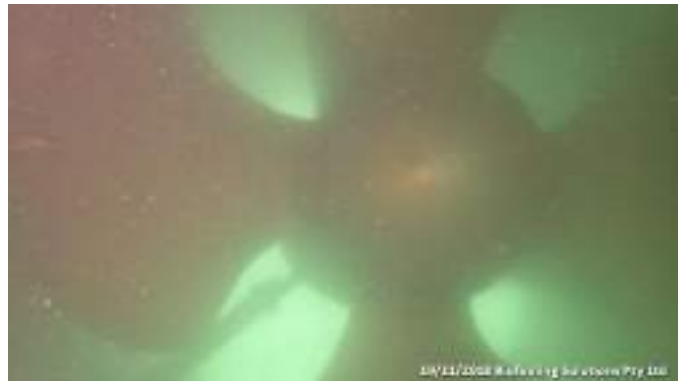
**Plate 34 AFTER CLEANING:** Bow thruster #2. Prop viewed through grating after cleaning.

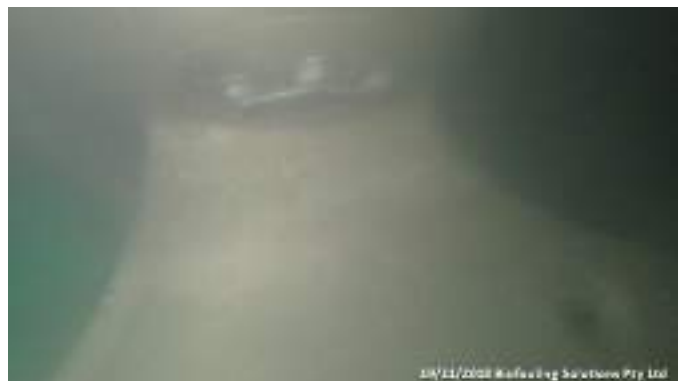
**Plate 36 AFTER CLEANING:** Aft tunnel thruster propeller blade after cleaning.

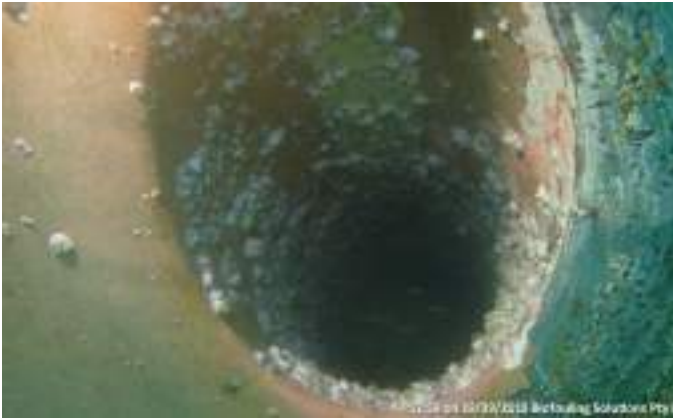
**Plate 37 PRIOR TO CLEANING:** Example of biofouling >5% on overboard pipes.

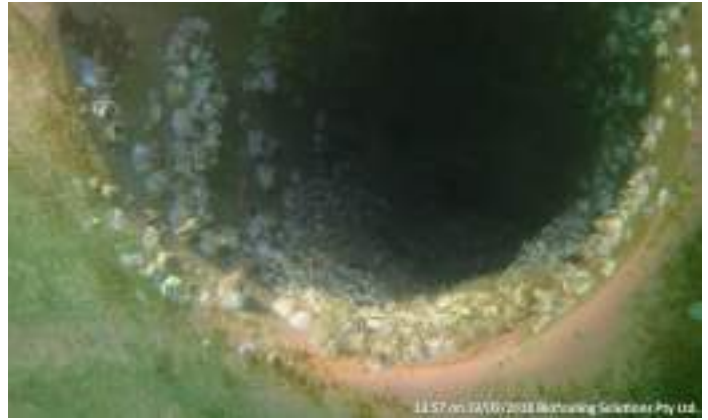
**Plate 38 PRIOR TO CLEANING:** Example of biofouling >5% on overboard pipes.

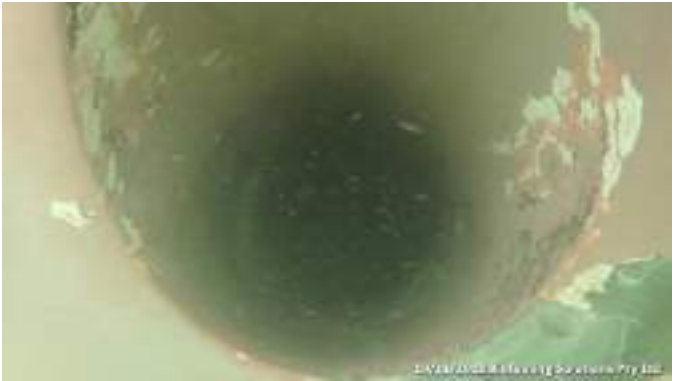
**Plate 39 AFTER CLEANING:** Example of overboard pipes after cleaning. Biofouling limited to non-viable acorn barnacles bases.

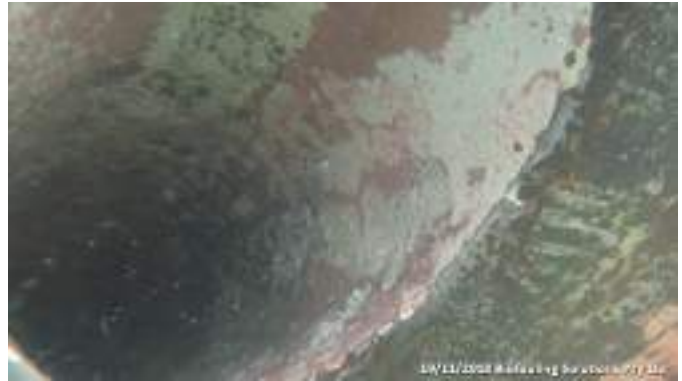
**Plate 40 AFTER CLEANING:** Example of overboard pipes after cleaning. Biofouling limited to non-viable acorn barnacles bases.

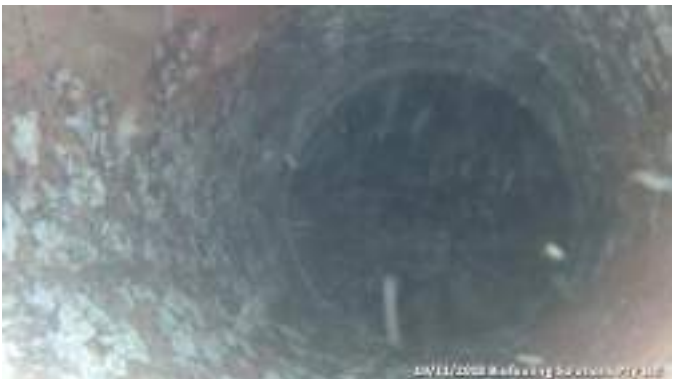
**Plate 41 AFTER CLEANING:** Example of overboard pipes after cleaning. Biofouling limited to non-viable acorn barnacles bases.

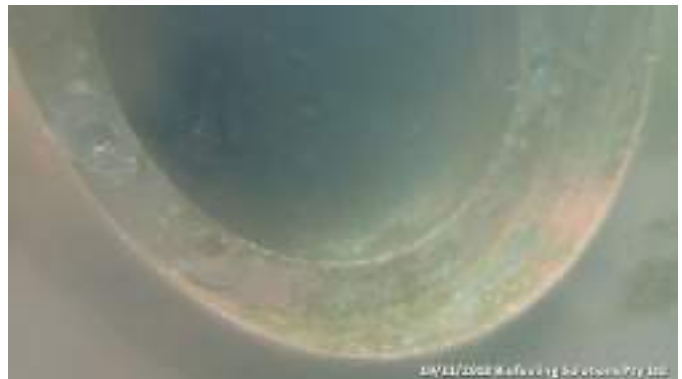
**Plate 42 AFTER CLEANING:** Example of overboard pipes after cleaning. Biofouling limited to non-viable acorn barnacles bases.

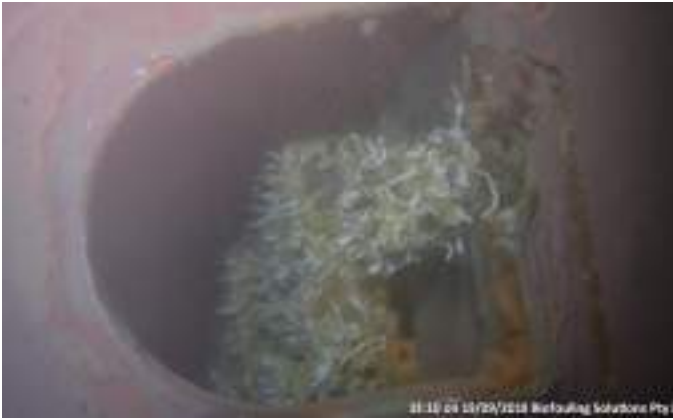
**Plate 43 PRIOR TO CLEANING:** Example of biofouling >5% within rope-guard void spaces

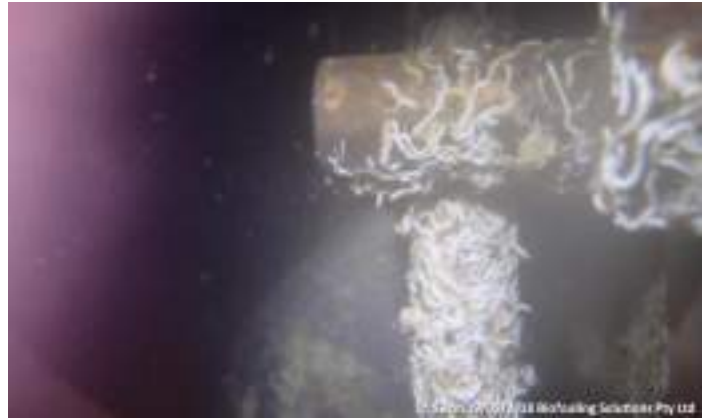
**Plate 44 PRIOR TO CLEANING:** Example of biofouling >5% within rope-guard void spaces

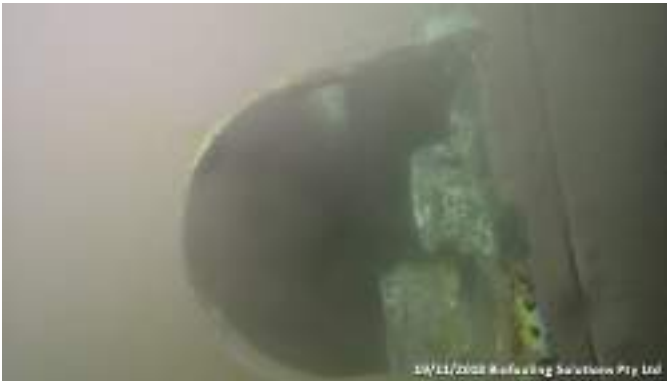
**Plate 45 AFTER CLEANING:** Example of rope guard void after cleaning.

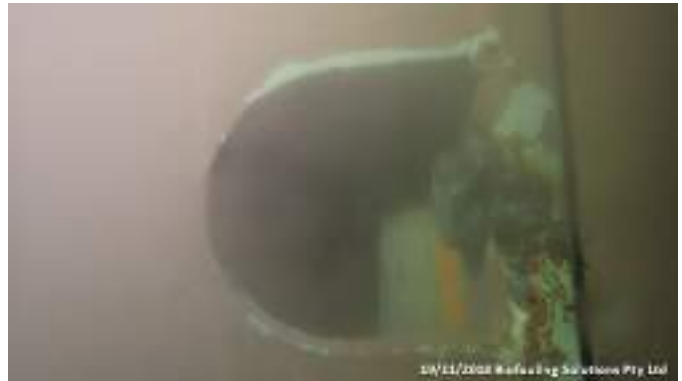
**Plate 46 AFTER CLEANING:** Example of rope guard void after cleaning.

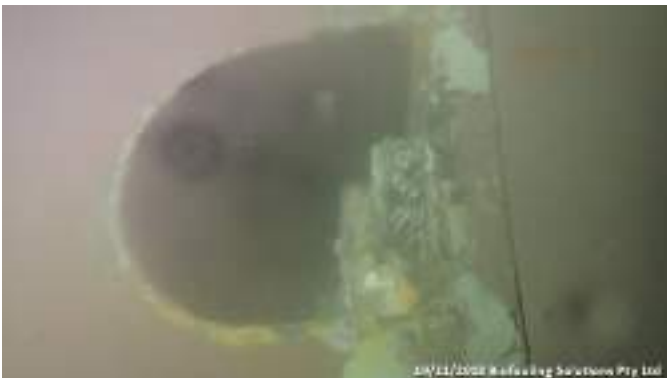
**Plate 47 AFTER CLEANING:** Example of rope guard void after cleaning.

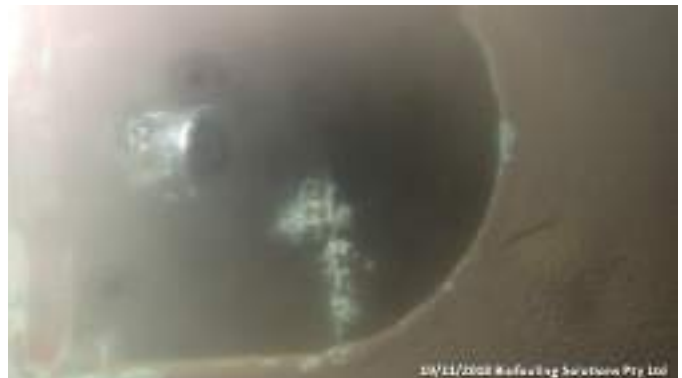
**Plate 48 AFTER CLEANING:** Example of rope guard void after cleaning.

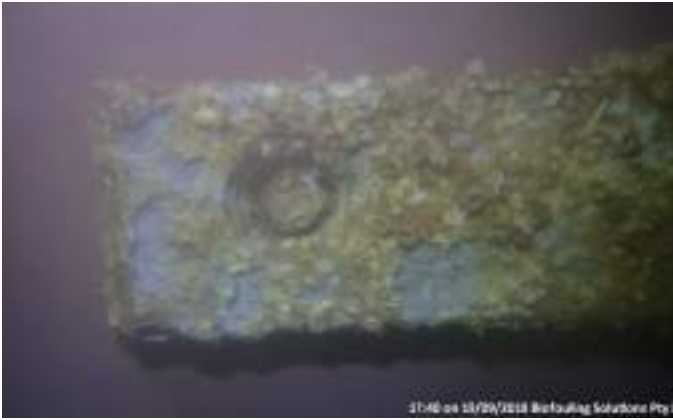
**Plate 49 PRIOR TO CLEANING:** Example of biofouling >5% on rudder anodes.

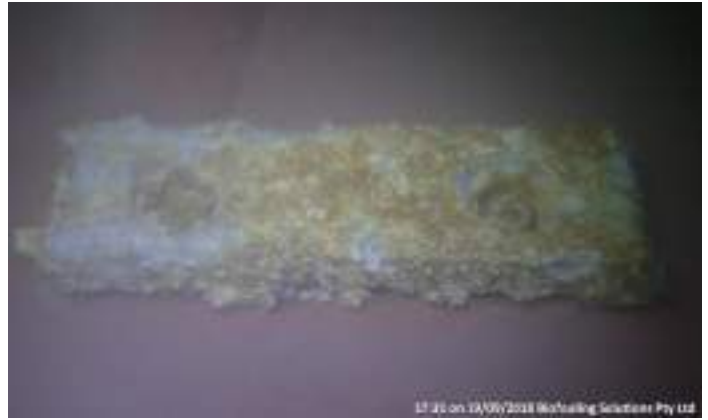
**Plate 50 PRIOR TO CLEANING:** Example of biofouling >5% on rudder anodes.

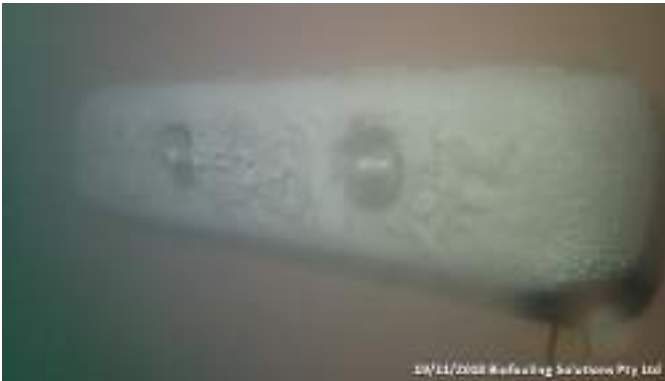
**Plate 51 AFTER CLEANING:** Example of rudder anode after cleaning.

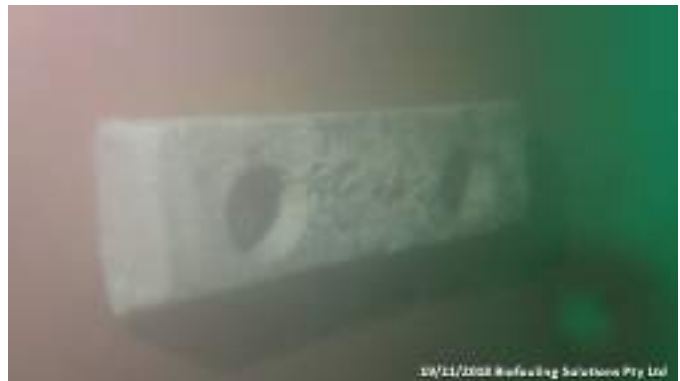
**Plate 52 AFTER CLEANING:** Example of rudder anode after cleaning.

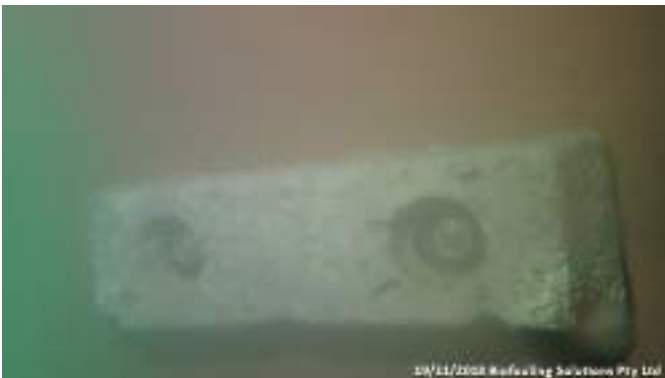
**Plate 53 AFTER CLEANING:** Example of rudder anode after cleaning.

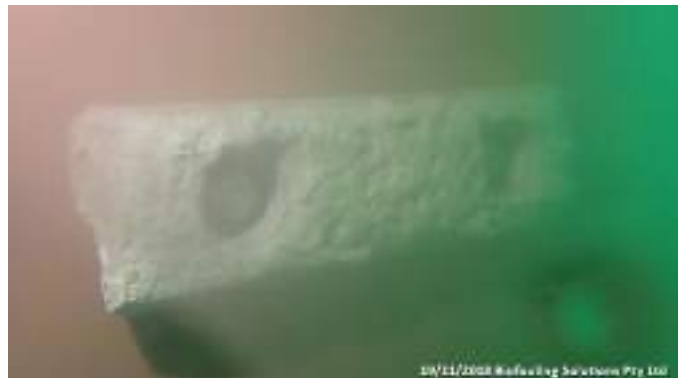
**Plate 54 AFTER CLEANING:** Example of rudder anode after cleaning.

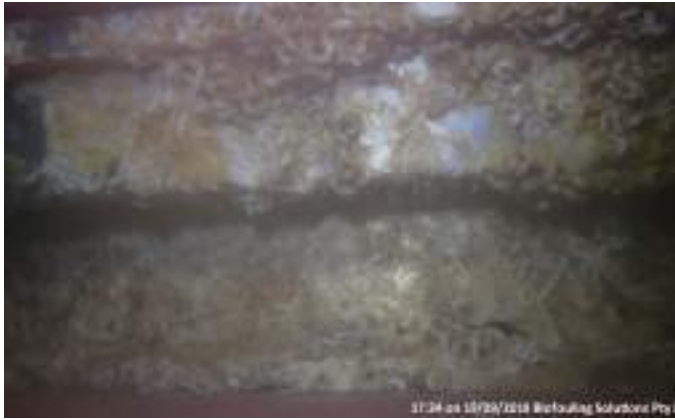
**Plate 55 PRIOR TO CLEANING:** Top of port rudder stock with >5% secondary biofouling.

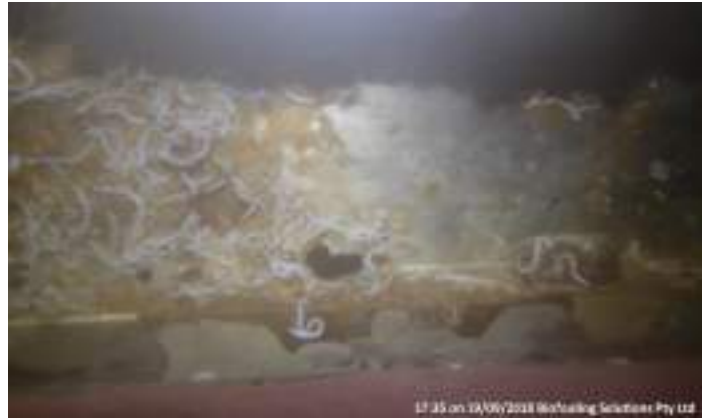
**Plate 56 PRIOR TO CLEANING:** example of >5% secondary biofouling and scattered tertiary biofouling (mussels) associated with rudders.
