# In-water clean and biofouling inspection of the *MV Example* to demonstrate compliance with New Zealand and Australian biofouling regulations

Initial Inspection: 19/09/18: Singapore Cruise Centre, Singapore  
In-water clean: 17/11/18: Laem Chabang, Thailand.  
Final inspection: 23/11/18: Singapore Cruise Centre, Singapore

Prepared for **Company X**

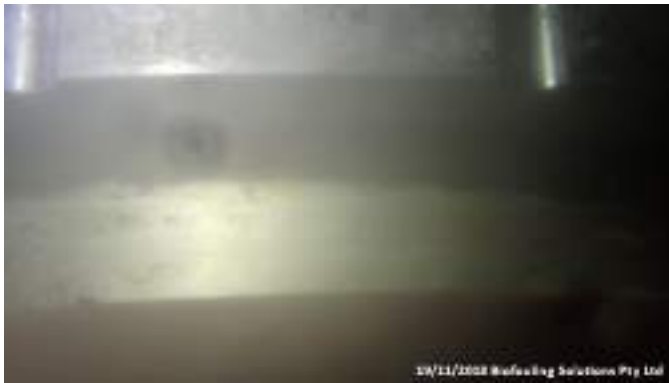
**Plate 57 AFTER CLEANING:** Example of non-antifouled rudder surfaces after cleaning.

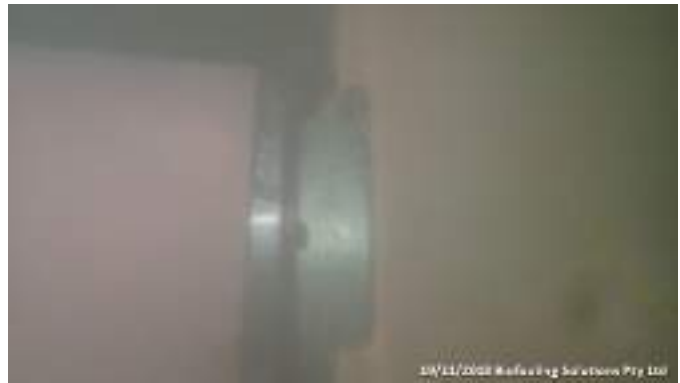
**Plate 58 AFTER CLEANING:** Example of non-antifouled rudder surfaces after cleaning.

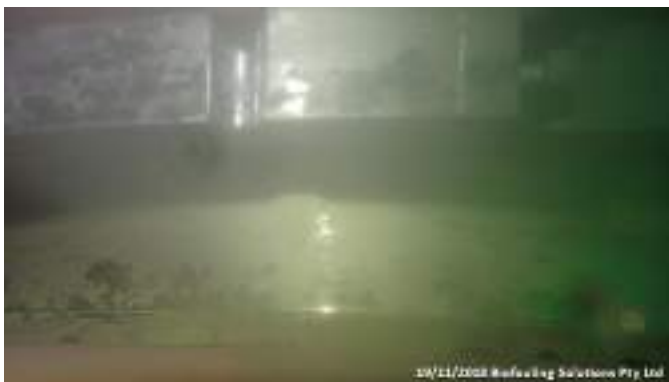
**Plate 59 AFTER CLEANING:** Example of non-antifouled rudder surfaces after cleaning.

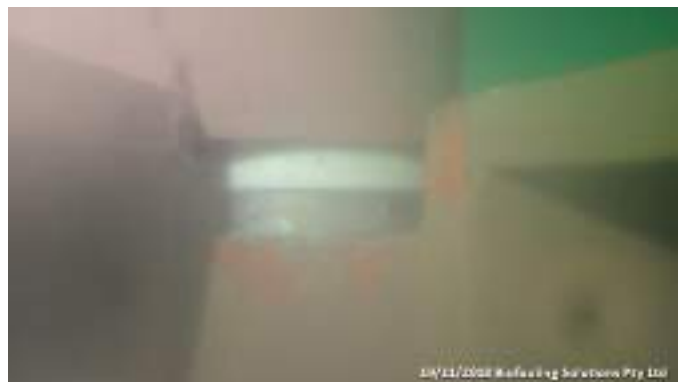
**Plate 60 AFTER CLEANING:** Example of non-antifouled rudder surfaces after cleaning.

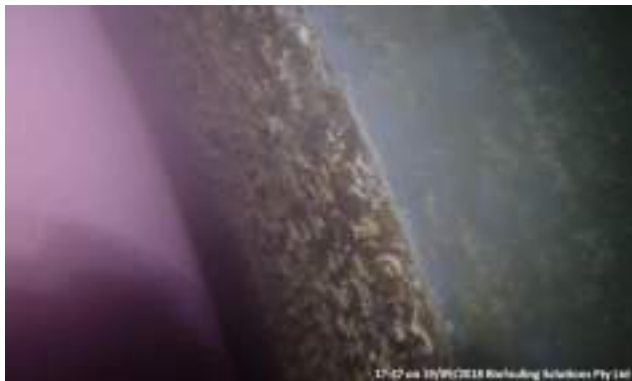
**Plate 61 PRIOR TO CLEANING:** Port Promes propeller showing interface surface with >5% secondary biofouling.

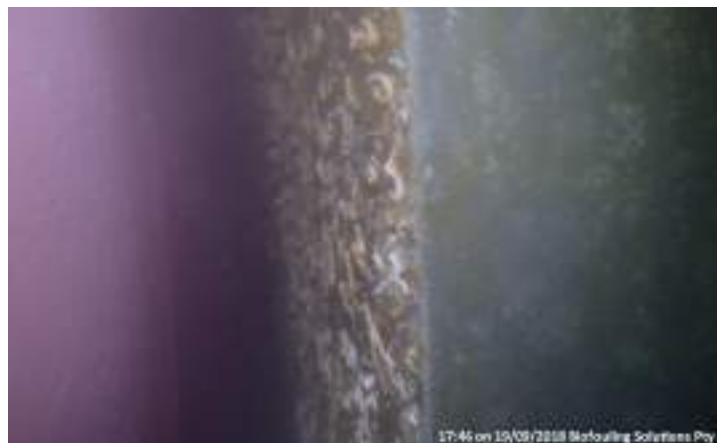
**Plate 62 PRIOR TO CLEANING:** Example of >5% secondary biofouling associated with Promes propeller.

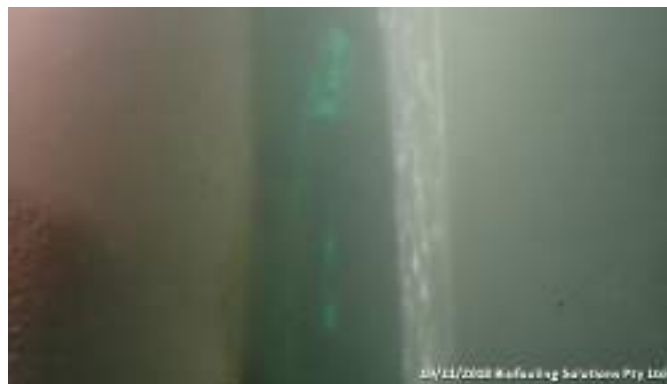
**Plate 64 AFTER CLEANING:** Example of propeller boss surface after cleaning.

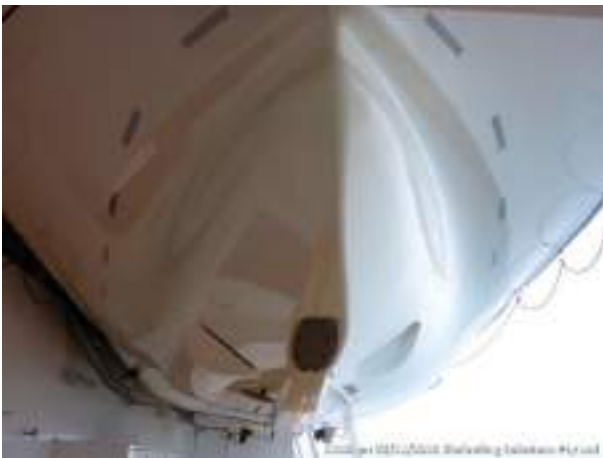
**Plate 21** Starboard side tender / lifeboat #6

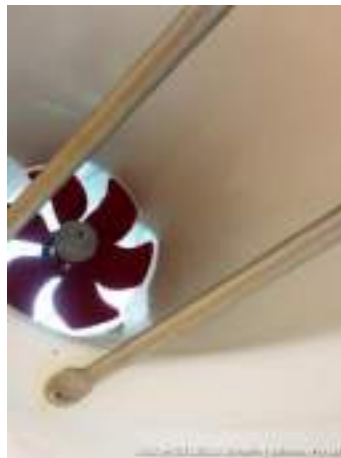
**Plate 22** Starboard side tender / lifeboat #6

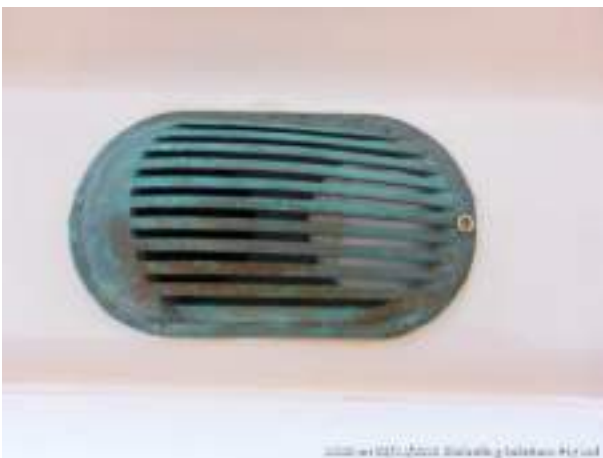
**Plate 23** Starboard side tender / lifeboat #6

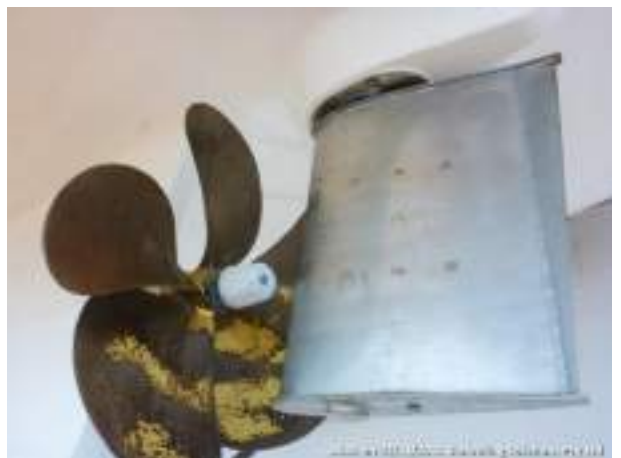
**Plate 24** Starboard side tender / lifeboat #6
