## BIOFOULING HULL INSPECTION

HIFOFUA

WEDNESDAY 19TH AUGUST 2026

*Hifofua*, a 27 metre tug operated by Ports Authority Tonga, was inspected alongside Fuaa Wharf at Nuku'alofa on 19 August 2026. The inspection was conducted using a Deep Trekker Pivot remotely operated vehicle deployed from the wharf, and findings were recorded in the MarineStream platform. Fouling was assessed against the Level of Fouling (LoF) scale set out in the New Zealand Craft Risk Management Standard.

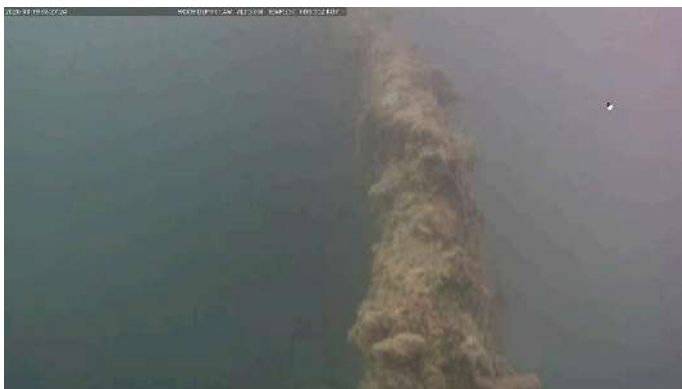
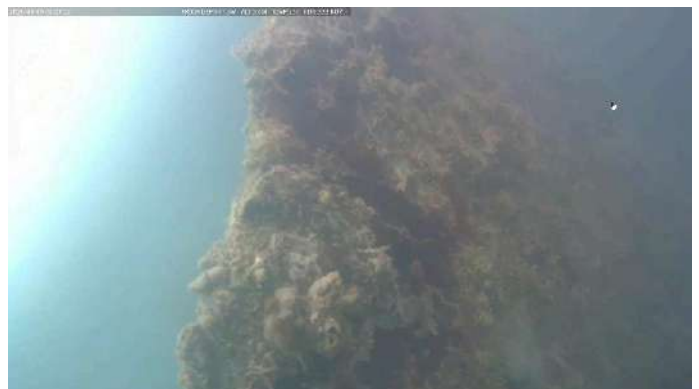
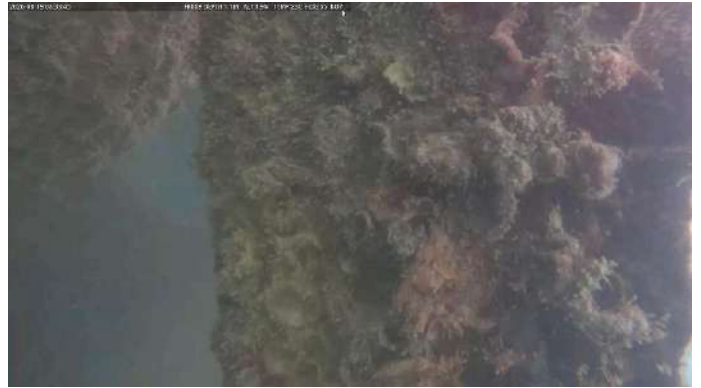
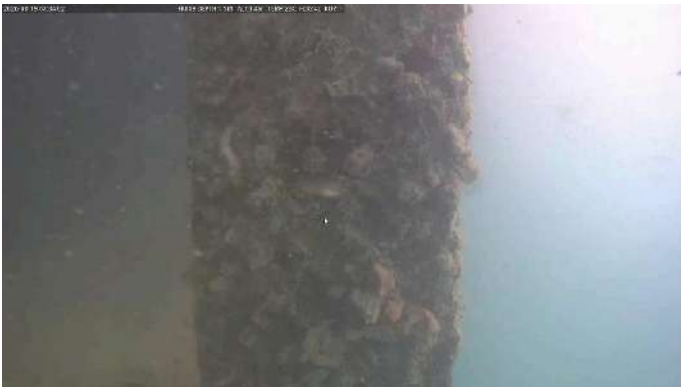
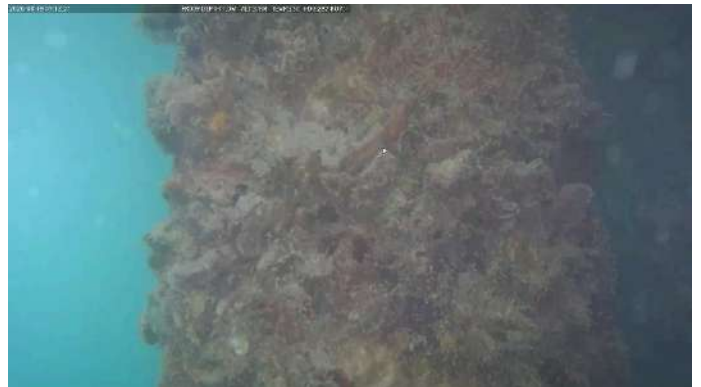
## 5.1 RUDDER

Heavy fouling recorded across the majority of the rudder. Top of rudder, leading edge, both rudder flat plates, both rudder hinges and both pintle bearings all rated LoF 5, with macrofouling covering 41–100 per cent of visible surfaces. Both inspection ports and the anodes rated LoF 4 at 16–40 per cent coverage. Anodes heavily fouled but appear approximately 80 per cent intact. Fouling density prevented assessment of the underlying coating.

The fouling is a mature composite community, consistent with a vessel held largely stationary in warm, sheltered harbour water. A filamentous algal turf overlies a base of calcareous hard fouling, with erect soft fouling and encrusting colonial growth established across the sheltered, low-flow surfaces. Fouling density and poor visibility prevented resolution of individual organisms, so composition is described at category level only. Confirmation would require physical sampling and taxonomic identification.

- Undertake an in-water hull clean with capture, prioritising the rudder assembly, propeller and stern arrangement.
- Collect samples during cleaning so the organisms present can be identified and the invasive marine species question closed out. This inspection cannot answer it.

- Confirm cathodic protection performance once the anodes are cleared. Anodes are approximately 80 per cent intact and were heavily fouled at inspection.

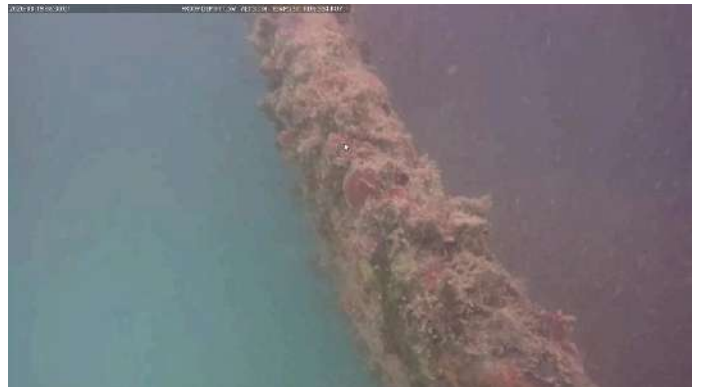
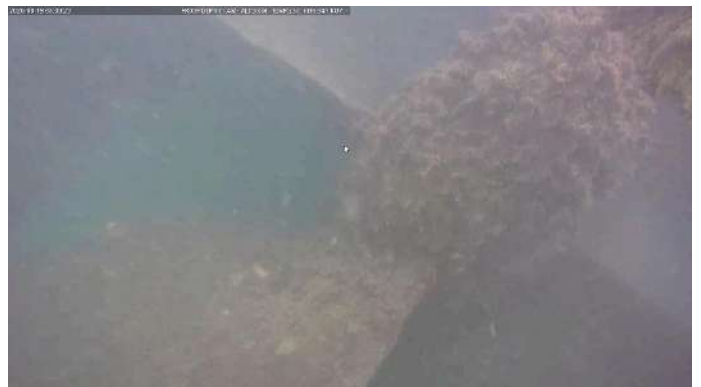
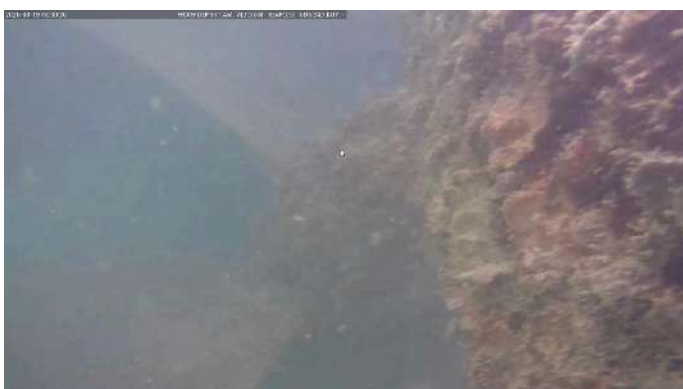
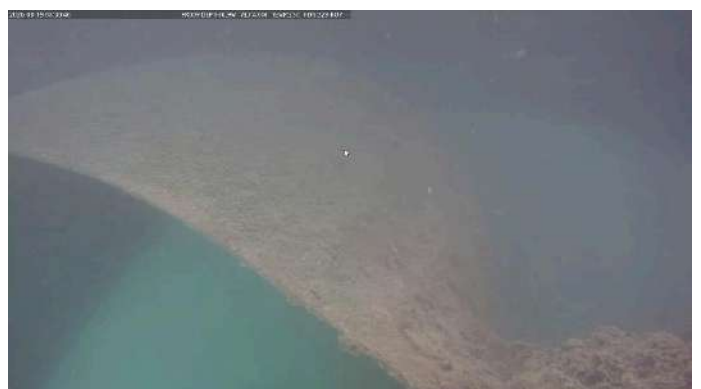
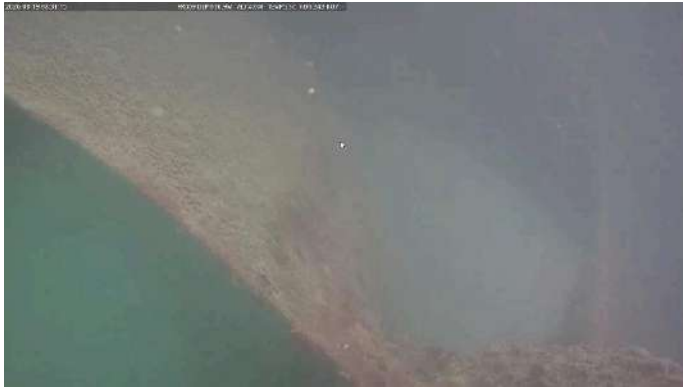
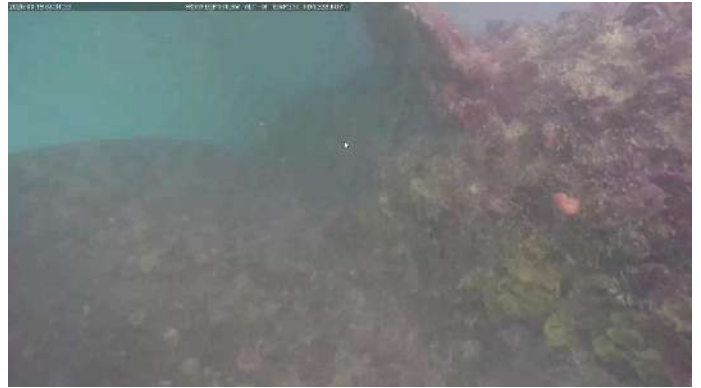
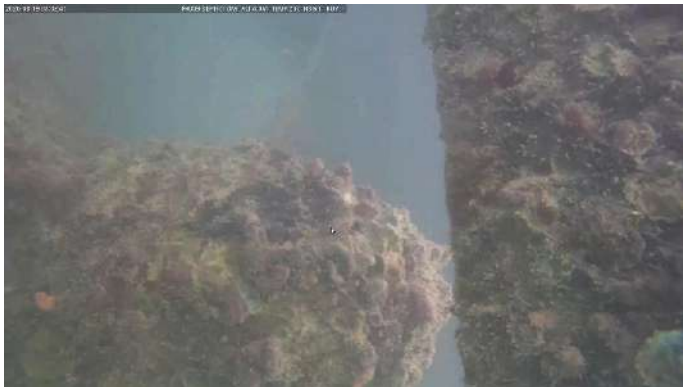
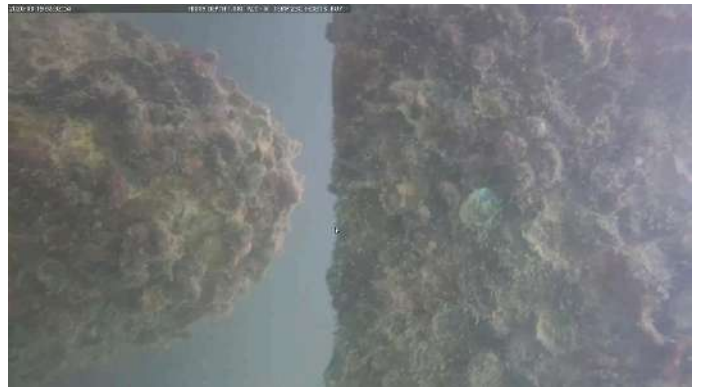
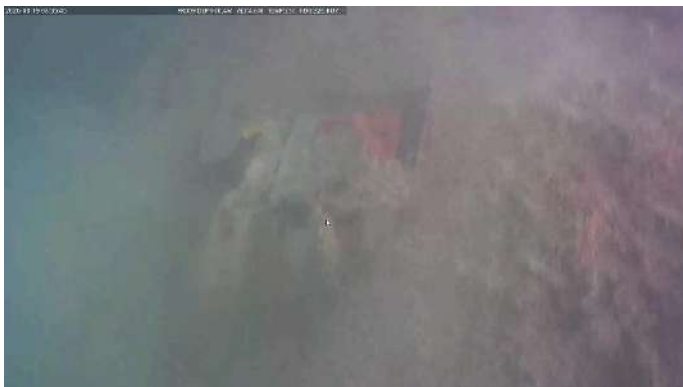
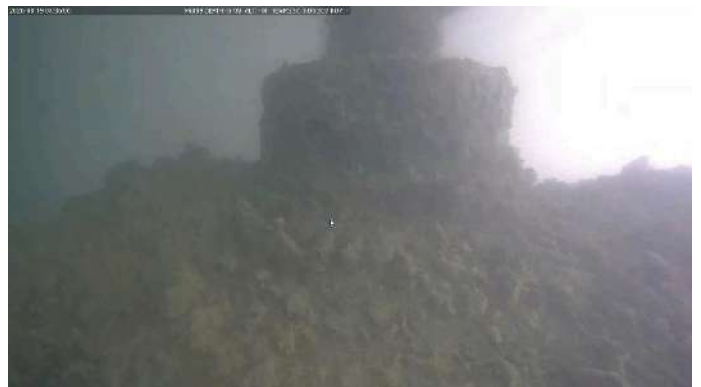
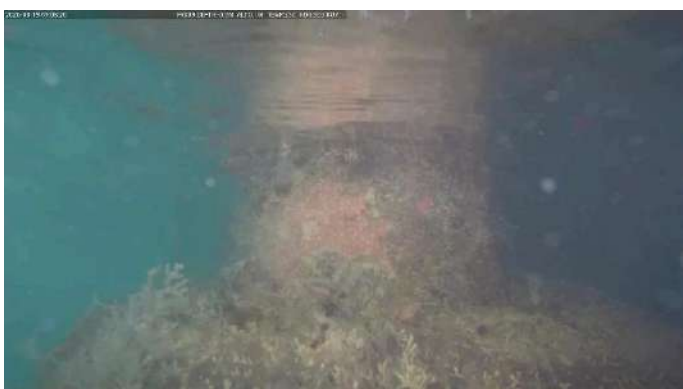
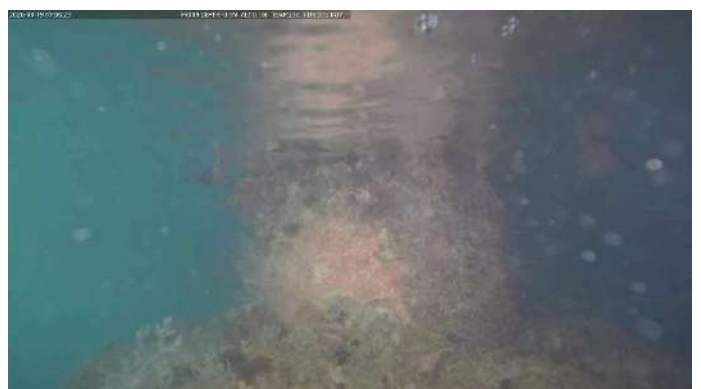
## 5.2 PROPELLER

Propeller inspected by ROV in poor visibility. Boss and all four blades rated LoF 5, with macrofouling covering the full visible surface. Calcareous fouling and heavy filamentous algae present. Fixings on the boss and blades were not visible due to the level of fouling. Propeller tunnel heavily fouled with calcareous fouling and filamentous algae.

The fouling is a mature composite community, consistent with a vessel held largely stationary in warm, sheltered harbour water. A filamentous algal turf overlies a base of calcareous hard fouling, with erect soft fouling and encrusting colonial growth established across the sheltered, low-flow surfaces. Fouling density and poor visibility prevented resolution of individual organisms, so composition is described at category level only. Confirmation would require physical sampling and taxonomic identification.

- Reassess antifouling coating condition once fouling is removed. No coating data exists for any part of the vessel.
- Verify the integrity of the propeller boss and blade fixings once cleaned, and locate and inspect the rope guard inspection ports.

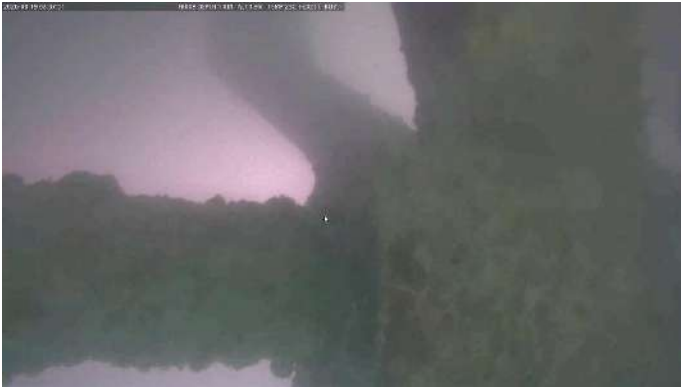
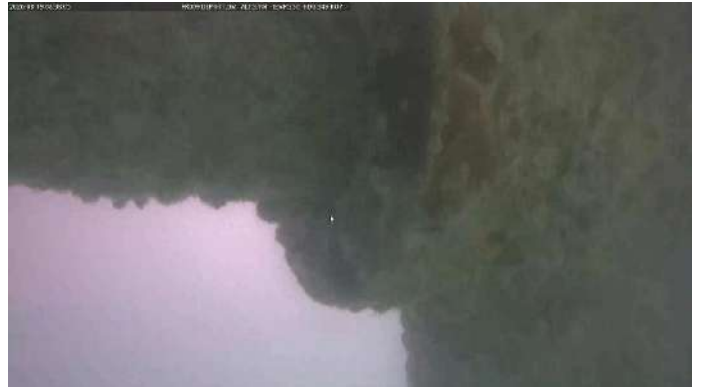
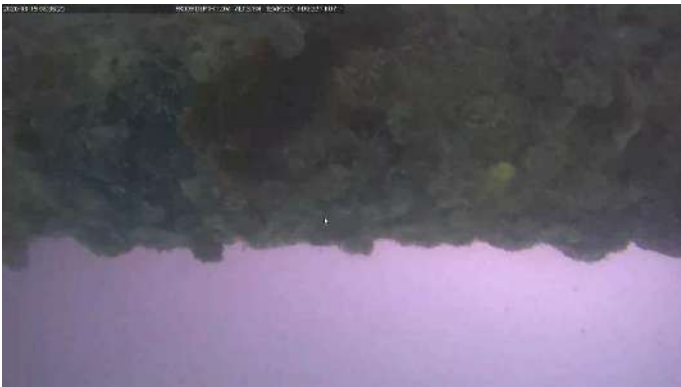
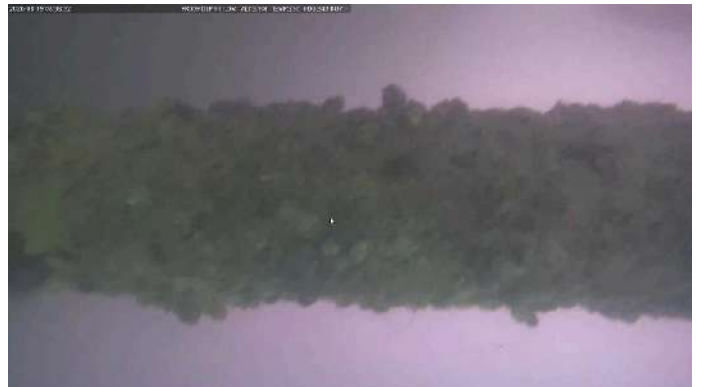
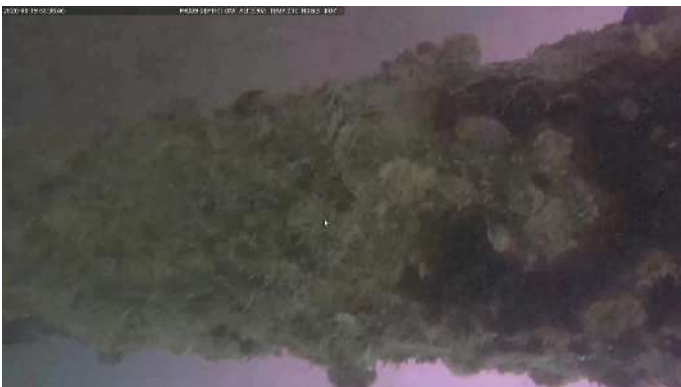
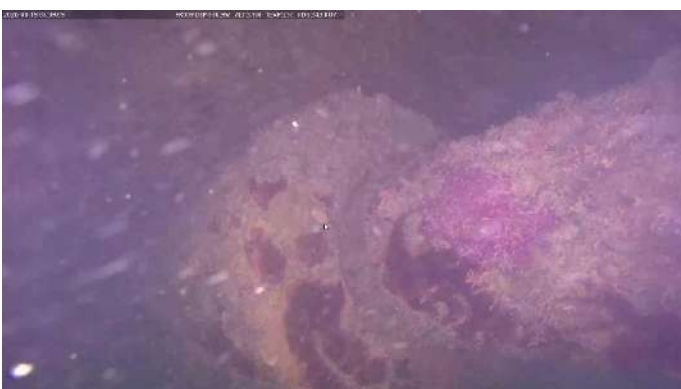
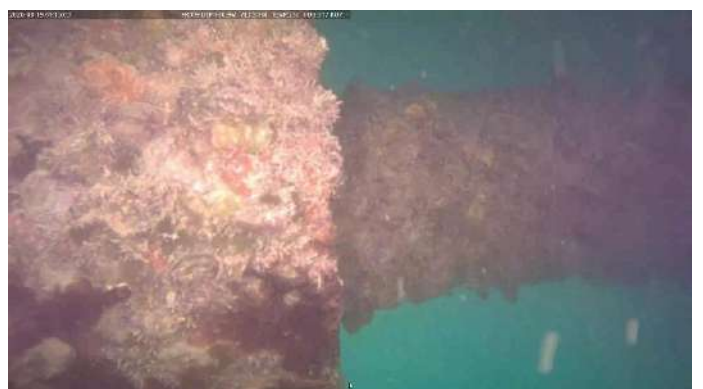
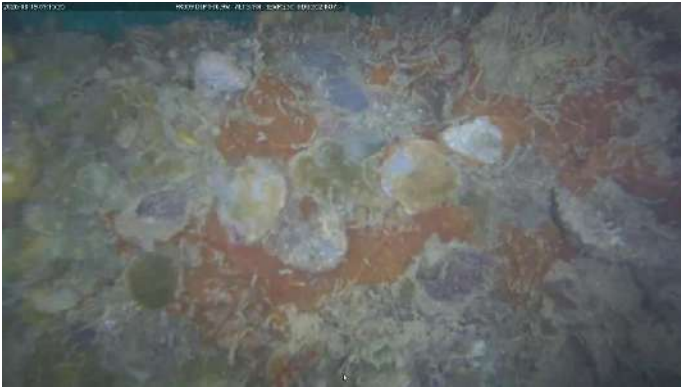
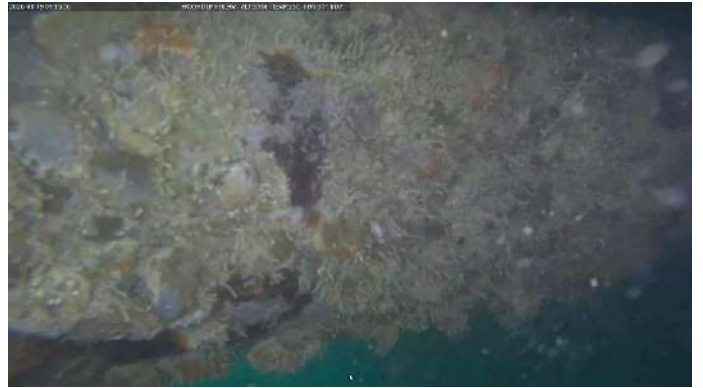
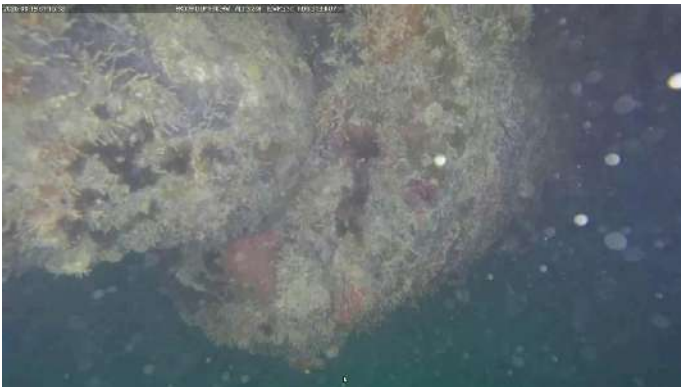
### 5.3 STERN ARRANGEMENT

Stern arrangement inspected by ROV in poor visibility. Rope guard, eddy cover, stern tube and A-bracket all rated LoF 5, with macrofouling covering 41–100 per cent of visible surfaces. Coating condition could not be assessed due to the level of fouling. The rope guard inspection ports could not be located.

The fouling is a mature composite community, consistent with a vessel held largely stationary in warm, sheltered harbour water. A filamentous algal turf overlies a base of calcareous hard fouling, with erect soft fouling and encrusting colonial growth established across the sheltered, low-flow surfaces. Fouling density and poor visibility prevented resolution of individual organisms, so composition is described at category level only. Confirmation would require physical sampling and taxonomic identification.
