# SAFETY INVESTIGATION REPORT

**201911/010** REPORT NO.: 20/2020 November 2020

MV FILIA T Fire in container in position 12° 39' N 109° 44' E, 11 November 2019

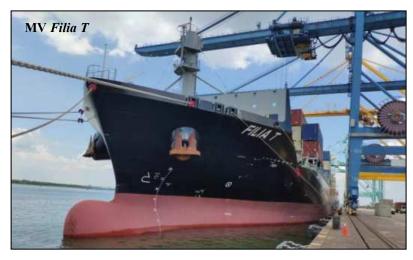
Filia T (Figure 1) was a container ship of 19,035 gt, 1,800 TEU, owned by Filia T Shipping Limited and operated by Virono Shipping S.A., Greece. The vessel was built by Jiangsu New Yangzi Shipbuilding Co. Ltd., China, in 2019 and was classed with Lloyds Register (LR). The vessel had a length overall of 172.00 m and a moulded breadth of 28.40 m. The vessel's summer draft was 9.50 m, corresponding to a summer deadweight of 23,421 metric tonnes. At the time of the occurrence, the vessel was drawing a maximum draft of 7.70 m.

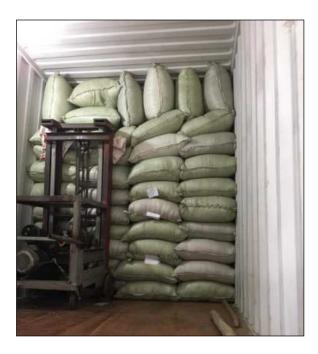
Figure 7: Indication of how the cinnamon leaves in bags were stowed inside the container

Figure 7 gives an indication of how the cinnamon leaves in bags were packed and stowed inside the container.
