Report on the investigation of the collision between

Seagate

and

Timor Stream

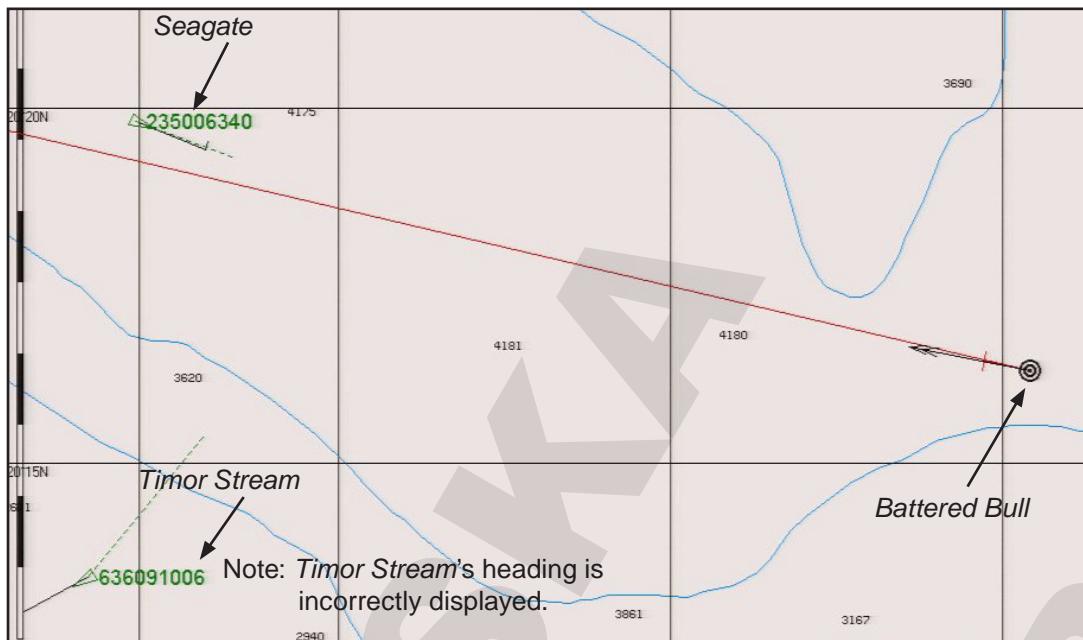
Figure 3: Battered Bull's ECS display at 0520

At 0520, the motor yacht *Battered Bull* was heading 326° at a speed of 12.5 knots at a range of 13nm from *Seagate*, on an almost reciprocal heading (**Figure 3**). *Timor Stream* was around 25° on *Battered Bull*'s port bow crossing from port to starboard. *Battered Bull*'s chief officer identified that *Seagate* and *Timor Stream* were 6.7nm apart and that action was required by *Seagate*, the give way vessel, to avoid a close quarters situation or collision.

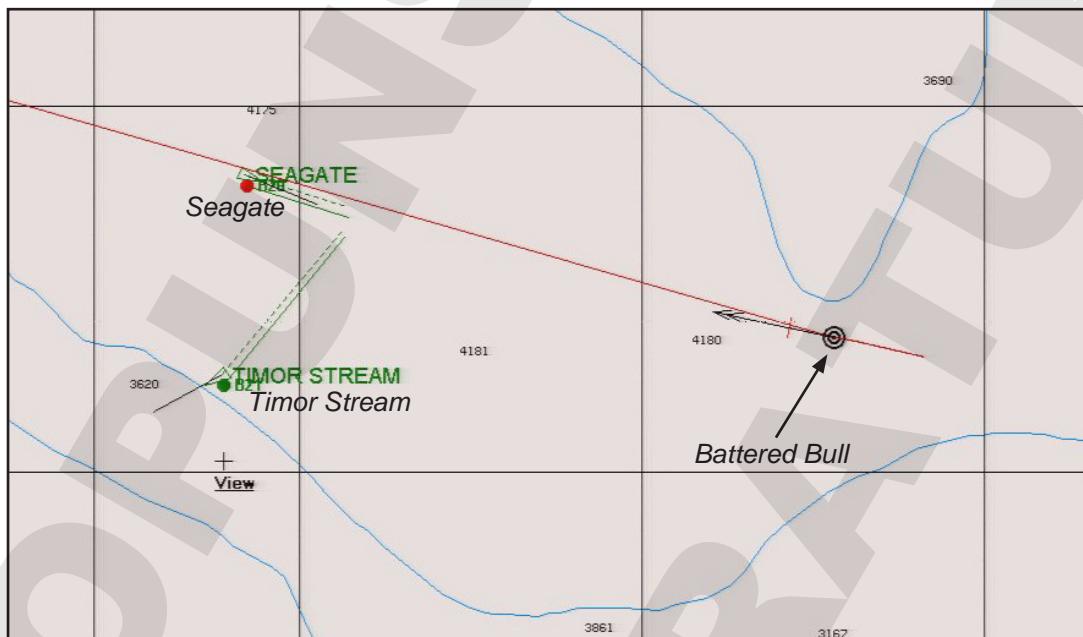
Figure 4: Battered Bull's ECS display at 0532

By 0532, *Seagate* and *Timor Stream* were 2.8nm from each other on a collision course (**Figure 4**); *Battered Bull* was 8.5nm from *Seagate*. *Battered Bull*'s chief officer altered course 24° to port to avoid the developing situation with both *Seagate* and *Timor Stream* (**Figure 5**).

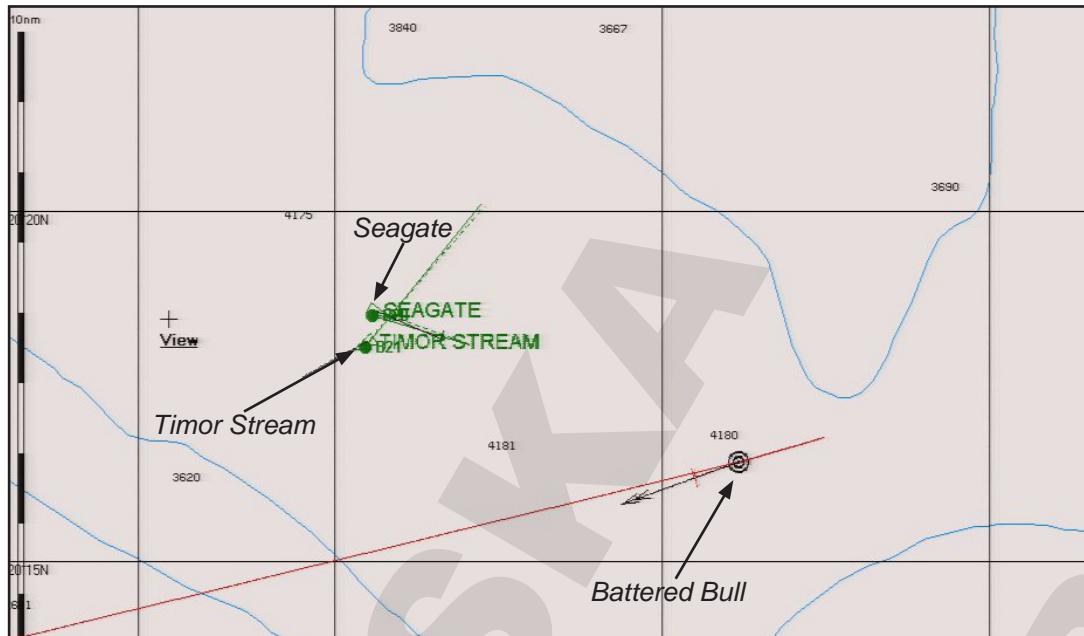
Figure 6: Battered Bull's ECS display at 0539

At around 0535, *Seagate*'s lookout again told the chief officer about the other ship on his starboard side. As the distance between the two ships further reduced, the lookout yet again alerted the chief officer to the presence of the other ship. At 0539 (**Figure 6**) the chief officer started to alter *Seagate*'s heading slowly to port; he predicted that this adjustment would increase the passing distance of the two ships. Shortly afterwards the lookout shouted at the chief officer to "do something". The chief officer reported that he saw *Timor Stream* turn to port towards *Seagate* and, when he realised that a collision was imminent, he put the steering controls into manual mode and turned the helm hard to port.

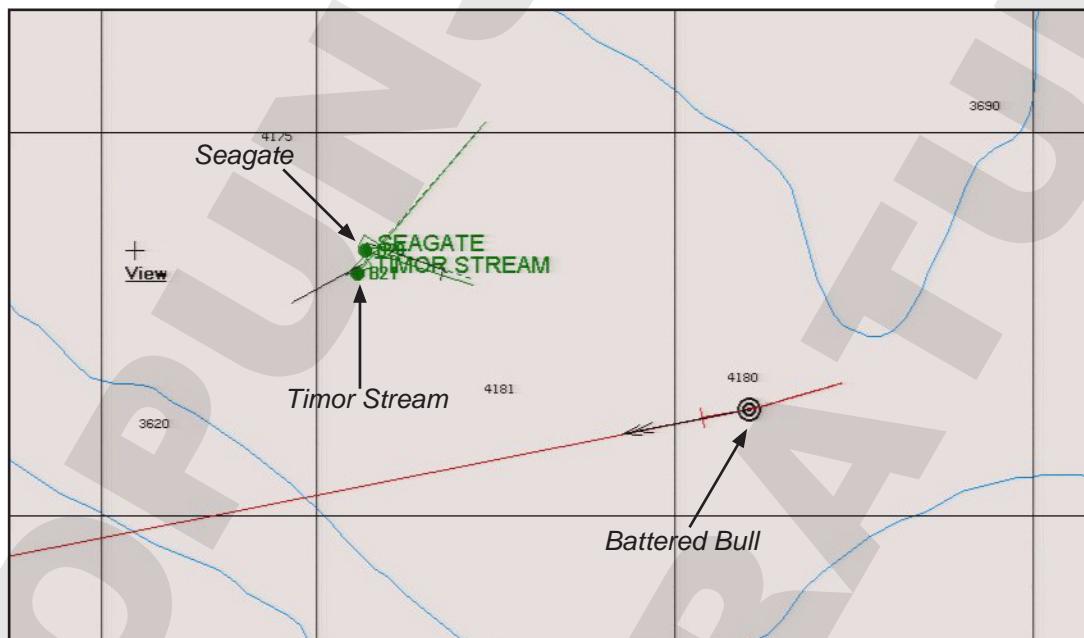
Figure 7: Battered Bull's ECS display at 0540

Timor Stream's master first saw a ship very close on his port bow at 0540 (**Figure 7**). He was unable to take avoiding action prior to the collision in the short time available to him.

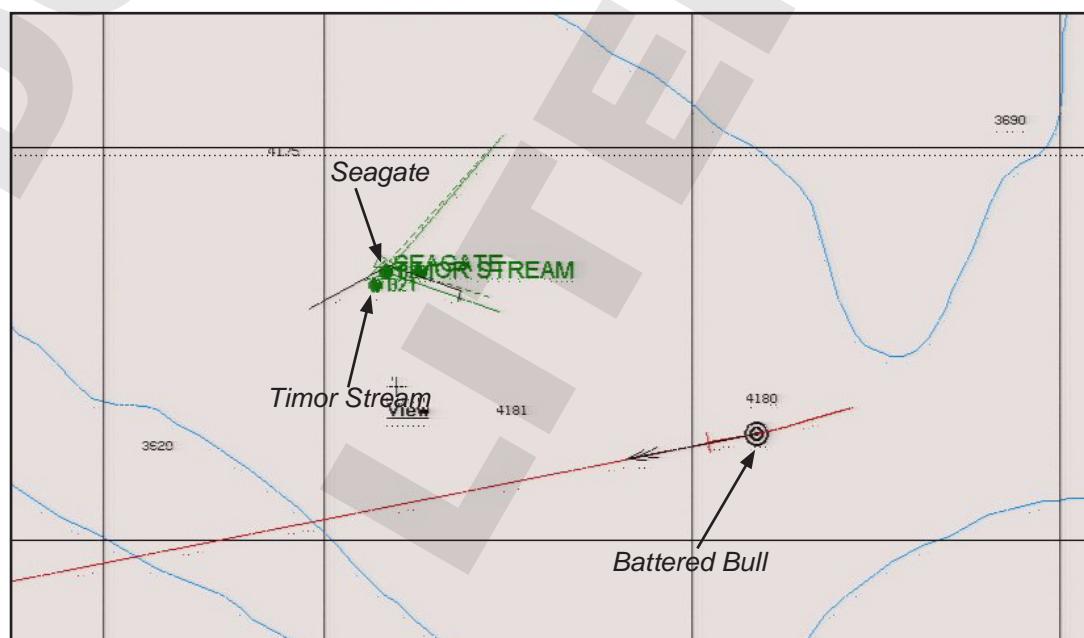
At 0540:50 the two vessels collided (**Figure 8**). *Timor Stream*'s heading had not changed; *Seagate*'s heading had altered by 7°. *Timor Stream*'s bow hit the after part of *Seagate*'s starboard side in the area of the accommodation block and engine room; the engine room started to flood and the electrical power system failed. *Seagate*'s starboard liferaft was destroyed and its starboard lifeboat fell onto *Timor Stream*'s damaged forecastle deck.

Figure 8: Battered Bull's ECS display at 0540:50

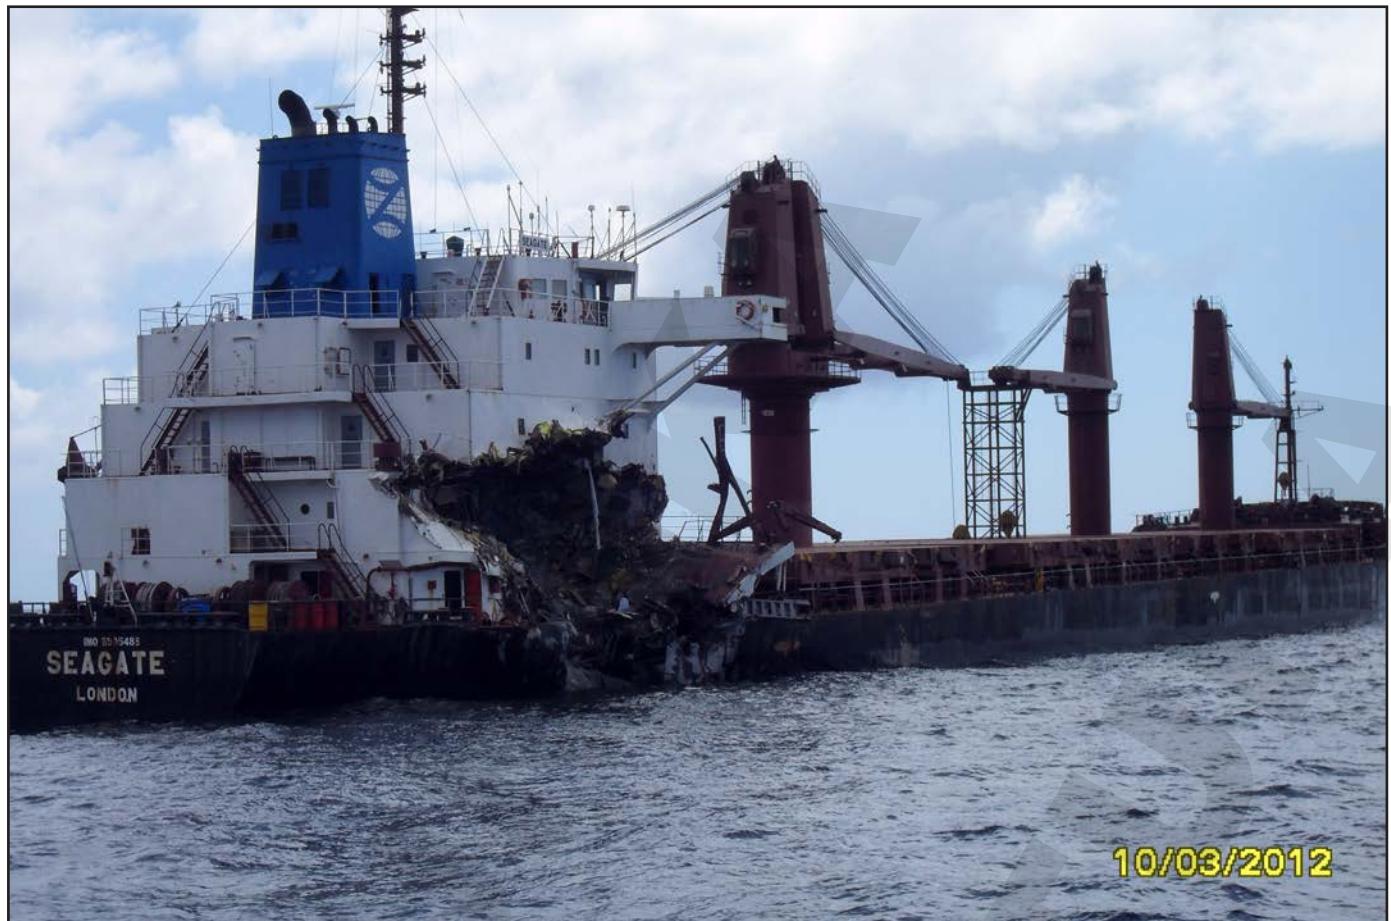
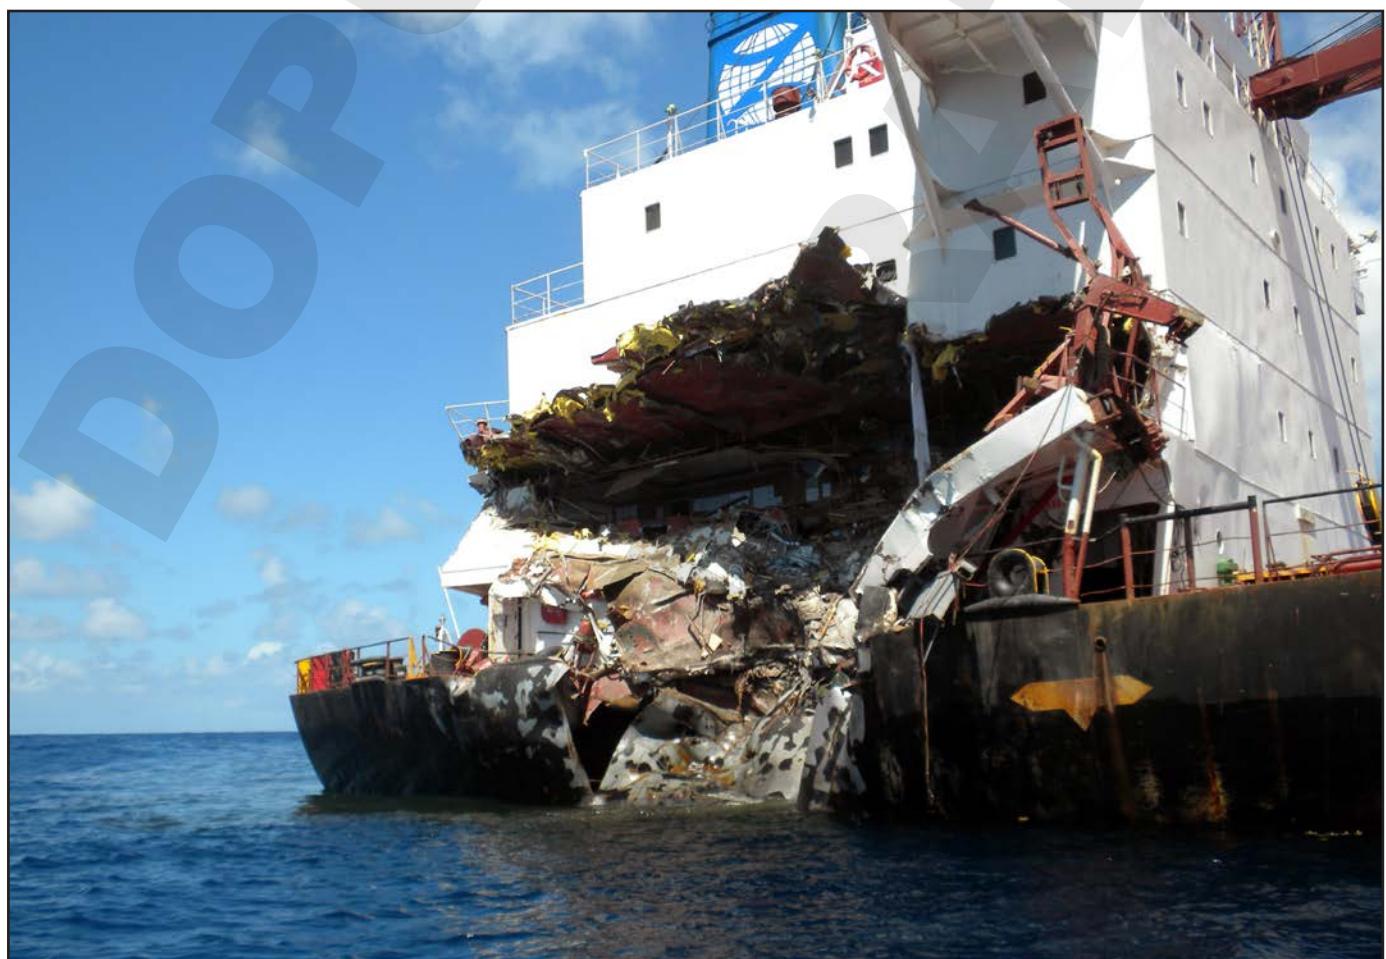
Seagate suffered extensive damage to the aft starboard side (**Figures 13a and b**). The engine room was holed above and below the waterline and flooded. Around 12500 litres of diesel oil and 5500 litres of lubricating oil spilled into the sea and flooded engine room from two damaged tanks. The accommodation on the starboard side was heavily damaged, including numerous cabins and the mess room. The starboard lifeboat and liferaft were destroyed. The cargo holds were undamaged and the vessel remained stable throughout the tow to Port-au-Prince.

Figure 13a: Seagate's starboard side – post-collision

Figure 13b: Seagate's starboard side – post-collision (close-up)

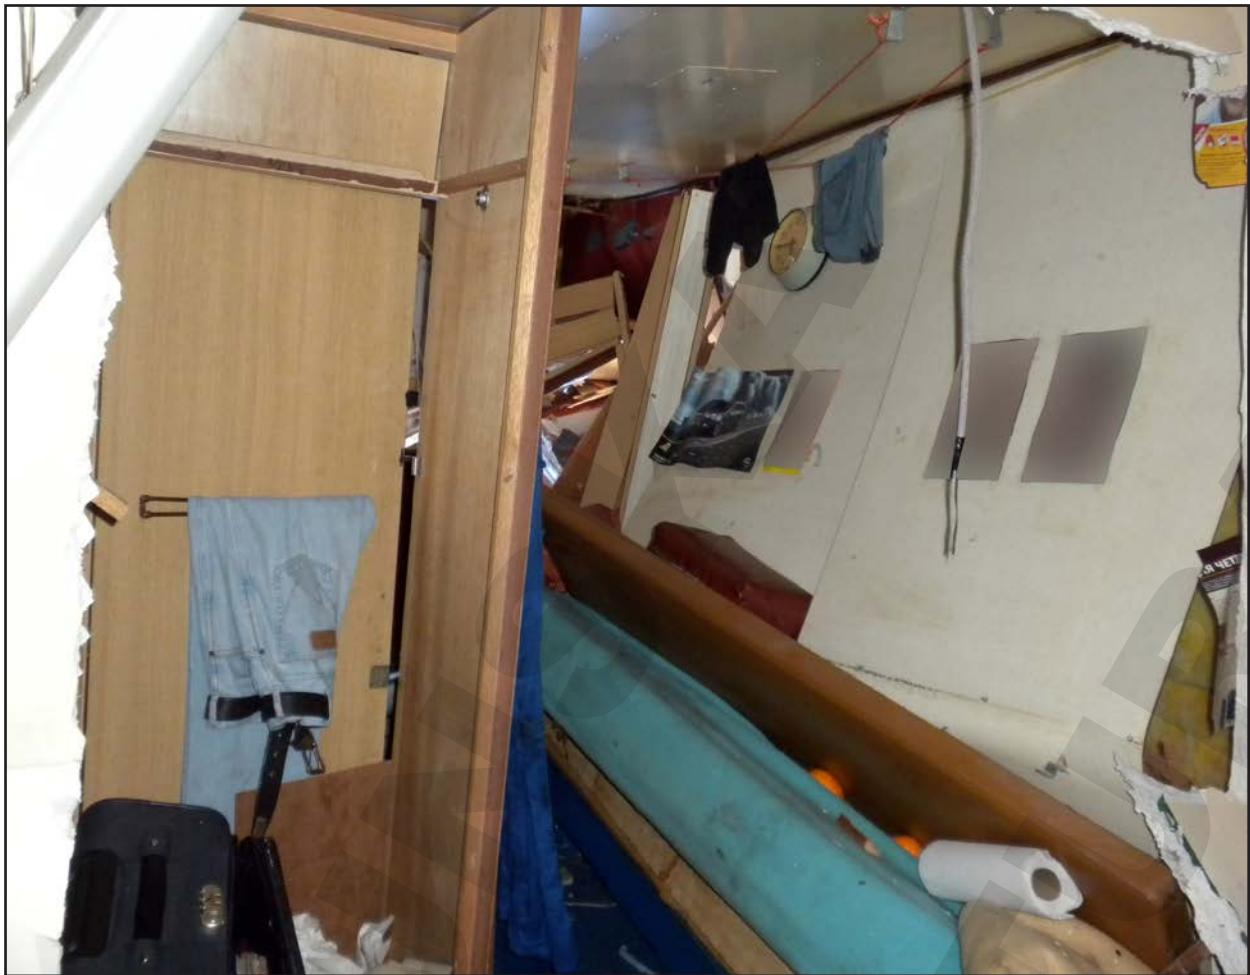
Although crew members were asleep in some of the heavily damaged cabins (**Figure 14**), there were no injuries either in the collision or subsequent abandonment.

Figure 14: Crew cabin on board *Seagate* – post-collision

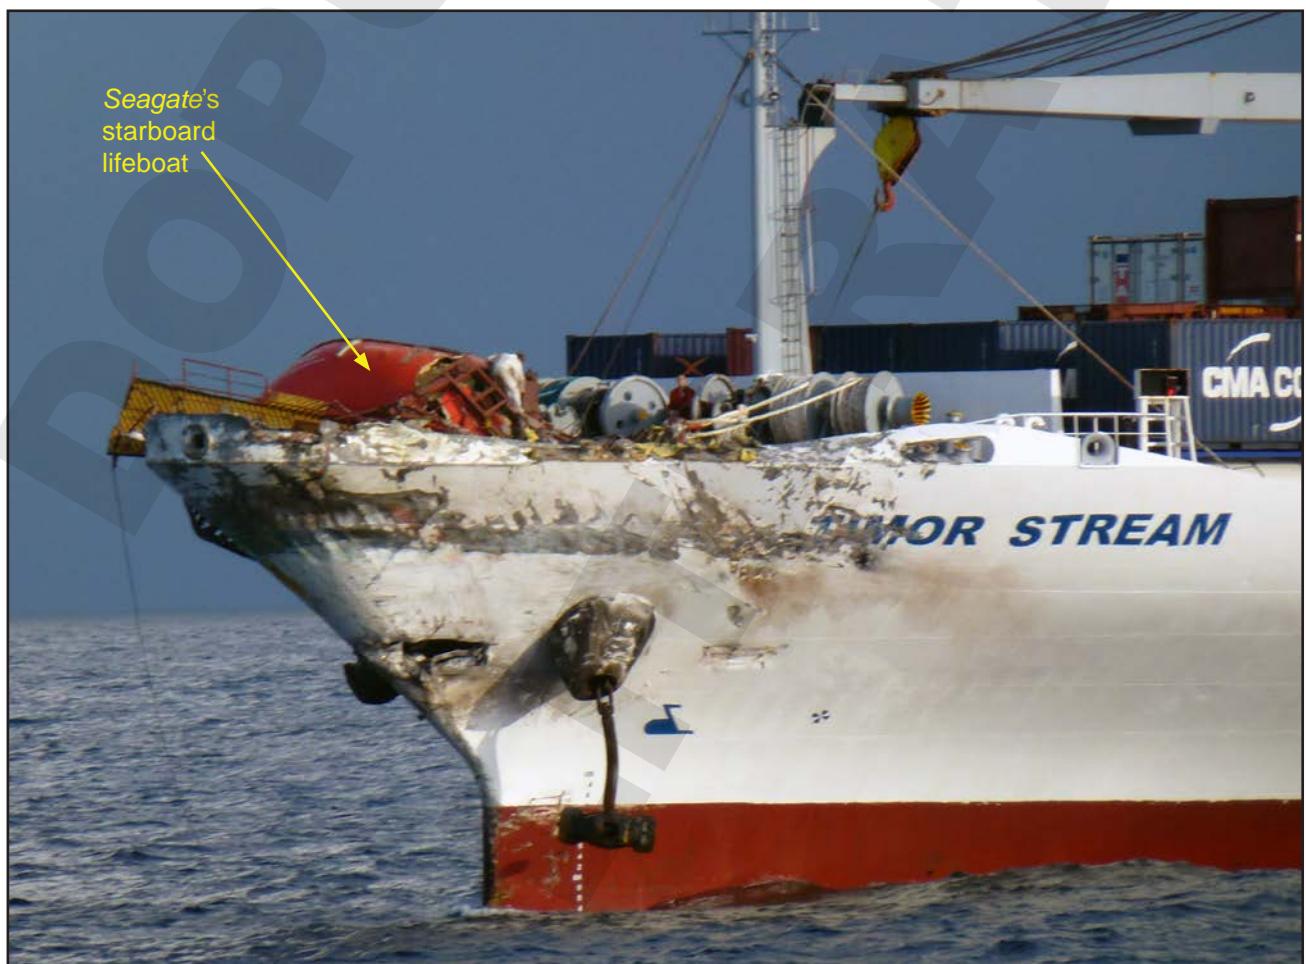
Timor Stream sustained major damage to its bow section (**Figure 15**); however, the collision bulkhead was not breached. The bulbous bow was damaged and the lower forepeak tank was holed. The shell plating to the upper fore peak tank was also holed above the waterline. Both anchors were badly damaged and were unusable. The forecastle deck, mooring equipment, bulwarks and mooring line fairleads were also severely damaged. There were no injuries and there was no pollution.

Figure 15: *Timor Stream*'s bow section – post-collision

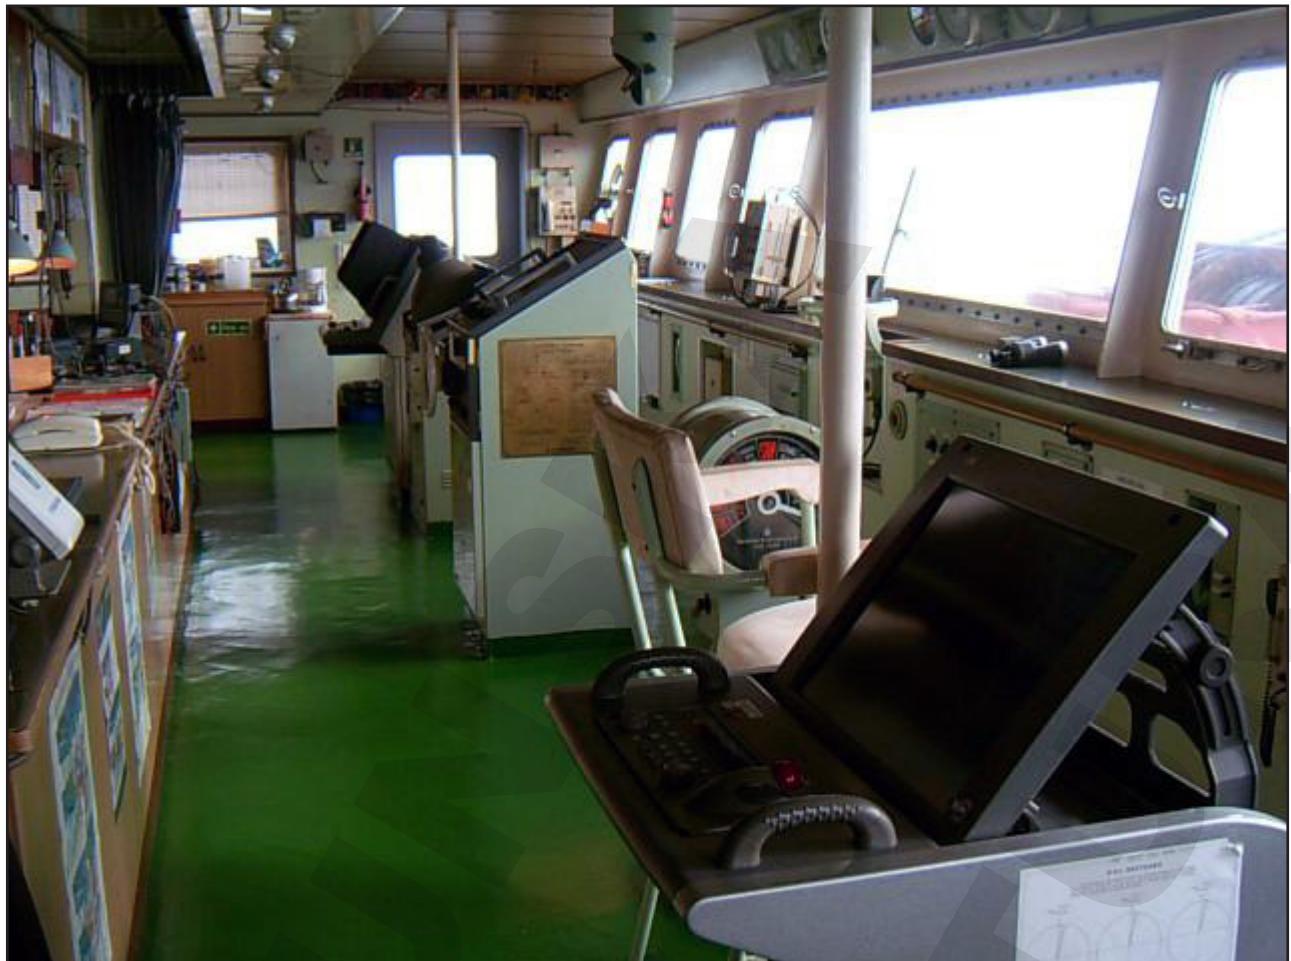
Figure 17: Seagate's bridge

Seagate's bridge (**Figure 17**) was fitted with two X band (3cm wavelength) radars, one on each side of the bridge. Both radars were fitted with an automatic radar plotting aid (ARPA). The starboard radar was also capable of displaying AIS data overlaid onto radar targets. At the time of the accident, it was reported that there was a fault with the system and, consequently, the radar was not able to display the AIS data.

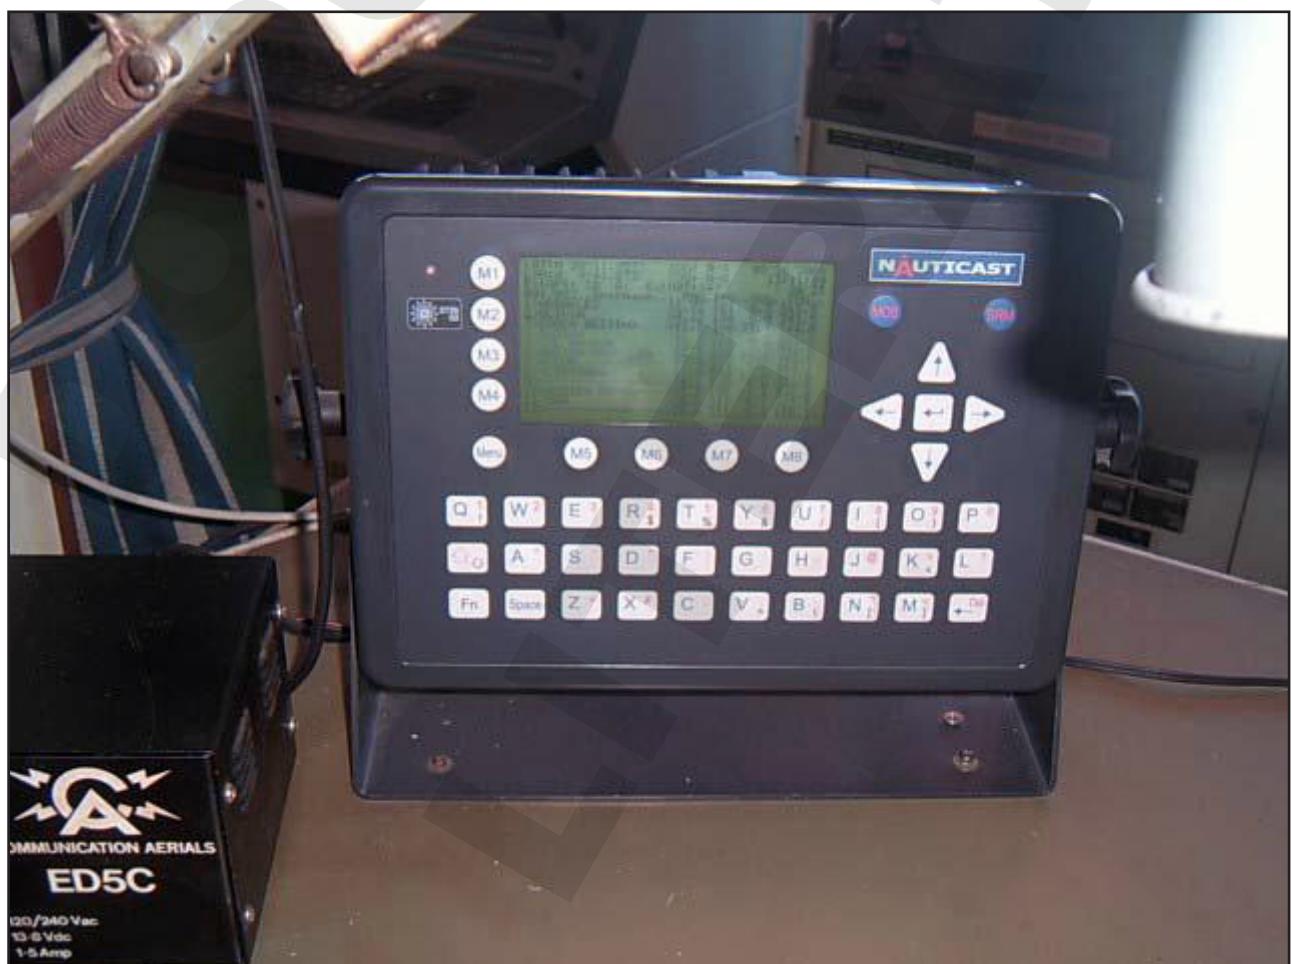
Figure 18: Seagate's AIS unit

A Nauticast AIS unit was located in the chart room (**Figure 18**). The AIS display screen was small and showed vessels' ranges, bearings, and names, in the form of text lists.

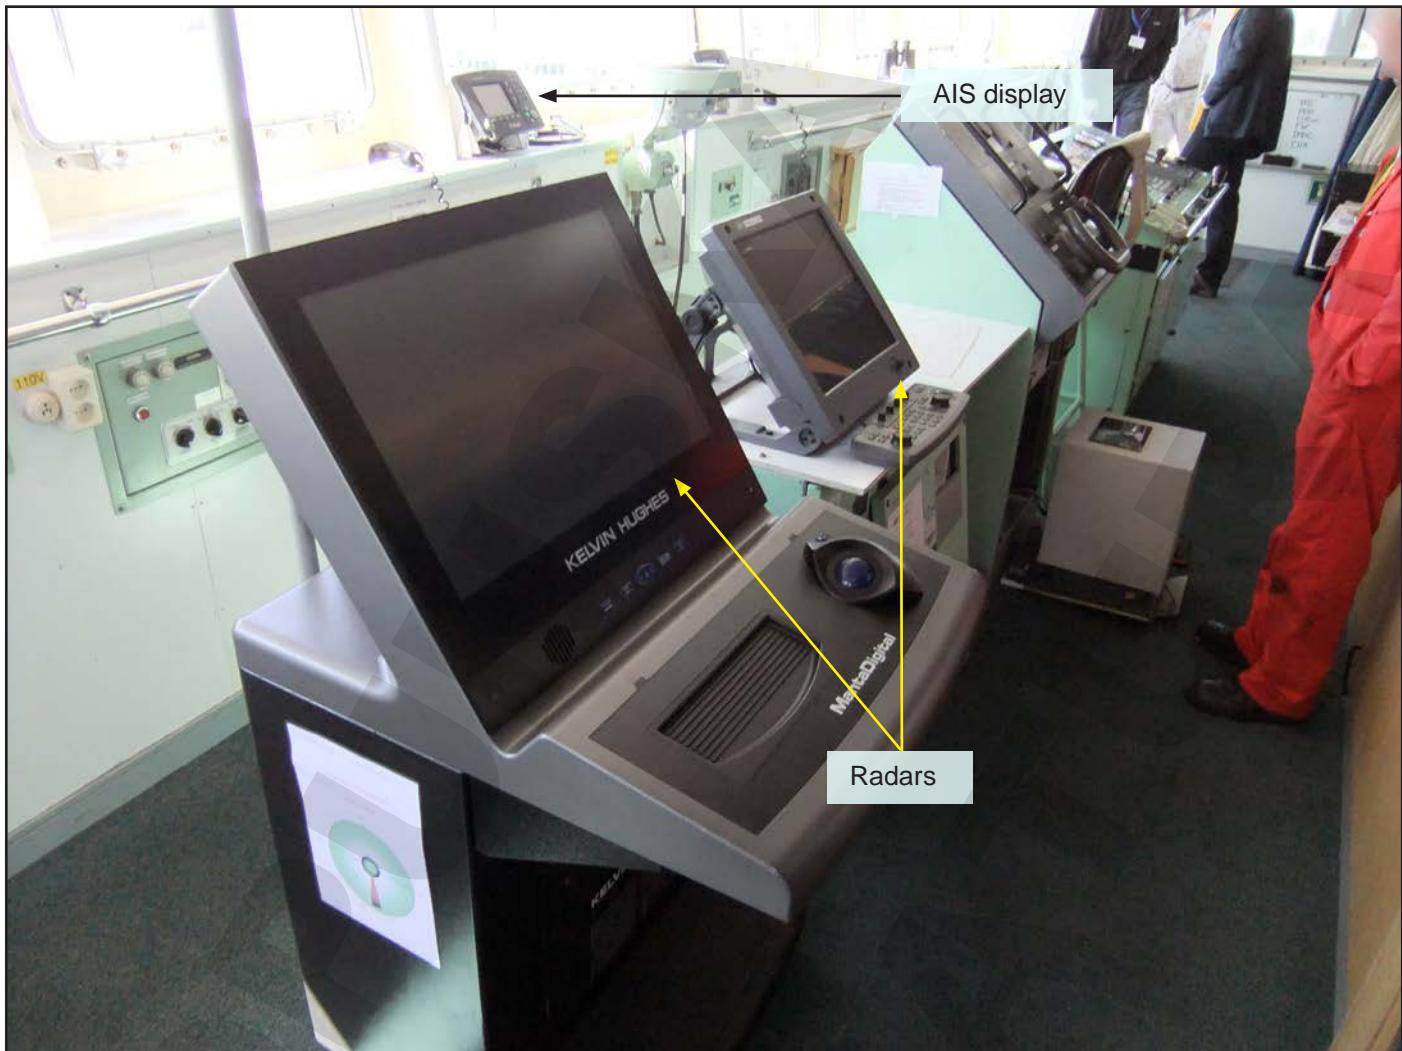
Figure 19: *Timor Stream*'s bridge – radars and AIS display

The primary means of navigation was with British Admiralty paper Standard Nautical Charts. Two X band (3cm wavelength) ARPA radars were located on the port side of the bridge (**Figure 19**). The AIS unit (**Figure 19**) was located by the centre bridge front window. A pilot chair was provided on the centre line and, although the view ahead was partially obstructed by the deck cranes (**Figures 20**), it was still possible to obtain a good view ahead by changing position on the bridge. A watch alarm was provided, but was not in use at the time of the accident.

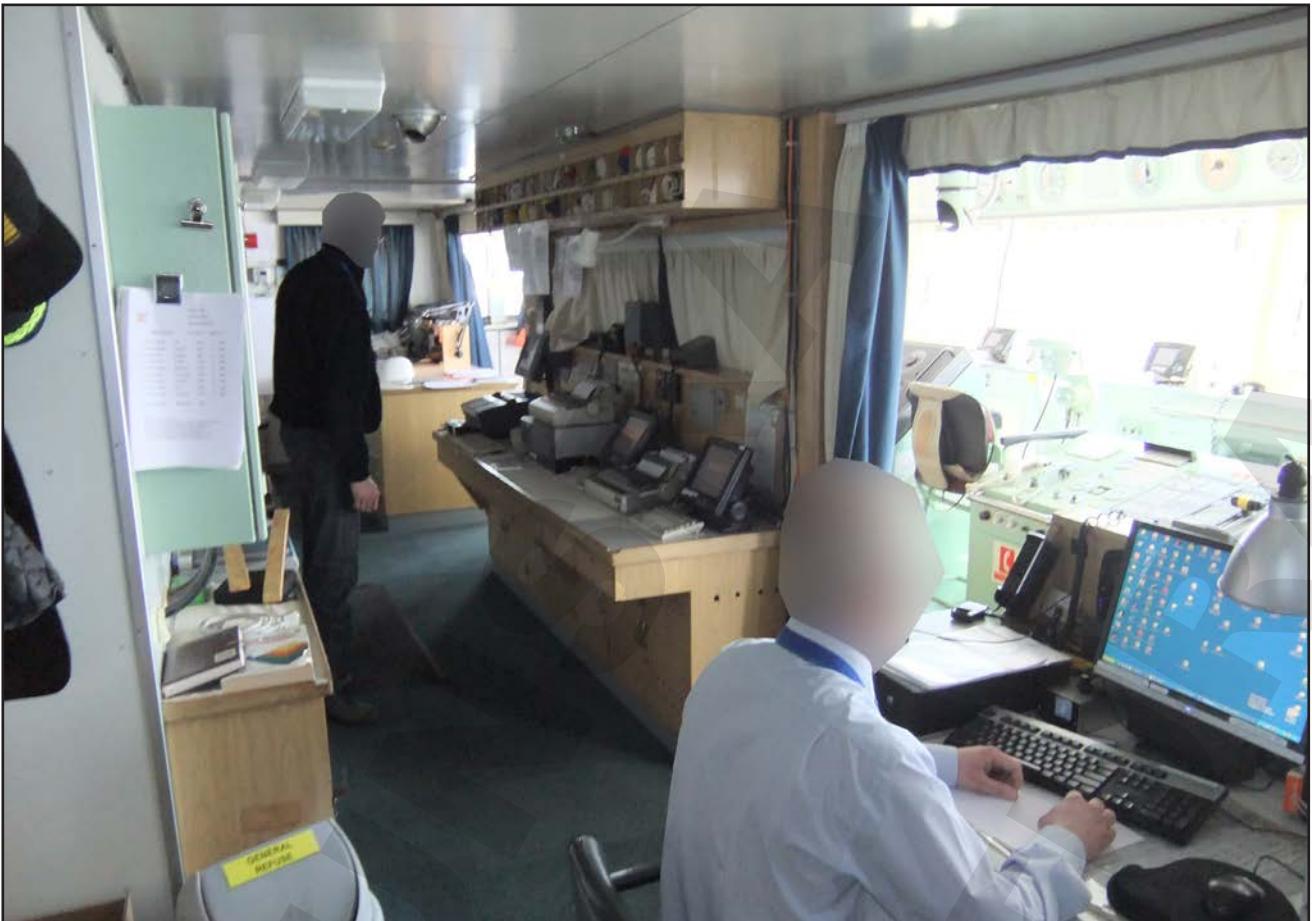
Figure 21: Timor Stream's bridge computer used for emails

At 0441, an hour before the collision, *Timor Stream's* master sent a departure email message from the computer located on the desk on the starboard side of the bridge. This would probably have taken him several minutes to complete. At that time, in the prevailing conditions, *Seagate* would probably have been detectable on *Timor Stream's* radar. At 0500, when the master plotted the ship's position on the chart, *Seagate* was 34° on *Timor Stream's* port bow at a range of 12nm. However, the master did not detect *Seagate* either visually or on his radar display. Similarly, he either did not notice, or took no action to correct, the incorrect heading information that was being transmitted from his vessel's AIS.

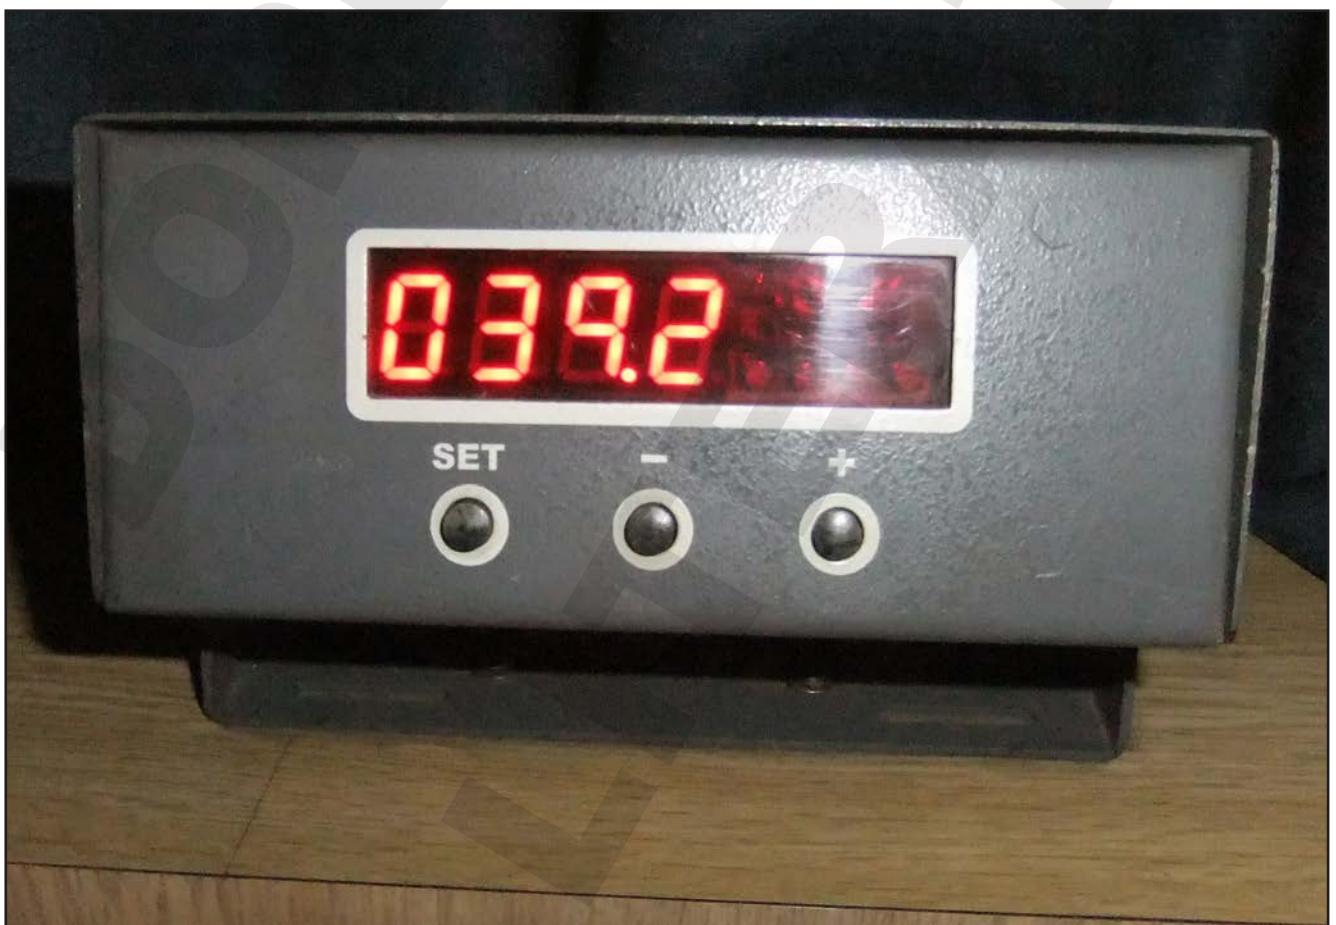
At the time of the accident, the AIS data transmitted from *Timor Stream* showed that the vessel's heading was around 160° different to its actual heading. This data was recorded on *Timor Stream*'s VDR and on *Battered Bull*'s electronic chart system. *Timor Stream*'s AIS data was received from the gyro compass via the gyro interface repeater (**Figure 22**). Following the accident it was established that the error introduced into the AIS was variable.

Figure 22: Timor Stream's gyro interface repeater

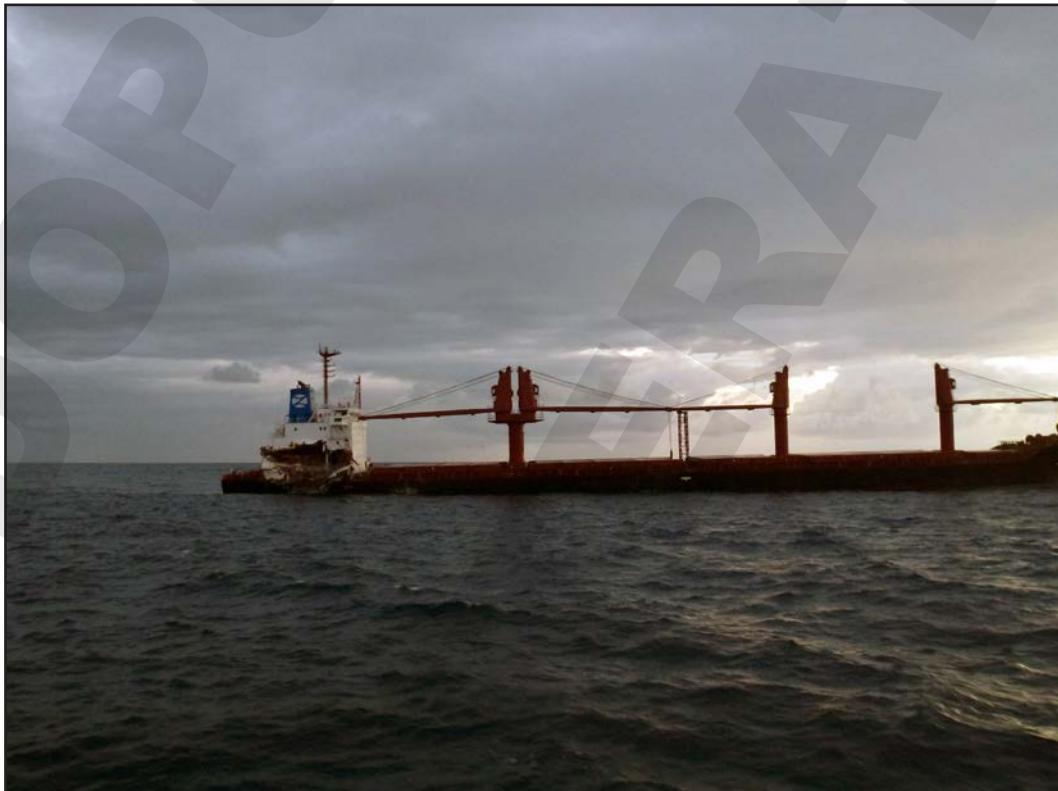
Figure 23: Environmental conditions shortly after the collision

- Cloudy, with occasional light isolated rain showers
- Wind: north-east, Beaufort Force 3
- Swell: north-east, height 1.5m (**Figure 23**)

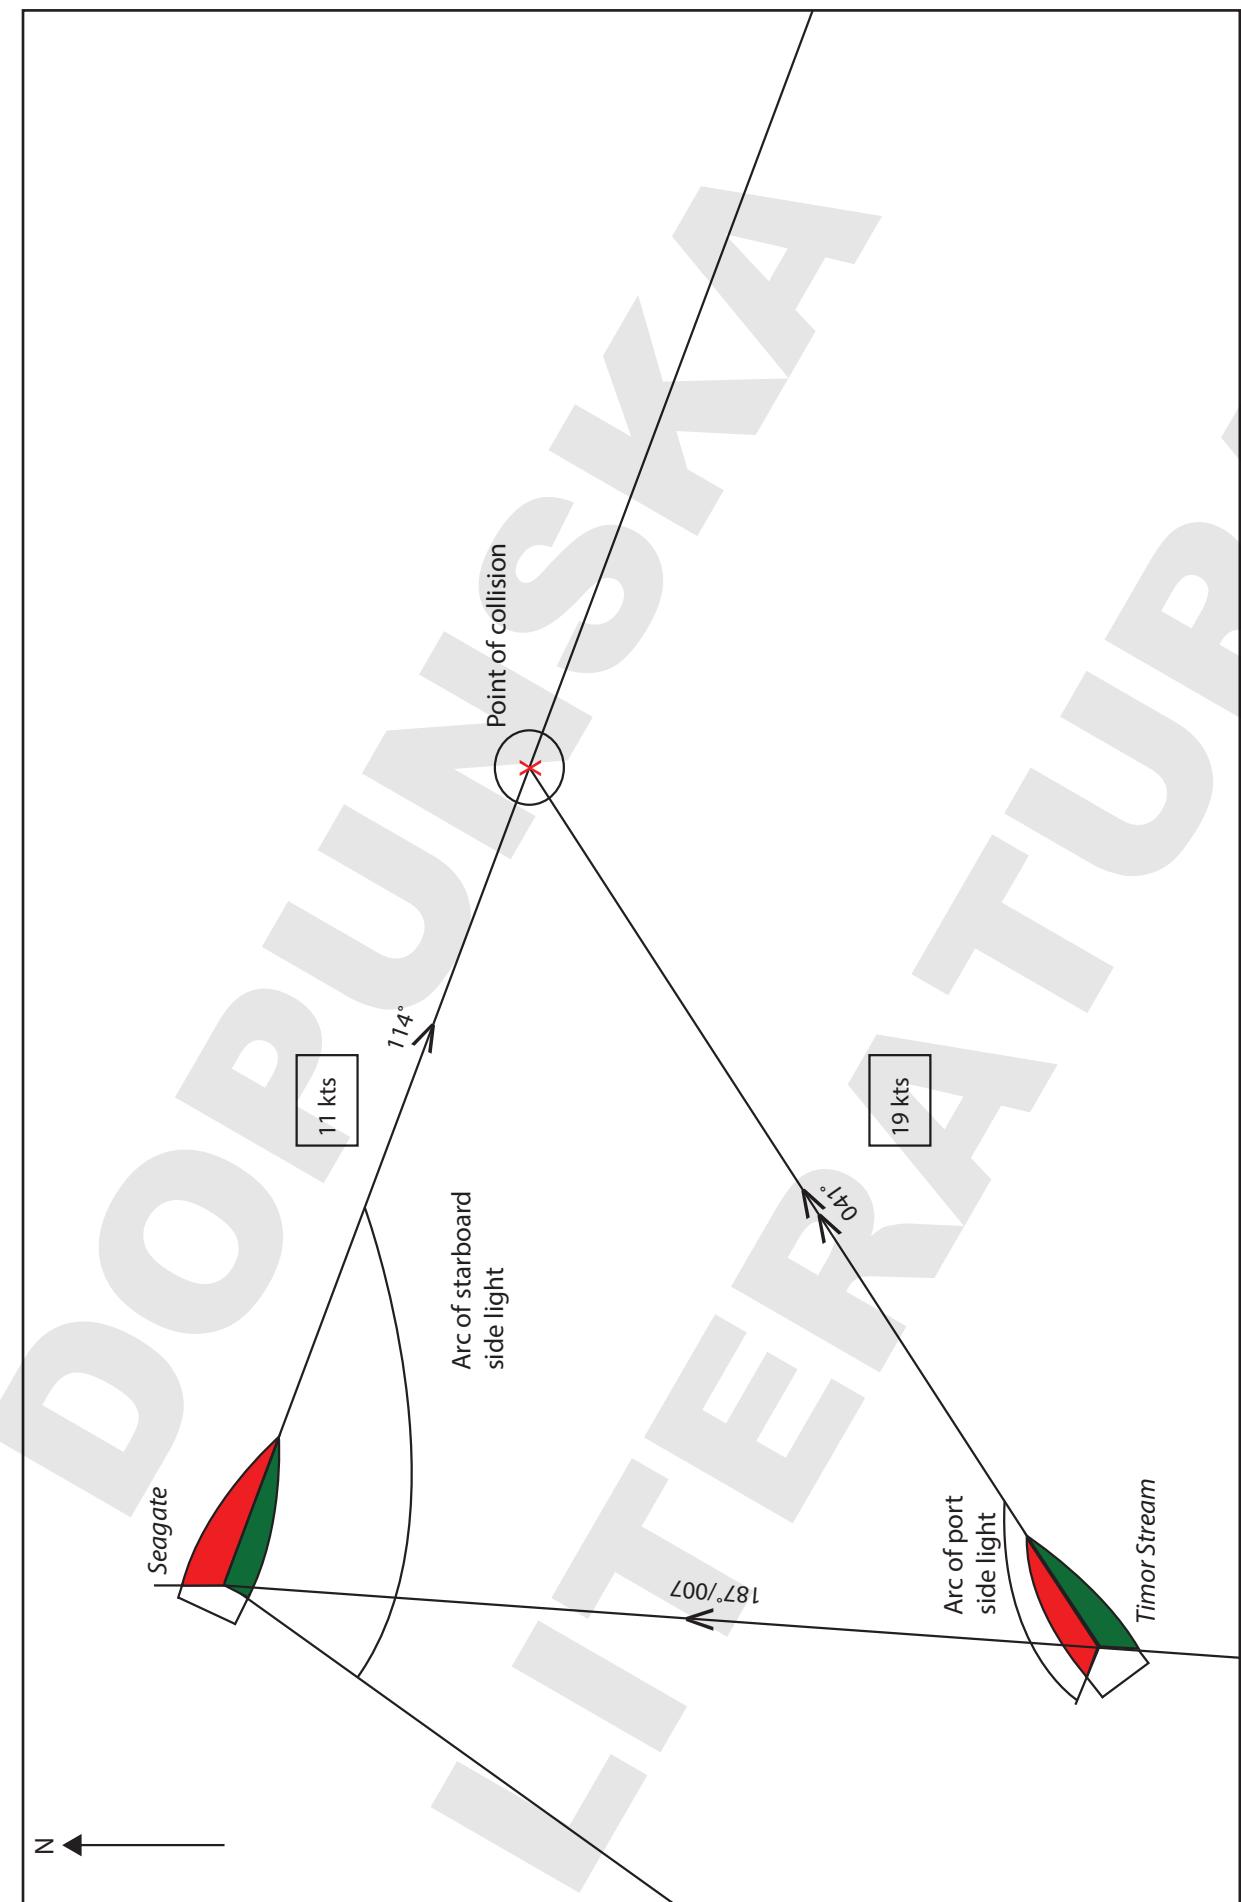
Seagate's chief officer believed that *Timor Stream* was on a heading of around 090° , at a speed capable of overtaking *Seagate* so that it would pass his vessel with a CPA of 3 or 4 cables. *Battered Bull*'s ECS data showed that, for the 40 minutes before the collision, *Timor Stream* was on a constant heading of 041° at a speed of 19.5 knots. *Timor Stream* was on a steady compass bearing of 187° from *Seagate*, 17° forward of *Seagate*'s starboard beam (**Figure 25**).

Figure 25: Collision analysis

his radar's ARPA, he should have identified that his estimate of *Timor Stream*'s heading differed by about 50° from its actual heading; he should also have realised that Seagate was in a crossing situation rather than an overtaking one.

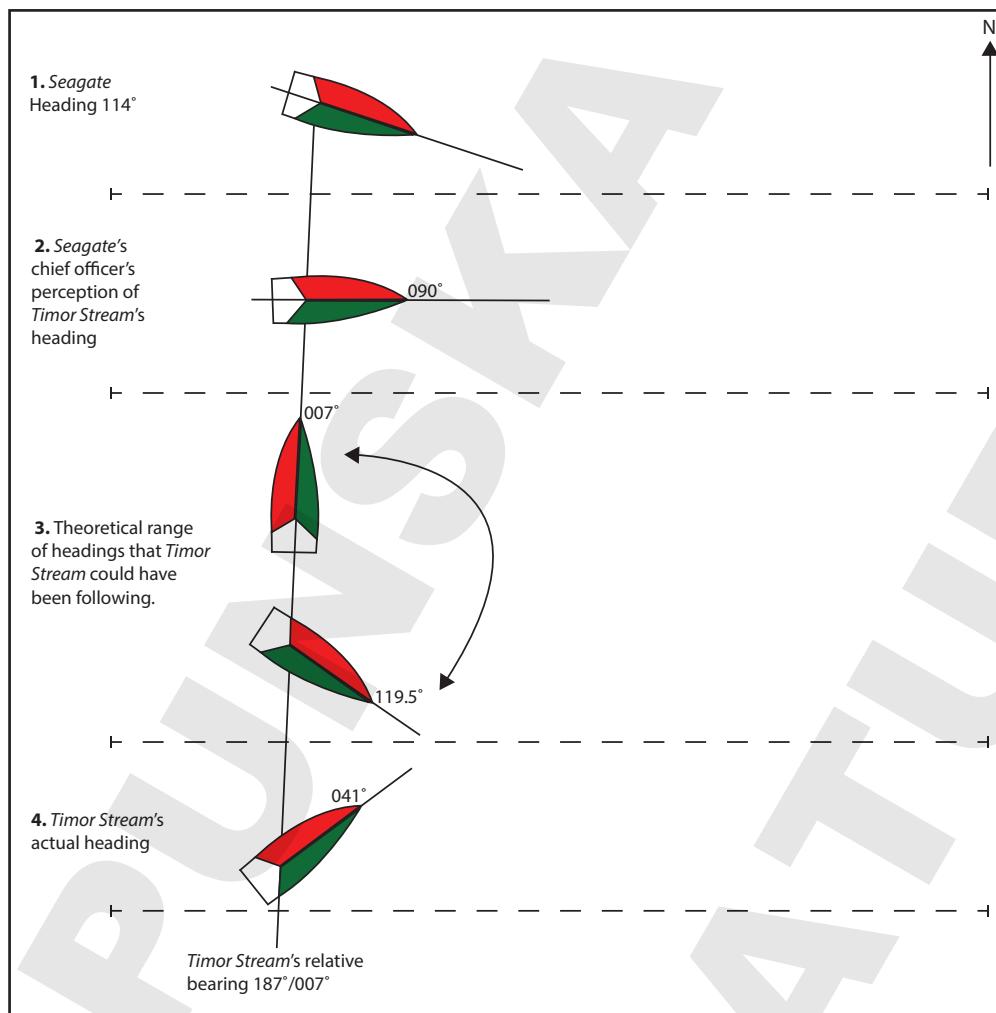
Figure 26: Analysis of the potential range of headings being followed by *Timor Stream* based on viewing its navigation lights alone

Timor Stream displayed the appropriate navigation lights for a ship of its size when underway. Its two masthead lights and port-side light could have, in theory, shown *Seagate*'s chief officer that *Timor Stream*'s heading was between 007° and 119.5° (**Figure 26**). Had the chief officer established *Timor Stream*'s actual heading using
