Storm surge damage to residential areas: a quantitative analysis for Hurricane Sandy in comparison with FEMA flood map

Siyuan Xian¹ · Ning Lin² · Adam Hatzikyriakou³

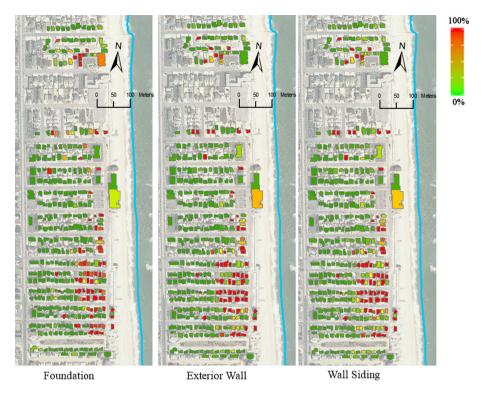
Fig. 2 Spatial distribution of the damage percentage for foundation (*left*), exterior wall (*middle*), and wall siding (*right*) of all surveyed buildings (the *blue curve* indicates the coastline)

strong surge and wave forces and waterborne debris impact. As discussed further in the following sections, the overall loss ratio at the building level also tends to decrease with increasing distance from the coast. In a few cases, houses far from the coast (e.g., beyond 200 m) suffered significant damage because of local debris impact.
