1 2 Rapid Assessment of Damaged Residential Buildings in the Florida Keys after Hurricane Irma 3 Siyuan Xian^{1,*}, Kairui Feng¹, Ning Lin¹, Reza Marsooli¹, Dan Chavas², Jie Chen², Adam 4 5 6 Hatzikyriakou¹ 7 Department of Civil and Environmental Engineering, Princeton University 8 ²Department of Earth, Atmospheric, and Planetary Sciences, Purdue University 9 10 **Abstract** 11 12 On September 10, 2017, Hurricane Irma made landfall in the Florida Keys and caused significant 13 damage. Informed by hydrodynamic storm surge and wave modeling and post-storm satellite imagery, a rapid damage survey was soon conducted for 1600+ residential buildings in Big Pine 14 15 Key and Marathon. Damage categorizations and statistical analysis reveal distinct factors 16 governing damage at these two locations. The distance from the coast is significant for the 17 damage in Big Pine Key, as severely damaged buildings were located near narrow waterways 18 connected to the ocean. Building type and size are critical in Marathon, highlighted by the 19 near-complete destruction of trailer communities there. These observations raise issues of 20 affordability and equity that need consideration in damage re

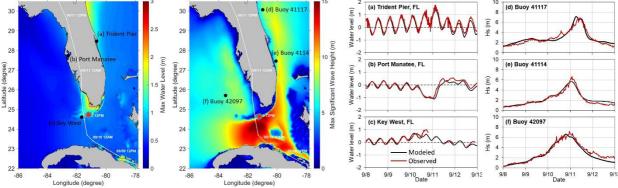
To understand the hazard and inform the field survey, we first use the coupled hydrodynamic and wave model ADCIRC+SWAN (Dietrich et al. 2012, Marsooli and Lin 2017) to simulate the storm tide (i.e., water level) and wave height for Hurricane Irma. To simulate Irma's storm tide and wave (Figure 1), we apply the surface wind (at 10-m) and sea-level pressure fields from National Center for Environmental Prediction Final (NCEP FNL) operational global analysis data (0.25· x 0.25· x 6 hours). The model results, e.g., time series in Figure 1, indicate that the model satisfactorily captures the temporal evolution and the peak values of the water levels and wave heights induced by Hurricane Irma. The model results show that the highest water levels, between 2 and 2.5 m, occurred in South/Southwest Florida. However, coastal zones in this region are predominantly uninhabited and covered by wetlands, so little loss of life or property is expected. High water levels are also estimated for the Florida Keys, especially islands located on the right side of the storm track. For example, the peak storm tide in Big Pine Key and Marathon reaches up to 2 m. The model results also show that large waves with a significant wave height of about 14 m reached a few kilometers off the Florida Keys. In contrast, wave heights off the southern and southwestern coasts of Florida are estimated to be small (< 2 m).

Figure 1. Hydrodynamic modeling of water level and wave height for Hurricane Irma. Left two panels show spatial distribution of modeled maximum water level and significant wave height, respectively. White curve represents storm track. Black points show locations of available tidal gauge and buoy stations. Red point indicates approximate location of study area. Right two panels compare observed and modeled time series of water level and significant wave height (H_i), respectively.

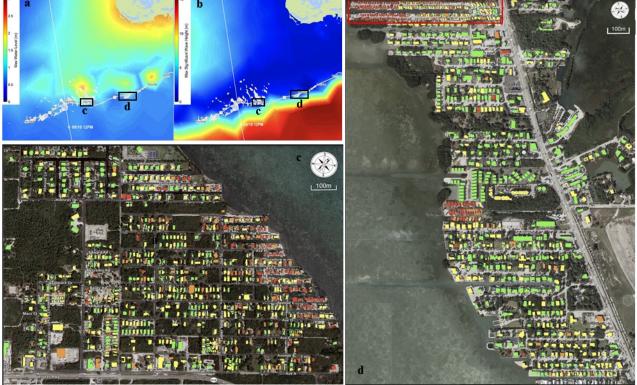
hydrodynamic modeling (Figs. 3a and 3b). The assessed damage state for each building appears in Figs. 3c and 3d. The number of buildings assigned into each category is shown in Table 1. The slightly and moderately damaged buildings (including limited, minor, and major damage states) are 72.7% and 75% of the total surveyed building for the assessed areas in Big Pine Key and Marathon, respectively. The percentages of the destroyed buildings are 13.9% and 16.9%, respectively. In both areas, the destroyed buildings are clustered. The destroyed buildings in Big Pine Key are near the coastline and narrow waterways, a strong indication that the damage was caused mainly by hydrodynamic forces. The completely destroyed buildings in Marathon cluster in the north and middle parts of the study area. The majority of those buildings are mobile homes.

106	Pine Key ⁴ . Some local homeowners in a destroyed trailer community in Marathon (indicated by
107	the red rectangle in Fig. 3d) with whom we talked had lived in trailers as their primary homes for
108	decades without flood insurance. Financial constraints may hinder their rebuilding or relocating
109	to somewhere safer. As low-income people living in mobile homes suffered most, natural
110	hazards worsen economic inequality in this case. In contrast, discussion with local residents in
111	Big Pine Key indicated that structures there were mostly secondary homes with two or three
112	stories, and many were designed to withstand hurricane hazards (e.g., key assets raised above the
113	ground floor). These observation raise again issues of affordability and equity (Montgomery and
114	Chakraborty, 2015). Policies relevant to hurricane damage recovery and rebuilding must address
115	these issues.
116	Future studies right following this work would focus on the development of

Figure 3. Spatial distribution of estimated hazards and damage states in study areas. (a) and (b) show simulated maximum total water level and significant wave height, respectively; (c) and (d) show assessed damage state (none: green; minor: yellow; major: orange; destroyed: red) for residential buildings in Big Pine Key and Marathon, respectively.

Possible measures to reduce flood vulnerability in the study areas include elevating and strengthening the buildings (especially mobile homes) and relocating homeowners living near the coastline (and narrow waterways) further inland. However, potential financial challenges exist, especially for Marathon, where the median annual income is \$50.976 vs. \$63,716 for Big
